Complete Streets in the City of Trenton: Existing Conditions Analysis

May 2018

Prepared for:
The Trenton Health Team

Prepared by:
The Alan M. Voorhees
Transportation Center
Edward J. Bloustein School of
Planning and Public Policy
Rutgers, The State
University of
New Jersey

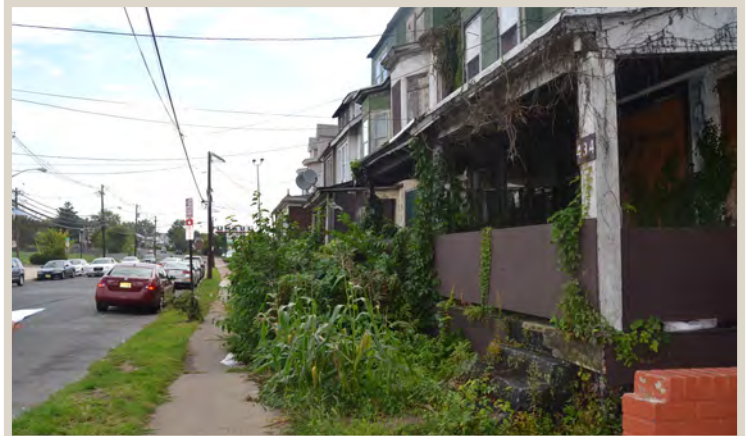
The sidewalk and the homes on the east side of the street are in poor condition. There is a narrow sidewalk in front of homes with vegetation that is overgrown (Figure 19). South of the homes, there are two auto-oriented businesses which have various driveways across the sidewalk. The business at the corner of Brunswick Avenue and Southard Street is a gas station with a continuous driveway.

Figure 19. Overgrown vegetation on sidewalk.

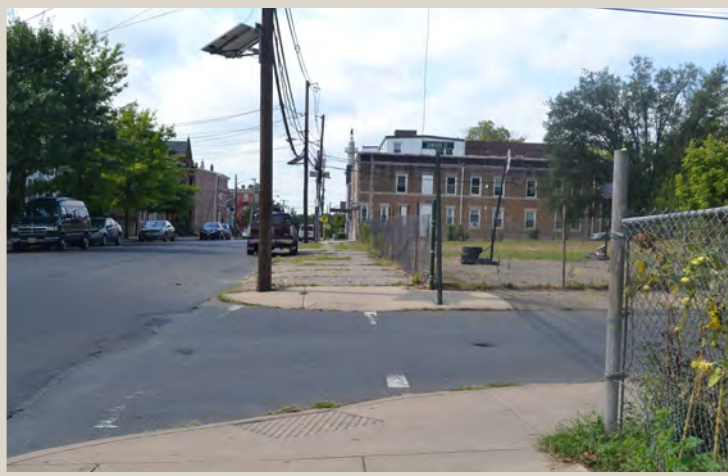
Avenue, is in especially poor condition with a section that has deteriorated into gravel (Figure 20). Across the street, the sidewalk conditions briefly become excellent in front of what appears to be more recently constructed townhomes. The sidewalk is wide with a brick trim and well maintained trees. Two additional minor streets, Cavell Street and Violet Street, terminate at Brunswick Avenue in close proximity.

Figure 20. Brunswick Avenue and Sanford Street. Sidewalk in front of vacant property is in especially poor condition.

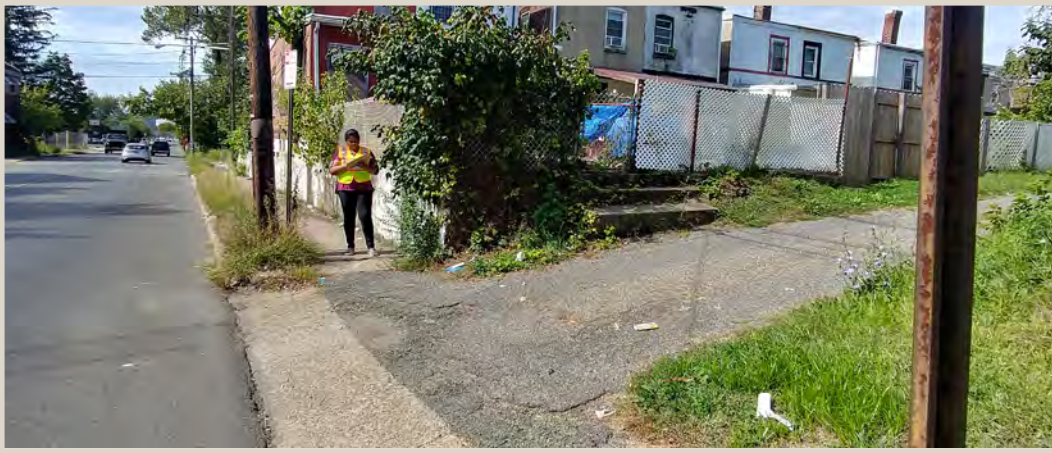
Figure 28. Poor sidewalk conditions north of Blane Alley.

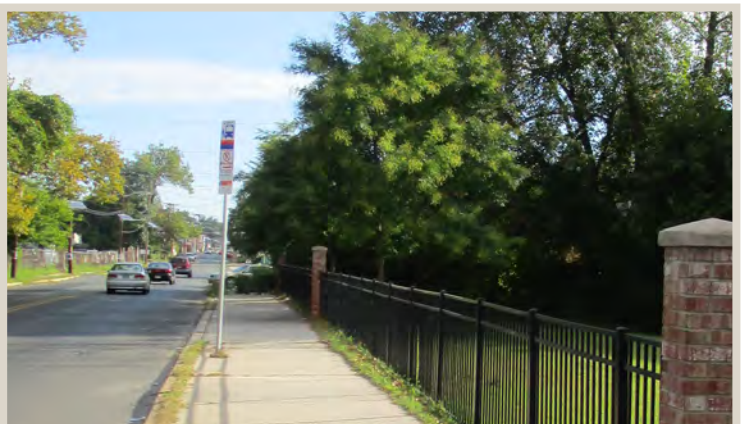
Figure 30. NJ Transit bus stop which lacks rider amenities.

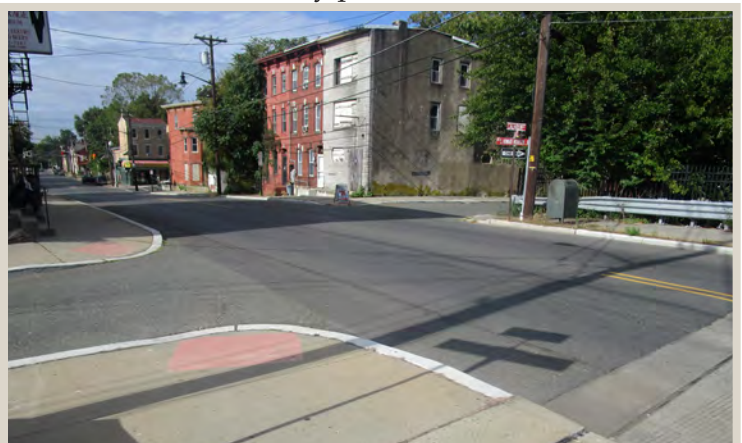
Figure 43. Missing crosswalks and faded ramps at the Church Street intersection.

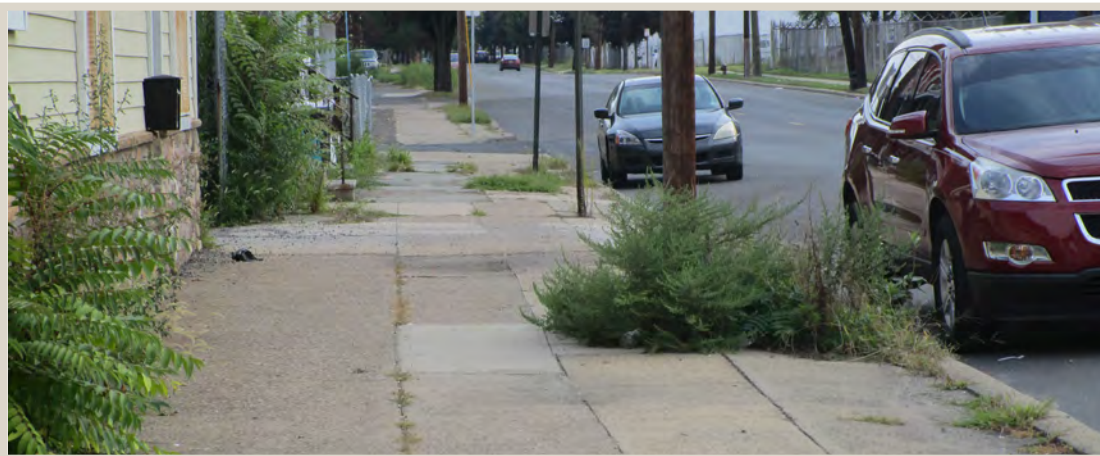
Figure 59. Cracked sidewalks and overgrown weeds.

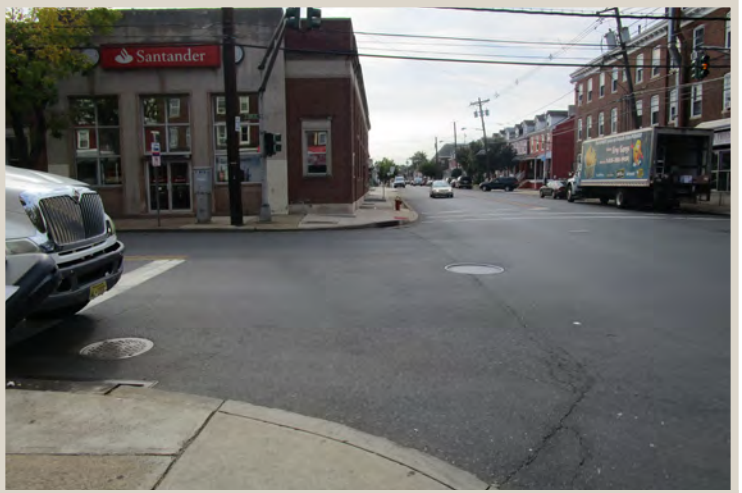
Figure 63. Missing crosswalk at North Olden Avenue intersection.

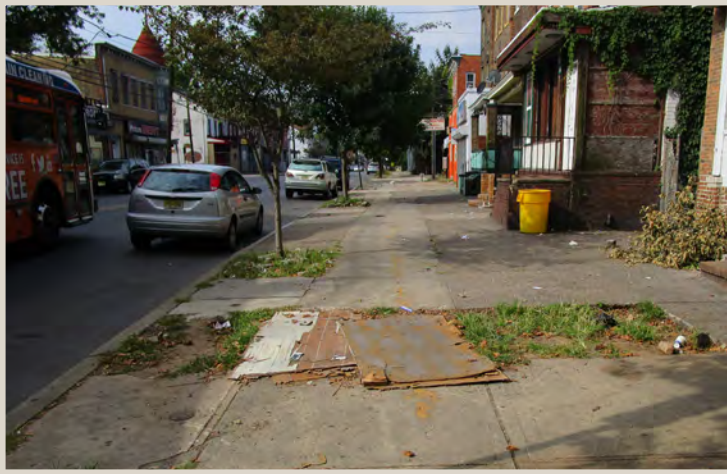
Figure 66. Missing sidewalk with makeshift bridge.

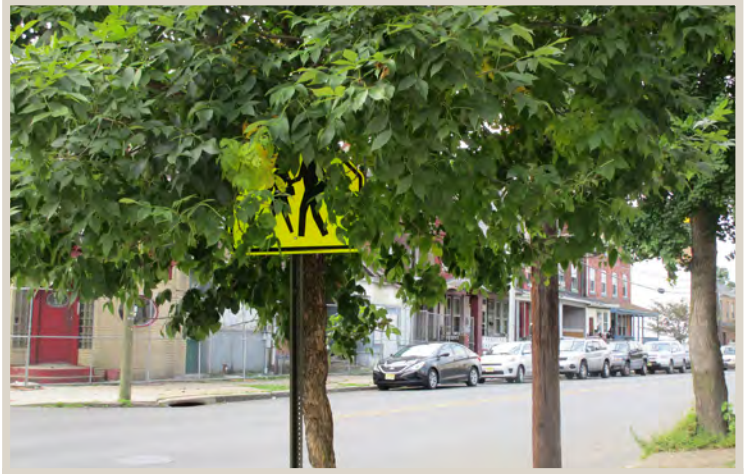
Figure 67. Mid-block crosswalk sign covered by overgrown tree.

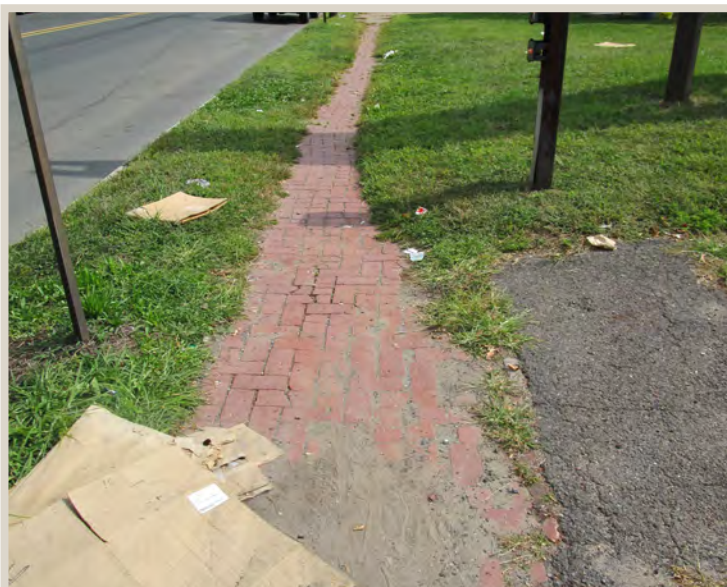
Figure 72. Sidewalk narrows and nearly disappears.

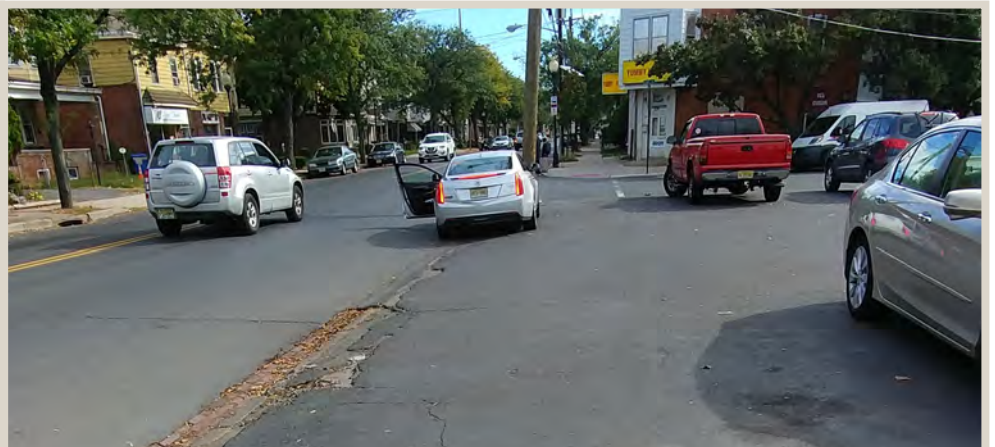
Figure 87. Missing sidewalks along Hamilton Avenue.

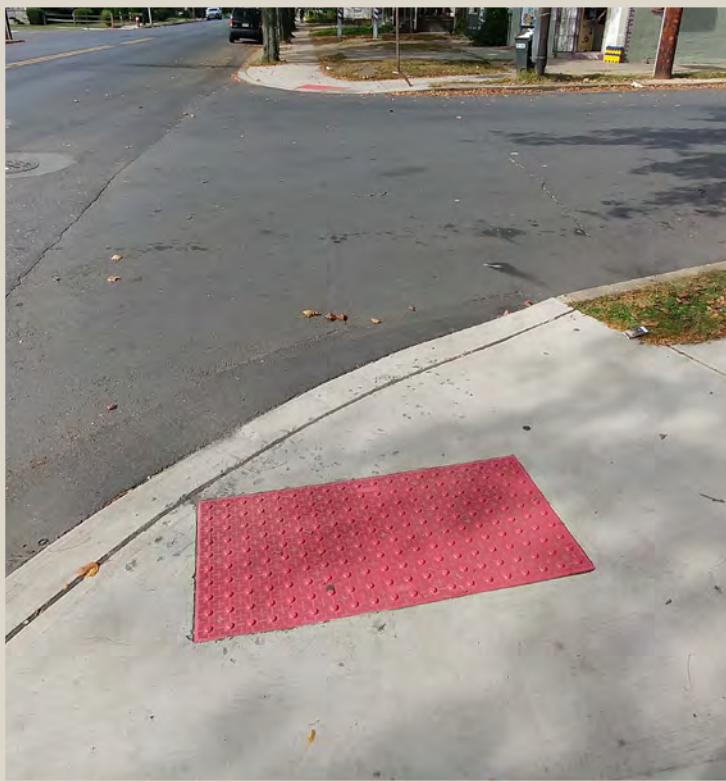
Figure 88. ADA compliant ramps, but missing crosswalks.

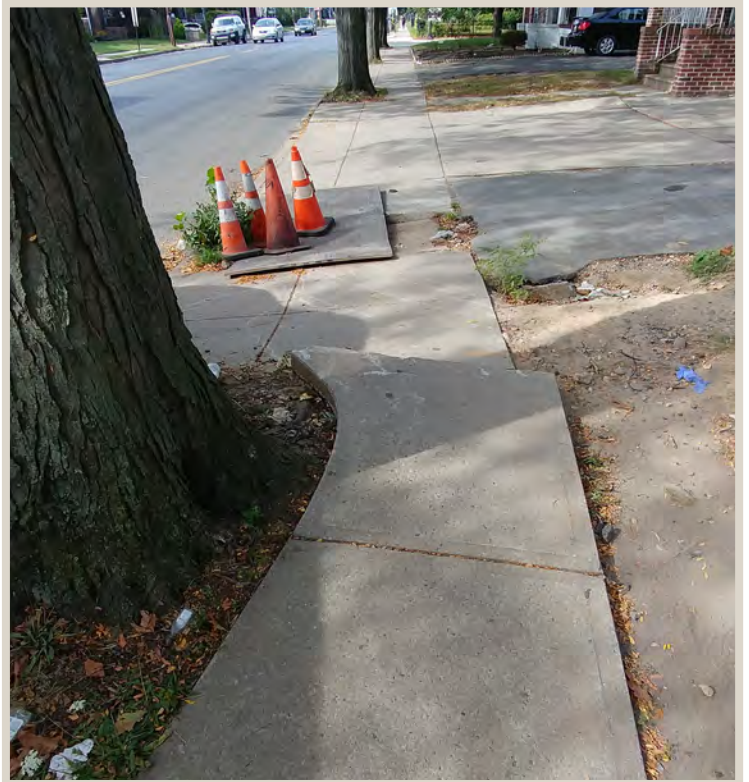
Figure 89. Tree-lifted sidewalk creates a barrier for some pedestrians.

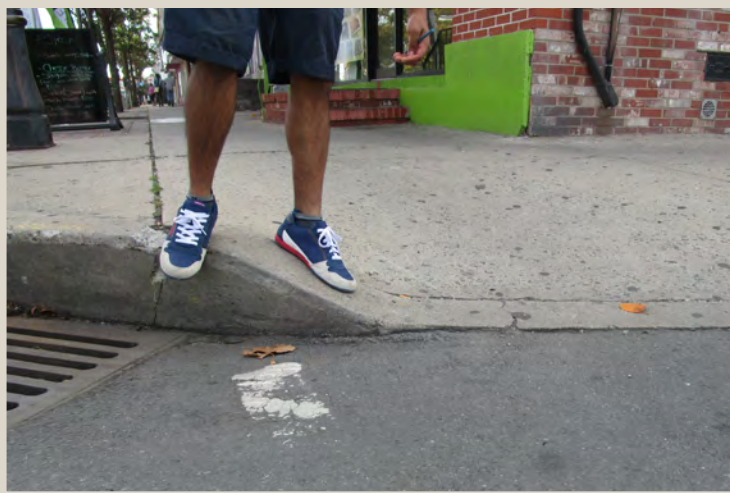
Figure 97. Curb ramp with a steep slope and missing truncated domes.

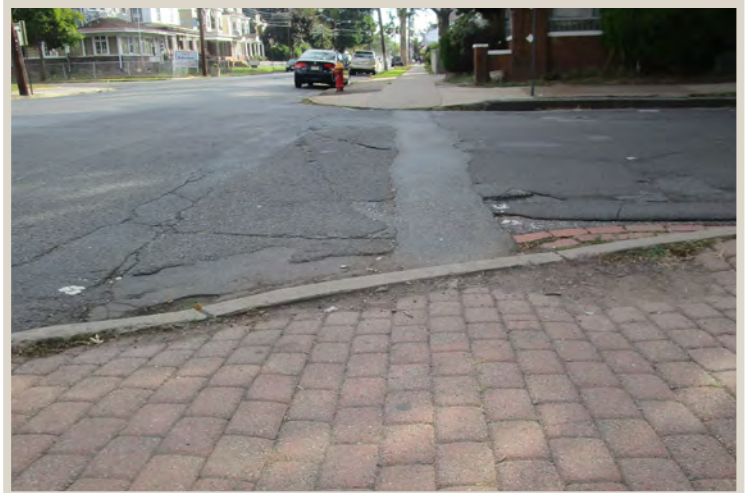
Figure 98. Missing crosswalk and non-compliant curb ramps.

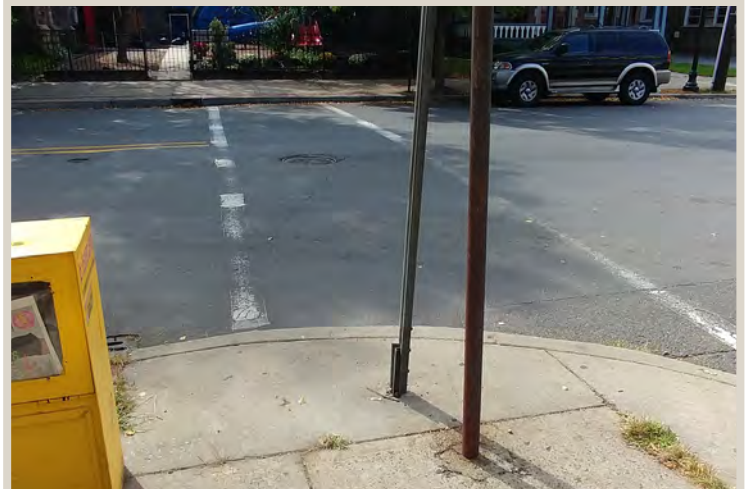
Figure 103. Missing curb ramps.

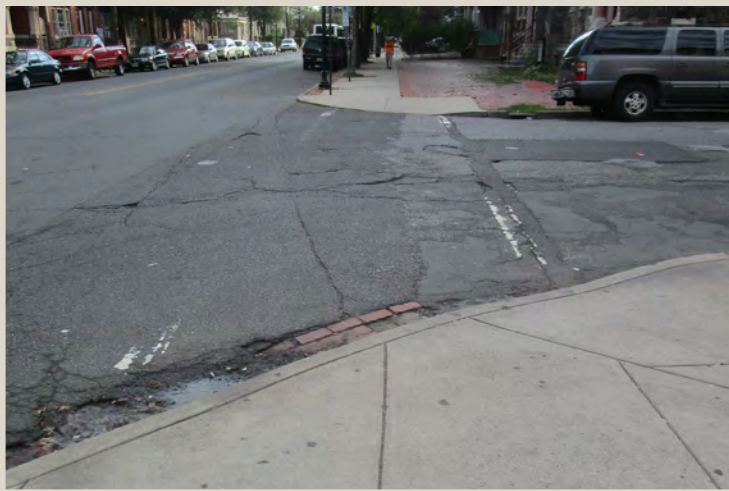
Figure 106. Faded crosswalks and non-compliant ramps.

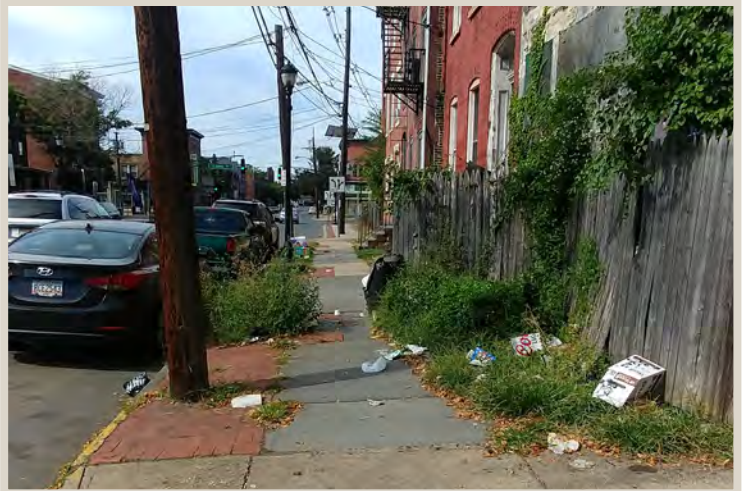
Figure 107. Sidewalk cluttered with litter and overgrown shrubbery.

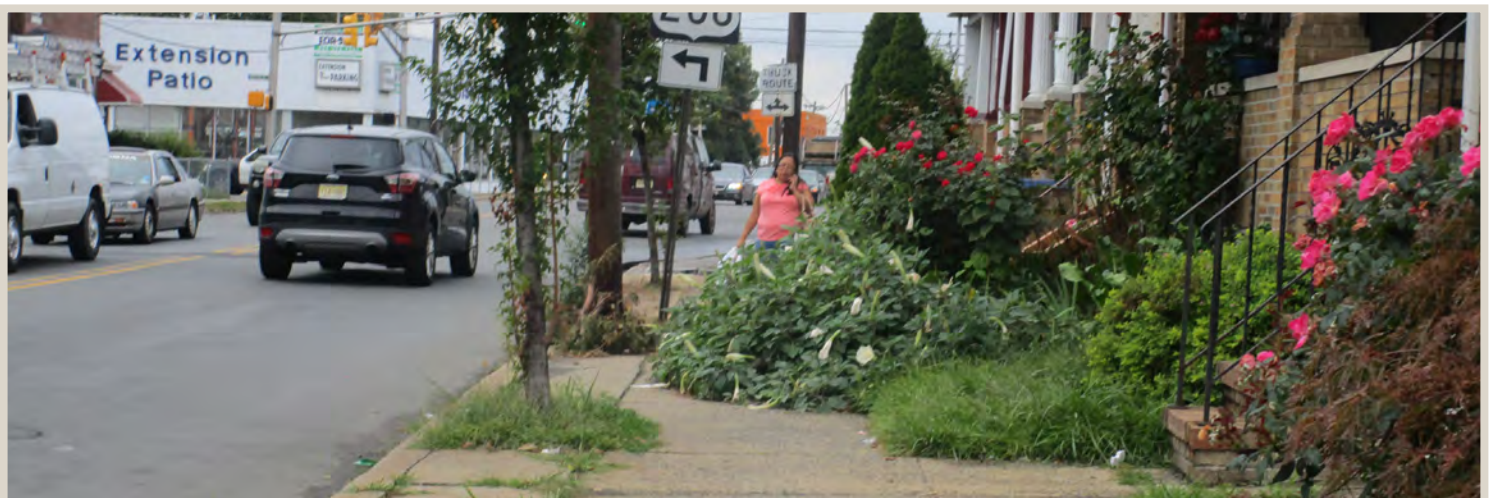
Figure 117. Overgrown plantings block entire sidewalk.

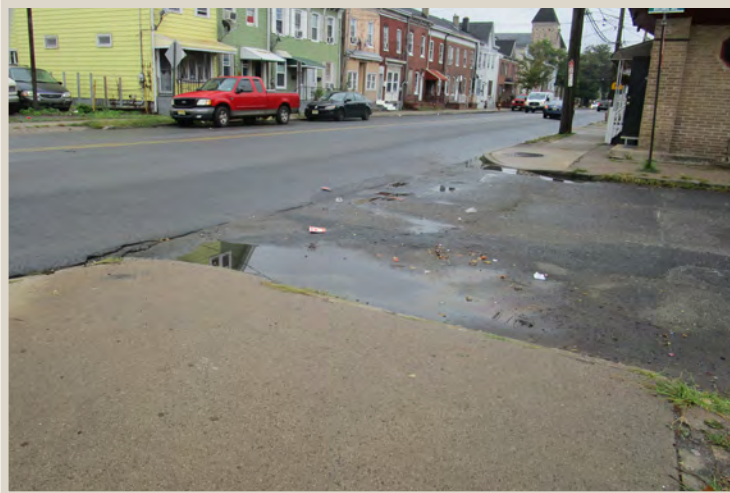
Figure 124. Missing crosswalk and non-compliant ramps.

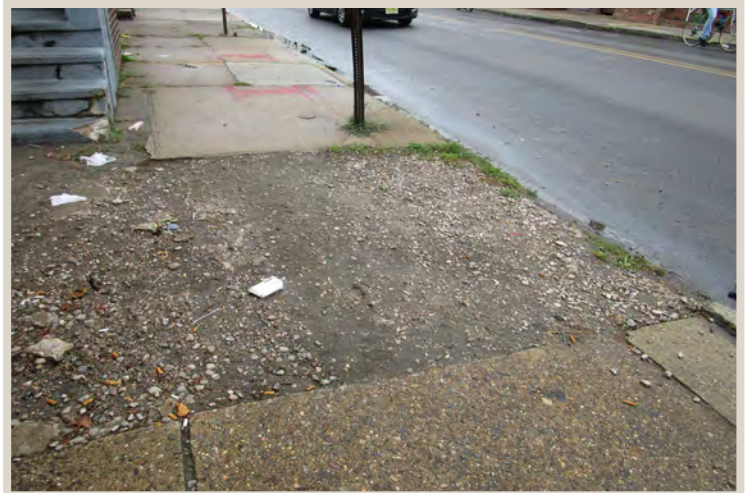
Figure 125. Sidewalk reduced to dirt and gravel.

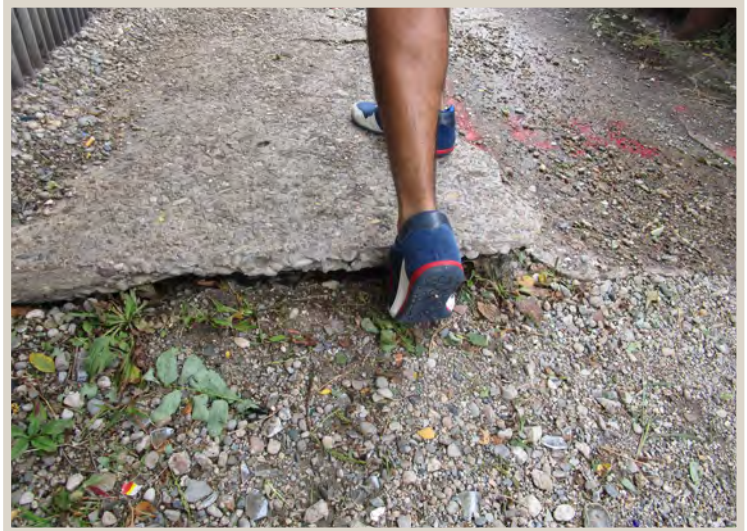
Figure 134. Sidewalks in extremely poor condition.

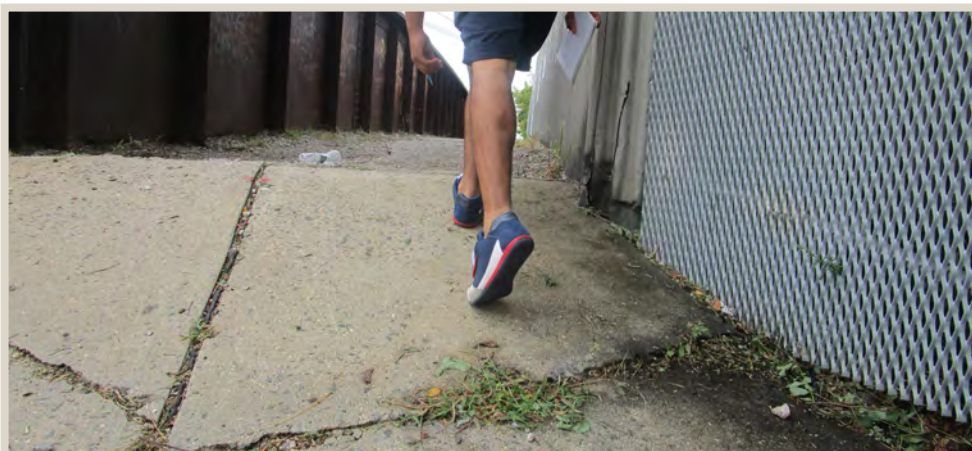
Figure 135. Steep incline along cracked sidewalks.

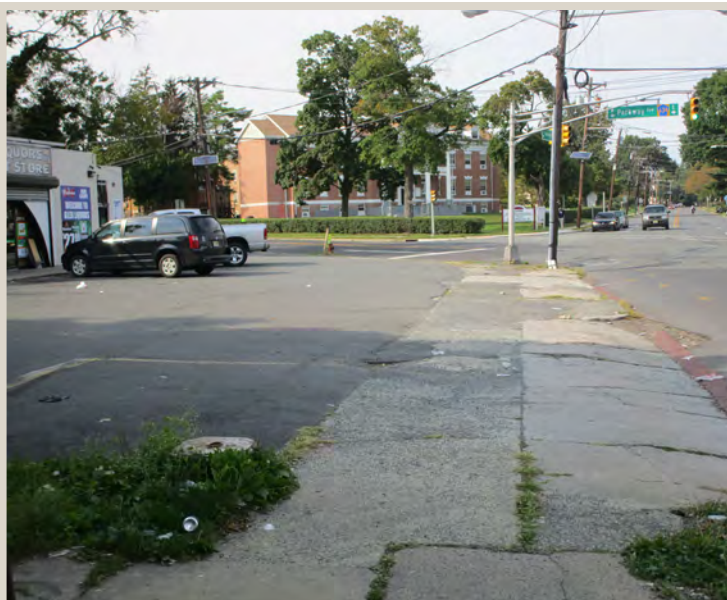
Figure 139. Continuous driveway access across sidewalk.

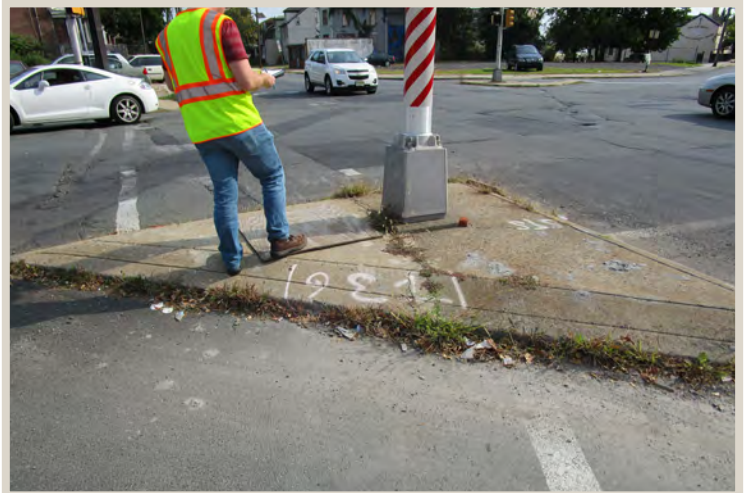
Figure 146. Missing ramps on pedestrian island.

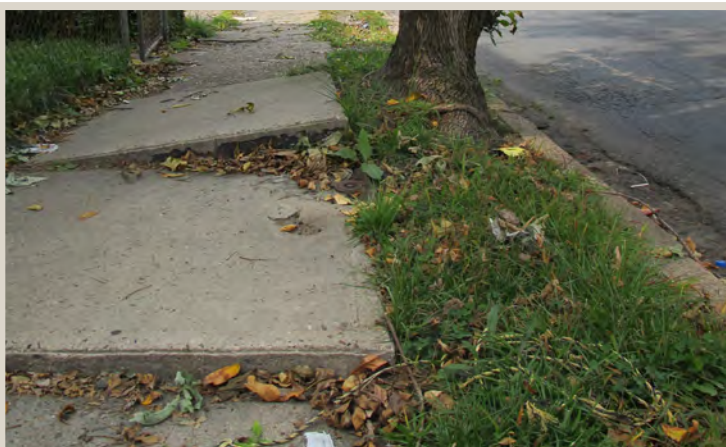
Figure 147. Roots have lifted the sidewalk into stairs.

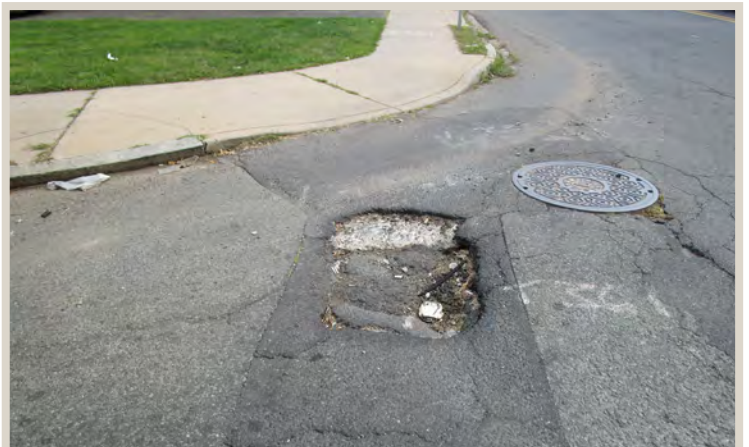
Figure 148. Asphalt near crosswalk in poor condition.

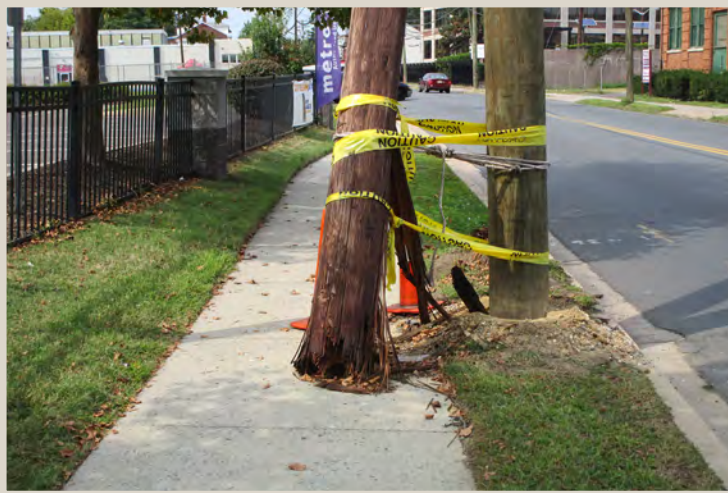
Figure 149. Haphazard utility pole work.

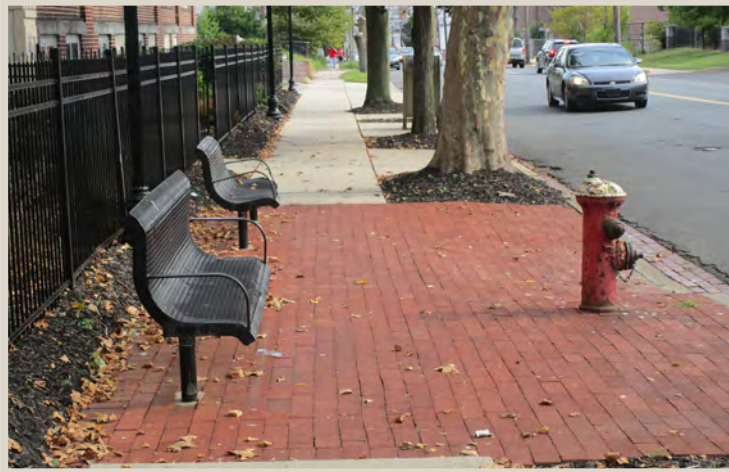
Figure 153. Bus stop amenities located away from the bus stop.

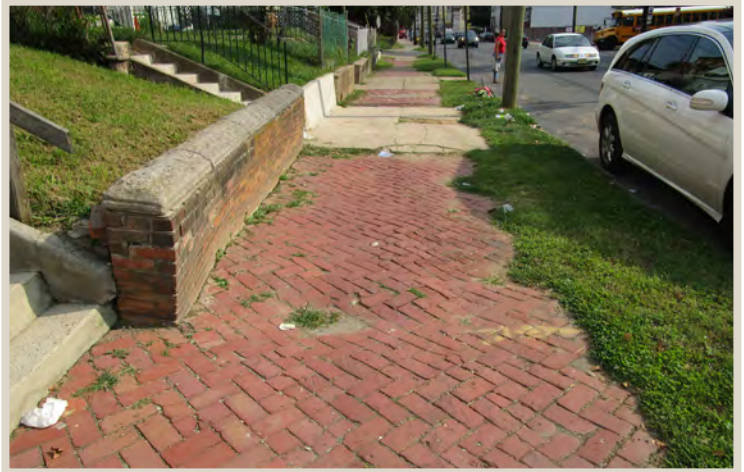
Figure 154. Sidewalk in poor condition.

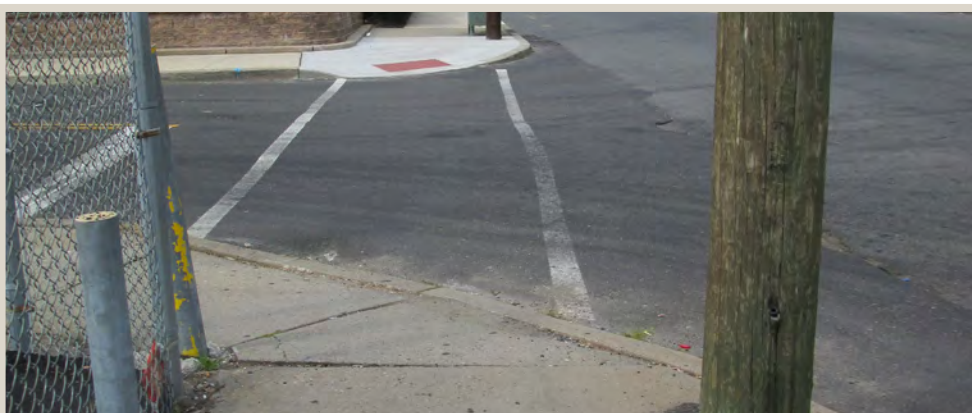
Figure 155. Non-compliant ADA ramp is oriented diagonally into the intersection.

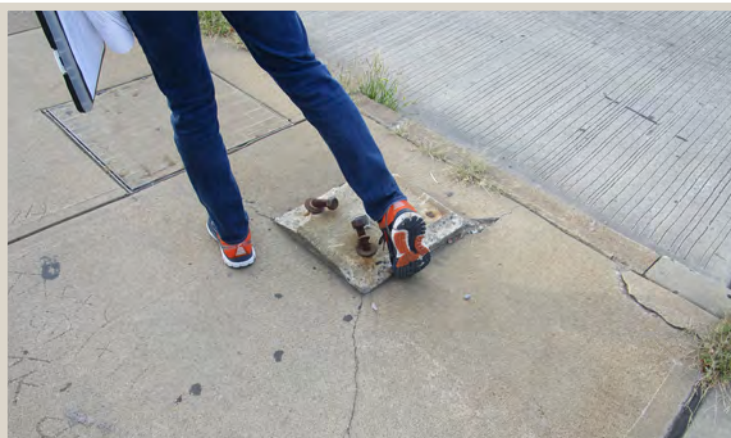
Figure 161. Tripping hazard along the sidewalk.

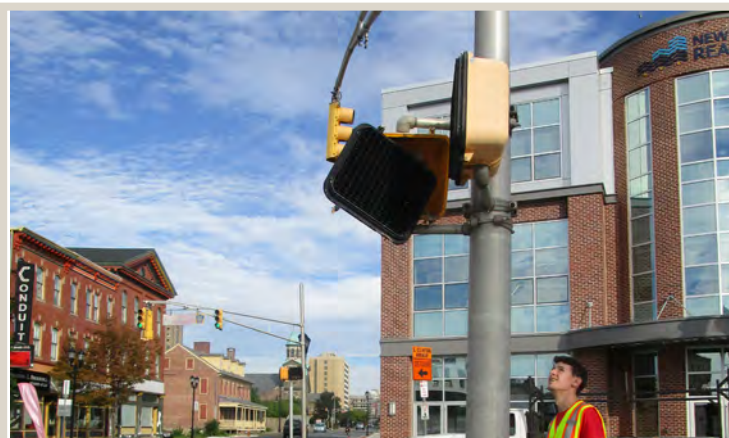
Figure 162. Non-operational pedestrian signal.

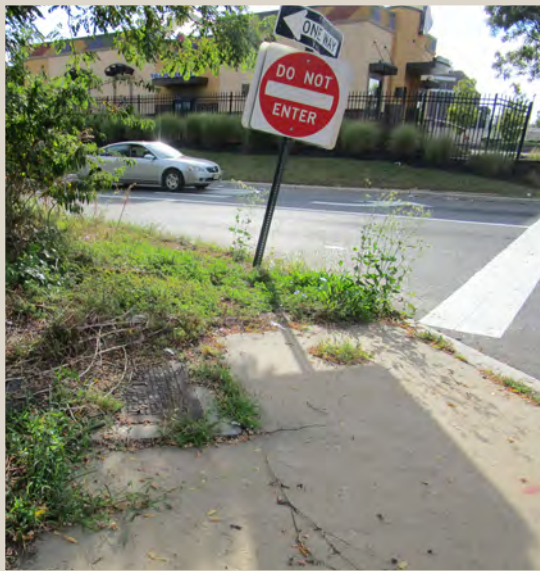
Figure 163. Missing sidewalks.

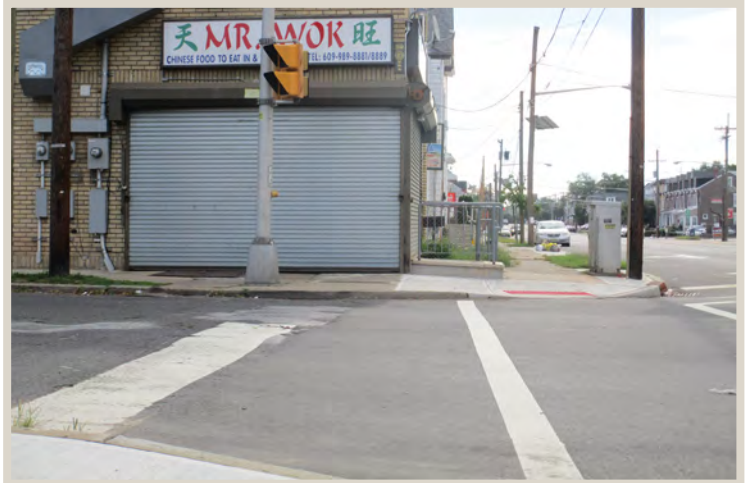
Figure 170. Misaligned pedestrian signal.

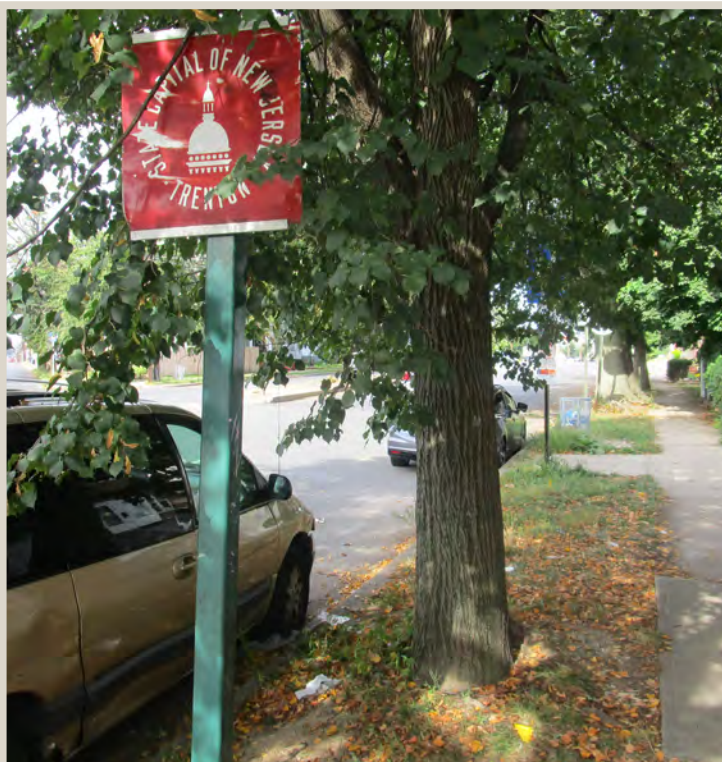
Figure 175. Signage blocked by a tree.

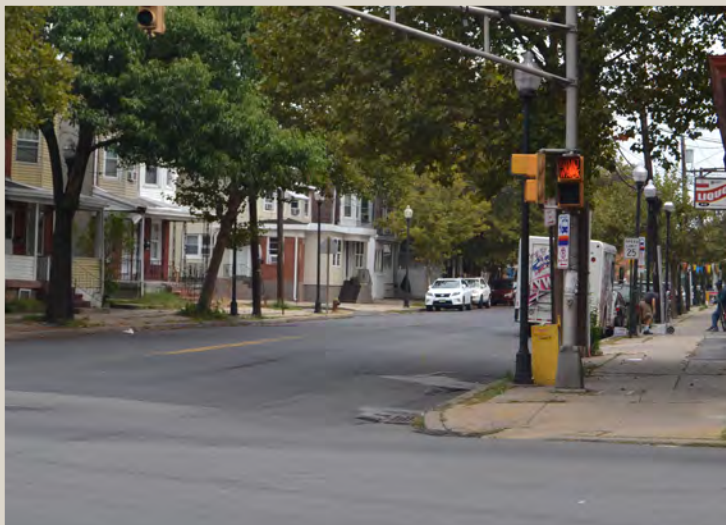
Figure 177. A missing crosswalk at the long intersection of Brunswick Avenue and N Olden.
