LOW-COST PEDESTRIAN SAFETY COUNTERMEASURES AT INTERSECTIONS AND CROSSINGS CASE STUDIES FROM NEW JERSEY

March 2025

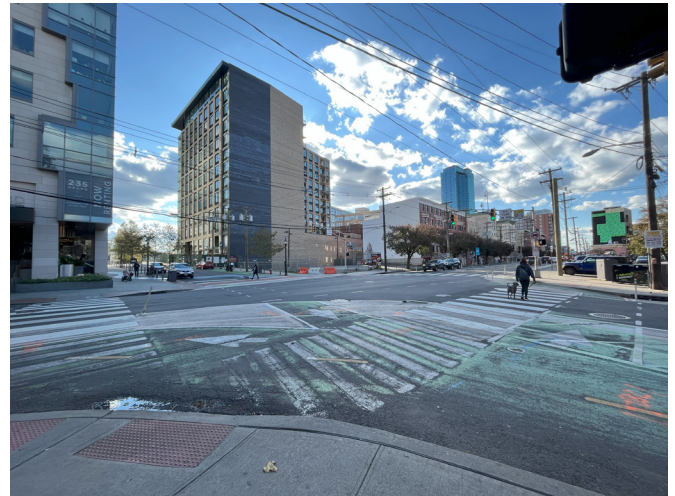
Figure 1 Image of the Grand Street and Grove Street Intersection.
Source: SGB, LLC

The intersection of Grand Street and Grove Street is located in Jersey City, Hudson County (see Figure 1). It is situated near the downtown and the waterfront. Grand Street runs through many neighborhoods and connects to major routes and highways, making this a well-traveled intersection in Jersey City. Given Bright Street's proximity to the principal intersection of Grand Street and Grove Street (located approximately 200 feet to the west), it has been included as part of the intersection for the purposes of this analysis.

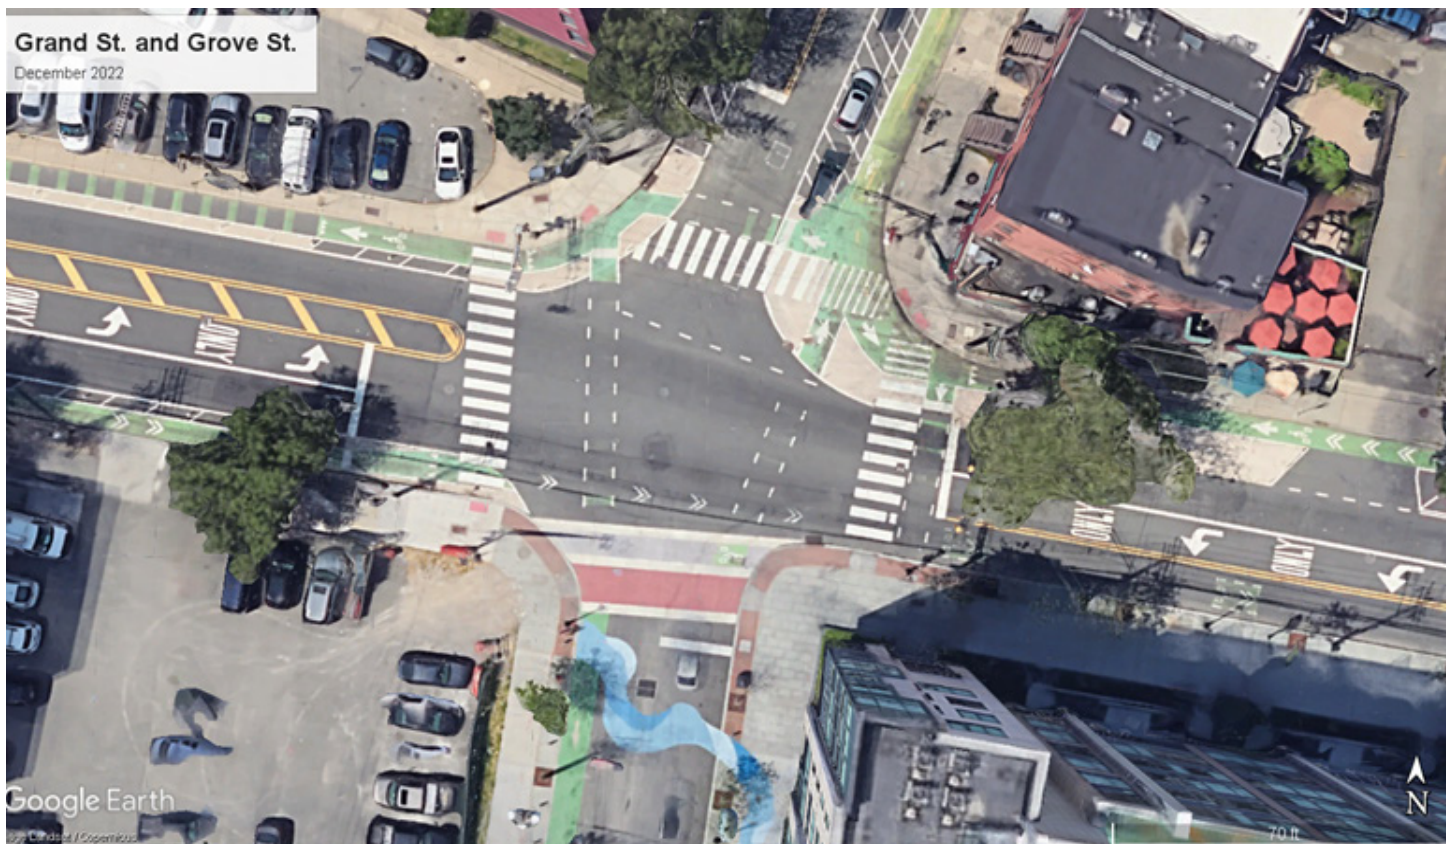
Figure 4 Aerial of Grand and Grove intersection in December 2022, after countermeasure implementation. Source: Google

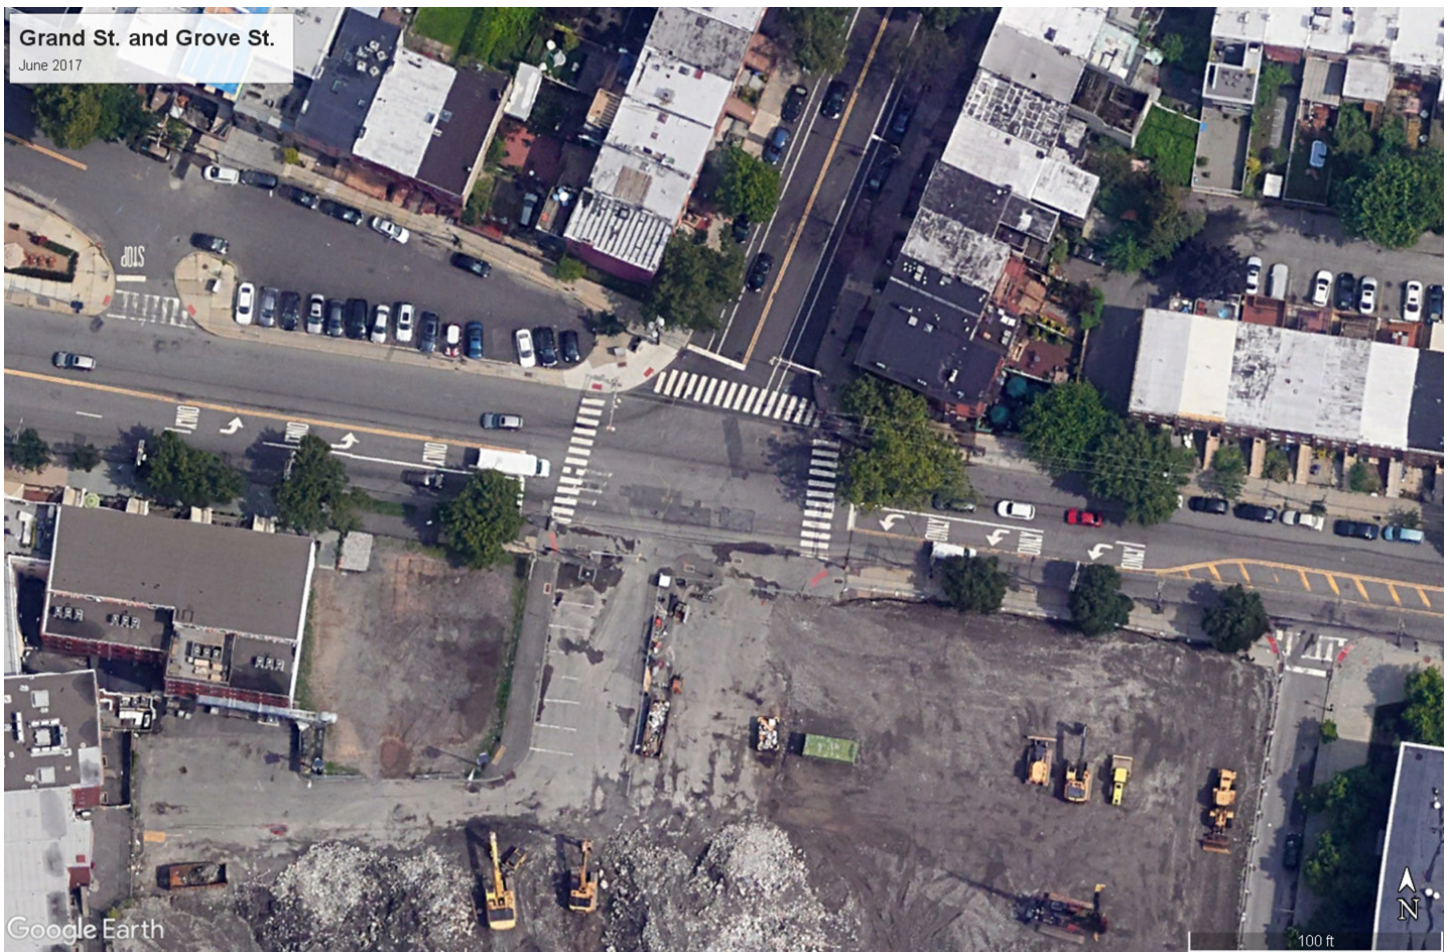
Figure 5 Aerial of Grand and Grove Streets intersection in June 2017, before countermeasure implementation. Source: Google

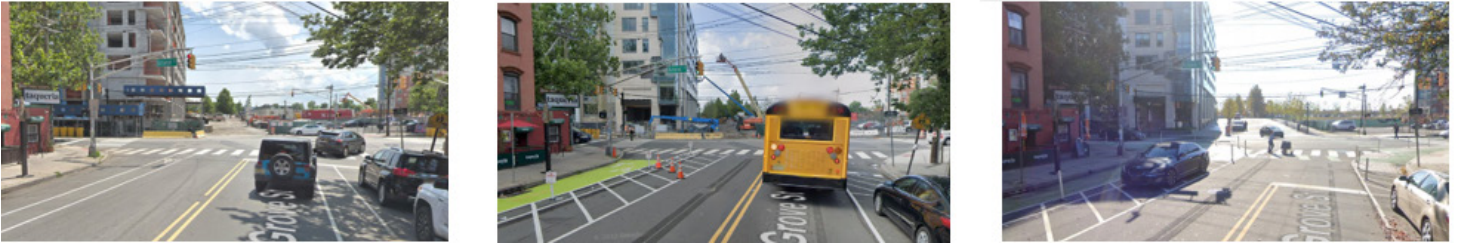
Figures 7-9 Grove Street (north of Grand Street) in July 2018, July 2019, and November 2020 (left to right). Source: Google

The improvements for Grove Street (north of Grand Street) were implemented in stages (see Figure 6). In July 2019, the conventional bicycle lane on the west side of Grove Street was removed and replaced with a two-way protected bike lane from Columbus Drive to Grand Street on the east side of the street. The bike lane was protected by on-street parking. In 2020, painted curb extensions and plastic soft-hit posts were added at the same time as the Grand Street improvements.

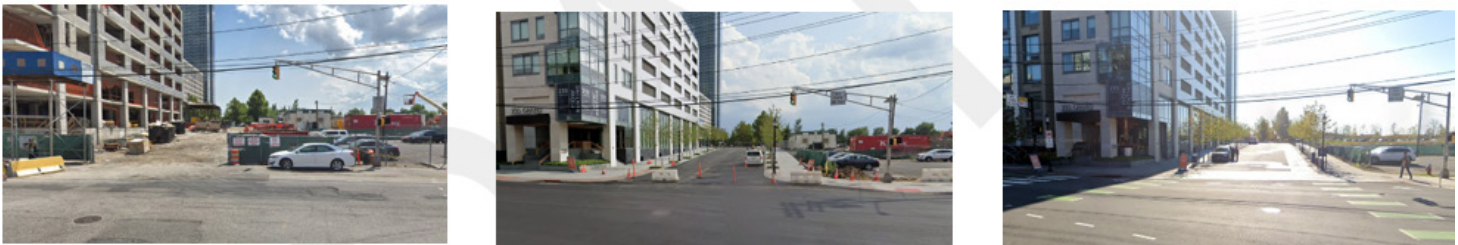
Figures 10-12 Grove Street (south of Grand Street) in July 2018, August 2019, and November 2020 (left to right). Source: Google

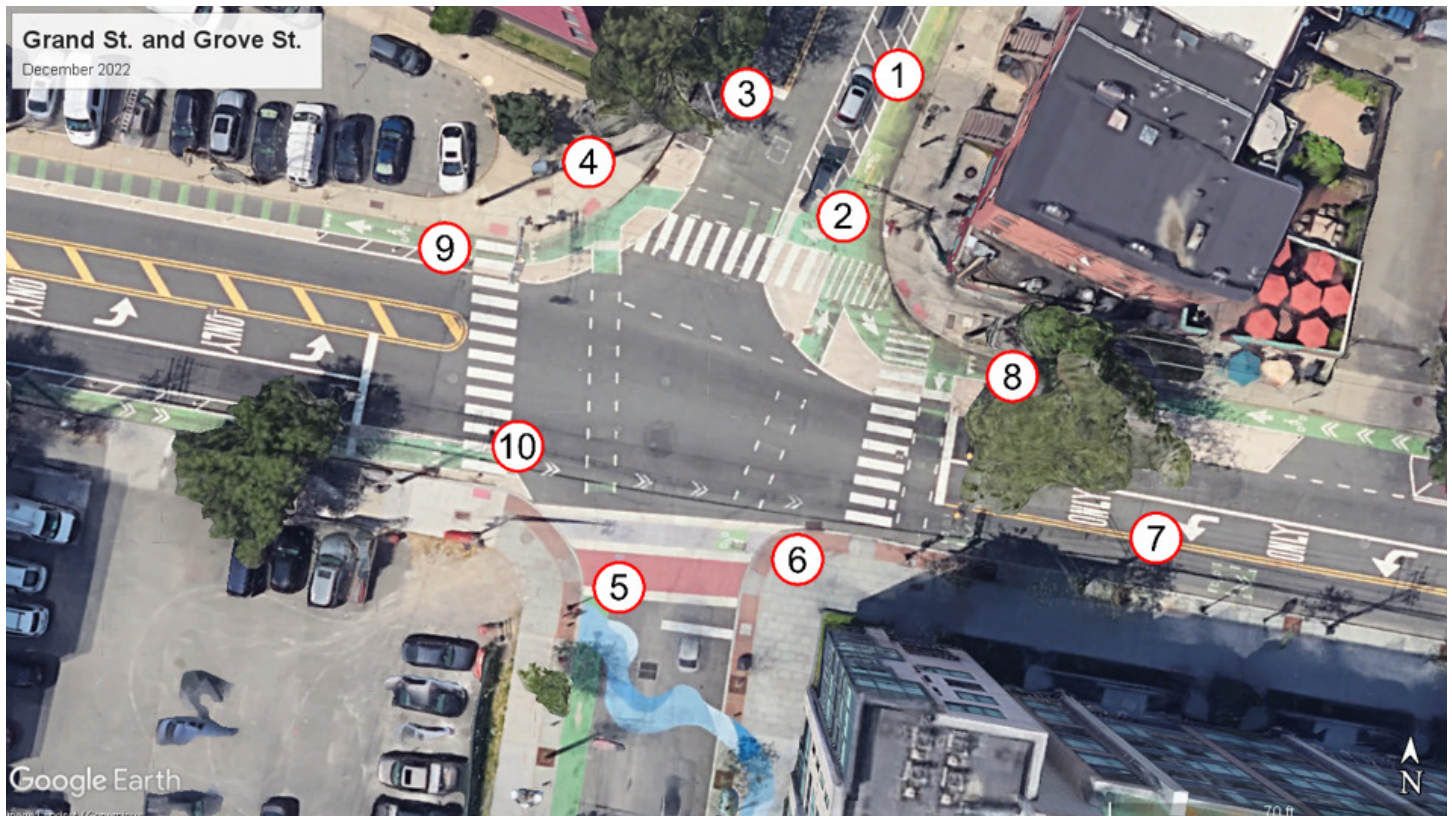
Figure 13 Aerial view of the Grand Street and Grove Street Intersection in December 2022, after countermeasure implementation. Source: Google

The graphic below explains the pedestrian countermeasures at the intersection in detail.

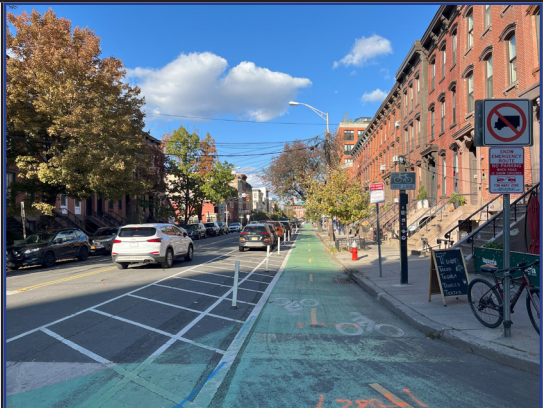
Explanation of Countermeasures from Figure 13		
1	<p>A two-way protected bicycle lane buffered by on-street parking protects bicyclists from drivers veering into the bicycle lane.</p>

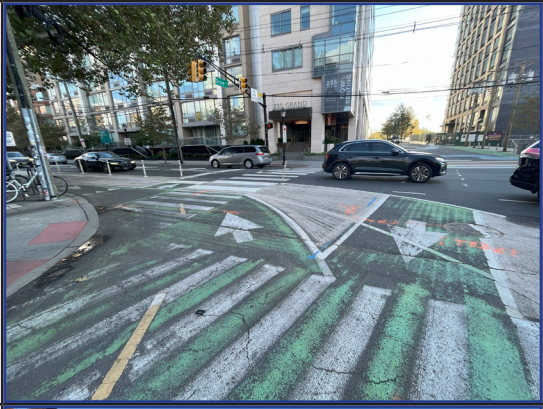
2	<p>Painted curb extensions with soft-hit posts as well as bicycle turning motions drawn in paint guide cyclists and reduce crossing distance for pedestrians.</p>

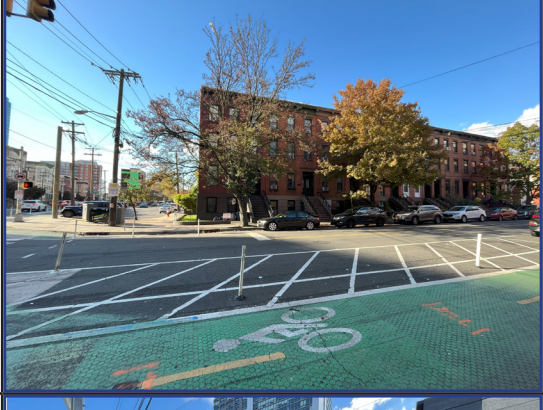
3	<p>The intersection was daylighted, removing parking spaces next to intersection with striped paint (car is illegally parked in daylighted area). This increases the visibility of pedestrians to drivers at the crosswalk.</p>

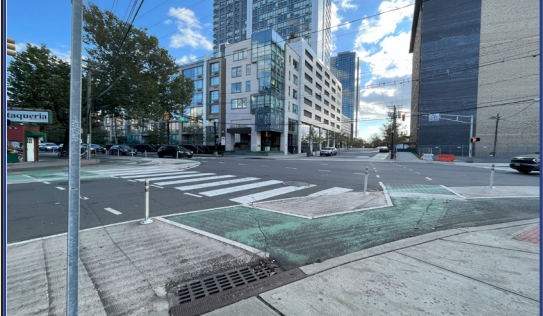
4	<p>Painted curb extensions and the bicycle lane with soft-hit flex posts force drivers to take slower turns, while also reducing crossing distances for pedestrians.</p>

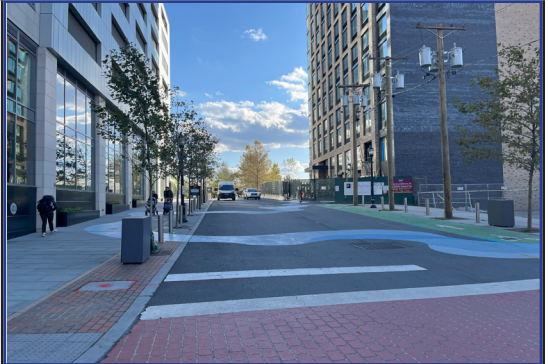
Explanation of Countermeasures from Figure 13		
5	<p>South of Grand Street, Grove Street has a conventional painted bicycle lane on the west side of the street, with a brick crosswalk and street mural representing the site of a former canal.</p>

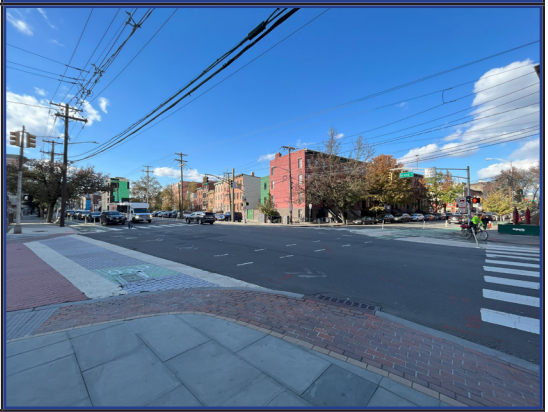
6	<p>The tightened turning radius with a brick curb forces drivers to slow down when making turns.</p>

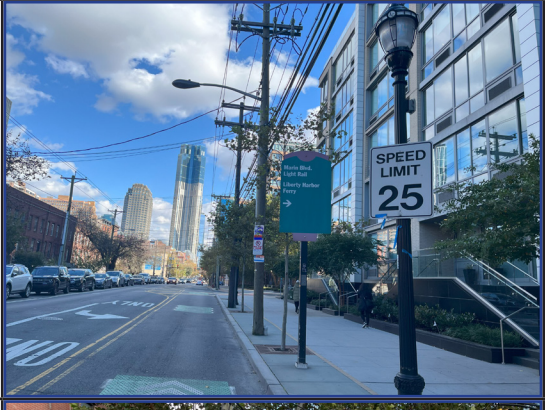
7	<p>There are painted shared-lane markers on Grand Street going east.</p>

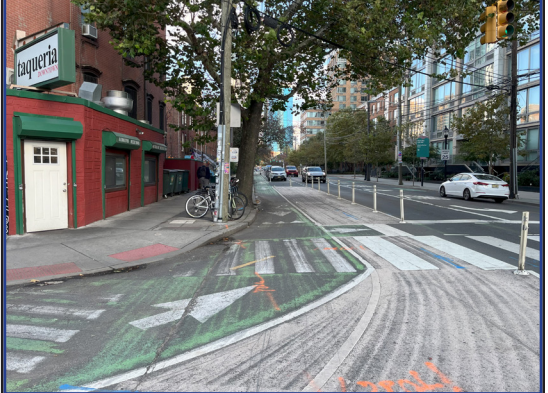
8	<p>On the northeast corner of the intersection, there is a protected one-way west-bound bicycle lane buffered by on-street parking, daylighting at intersection with painted curb extensions, and soft-hit posts (facing east).</p>

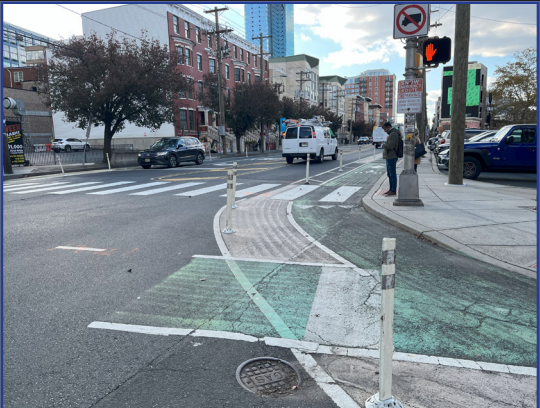
Explanation of Countermeasures from Figure 13		
9	<p>On the northwest corner of the intersection, there is a buffered bicycle lane protected by soft-hit posts with small painted curb extensions (facing west).</p>

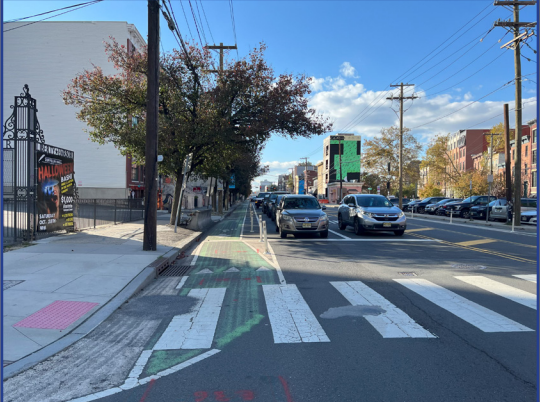
10	<p>On the southwest corner of the intersection, there is a buffered bicycle lane protected by soft-hit posts (facing west).</p>

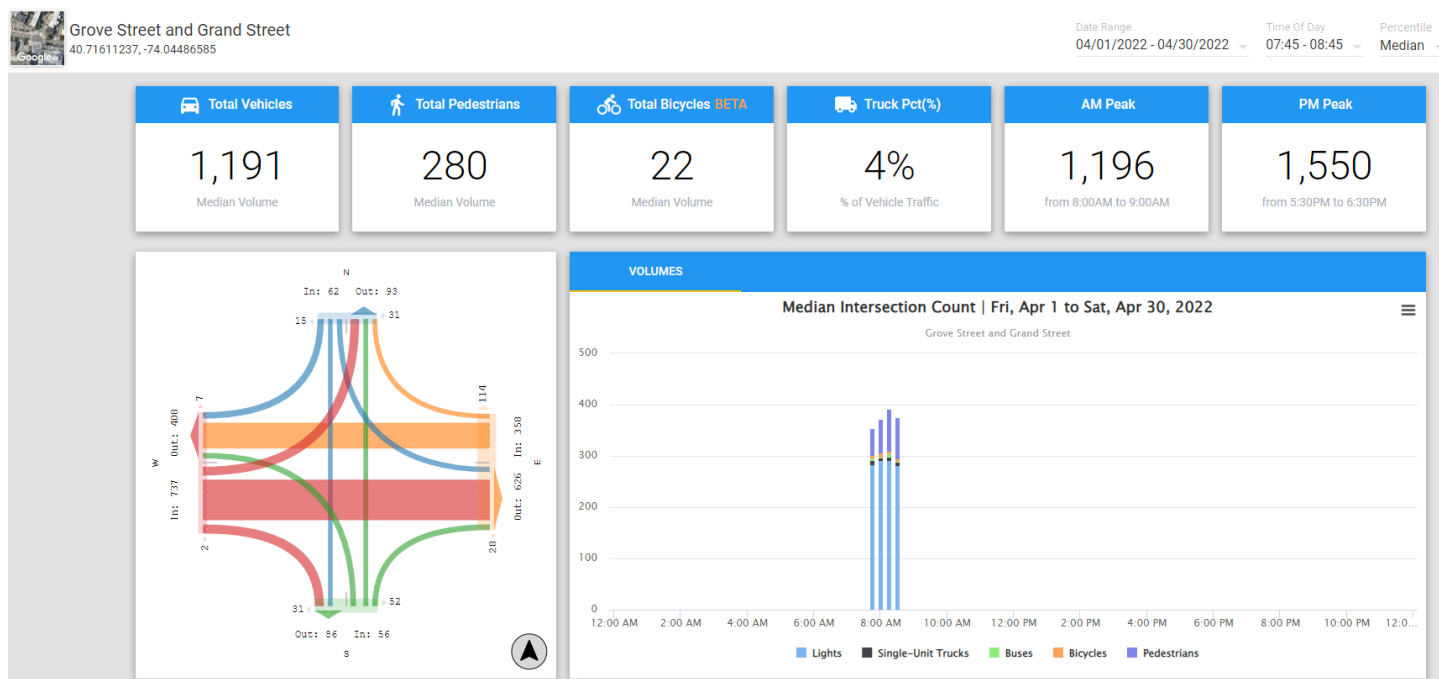
Figure 24 Traffic Count at Grand and Grove Streets Showing AM Peak. Source: Jersey City Division of Transportation Planning

Peak AM traffic volumes decreased from 2,000 in 2017 to 1,196 in 2022. Peak PM traffic volumes also decreased during this timeframe, from 2,011 in 2017 to 1,550 in 2022. Notably, this decrease in traffic volume occurred despite the construction of Grove Street south of the intersection between 2017 and 2022.

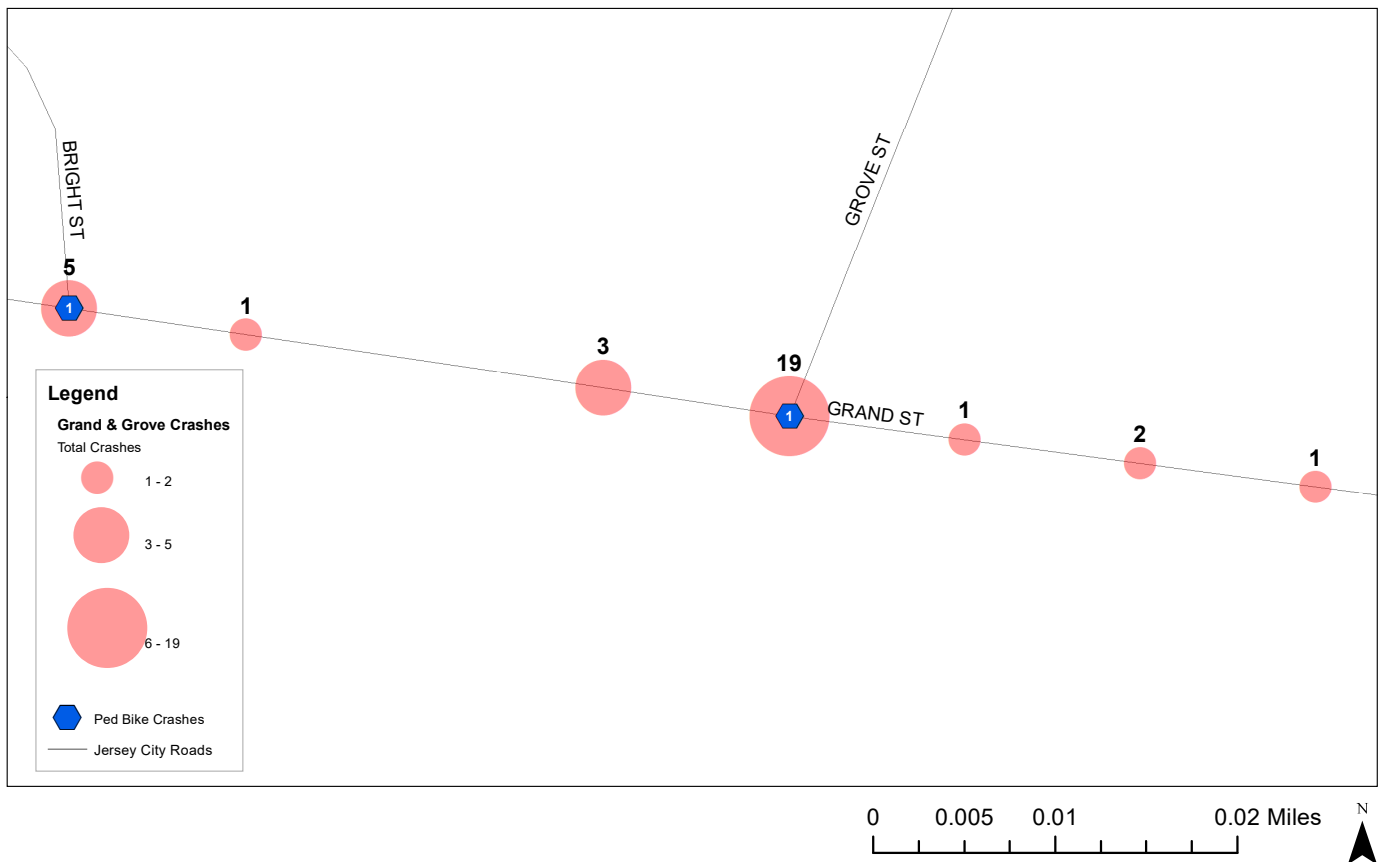
Figure 28 Map of Reported Crashes at Intersection of Grand and Grove Streets. Source: Safety Voyager

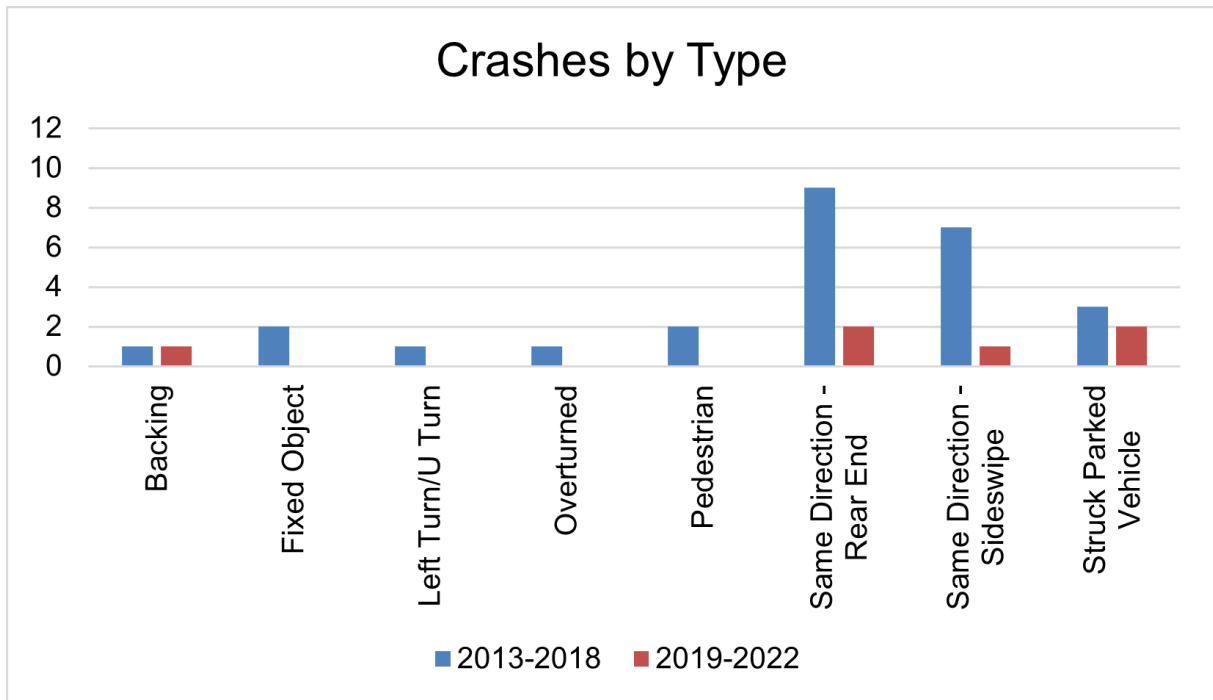
Figure 34 Graph Showing Number of Reported Crashes by Type Before and After 2019

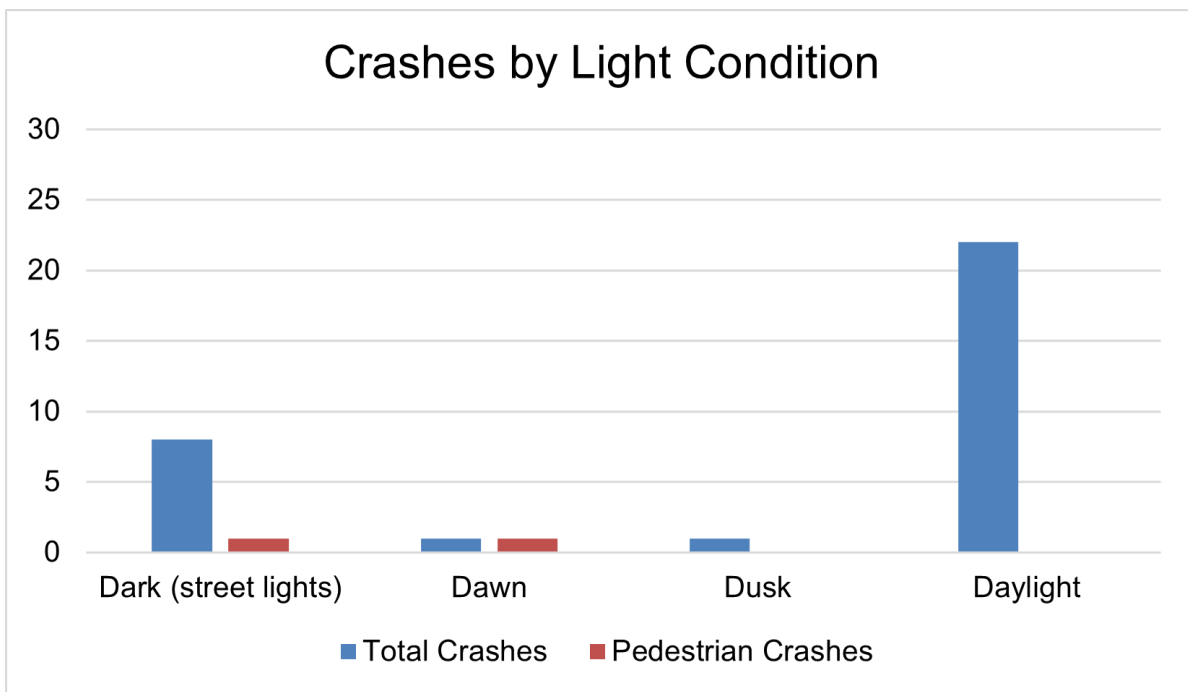
Figure 36 Graph Showing Reported Crashes by Light Condition

25 (78%) reported crashes occurred when road conditions were dry. One of the two pedestrian crashes took place when it was dry, while the surface conditions are not recorded for the other pedestrian crash. 22 (69%) crashes occurred during the day, while eight (25%) crashes occurred at night. Both pedestrian injuries occurred under lower-light conditions, once when it was dark and once at dawn.

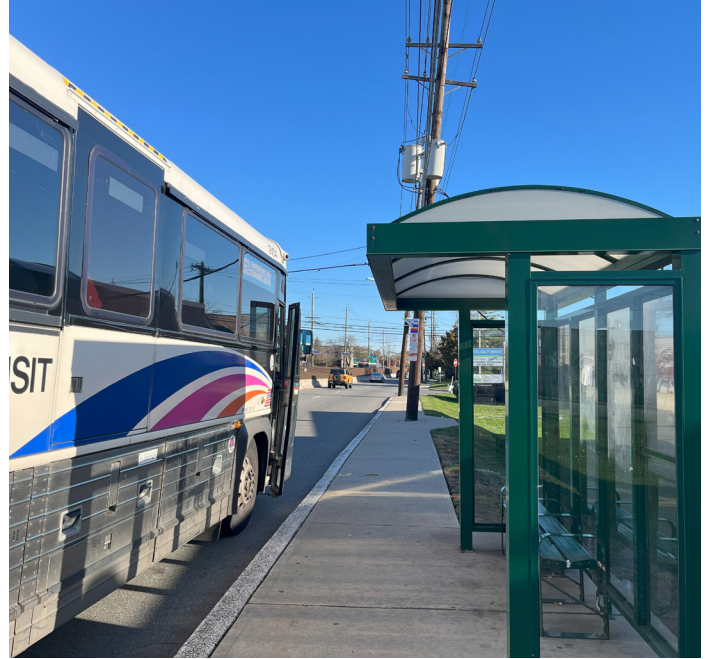
Figure 39 Bus stop located on the east side of Washington Avenue, north of Barell Avenue. Source: SGB, LLC

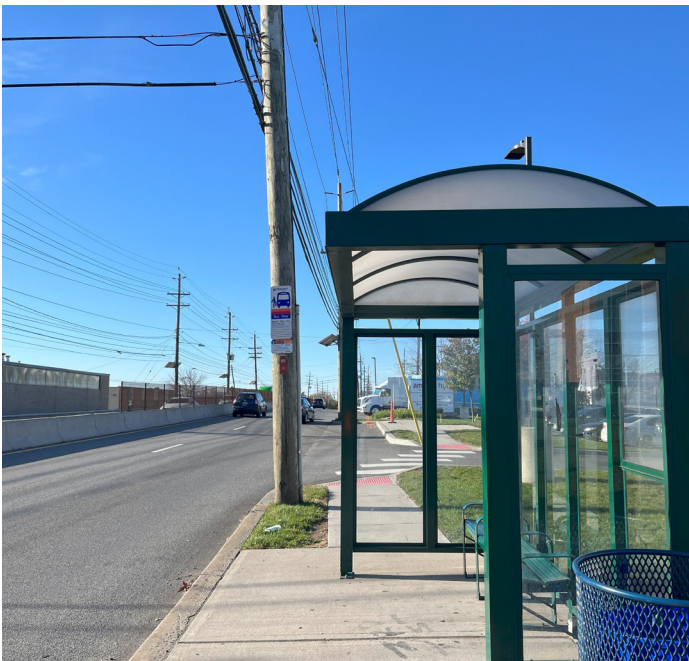
Figure 40 Bus stop located on the west side of Washington Avenue, south of Barell Avenue. Source: SGB, LLC

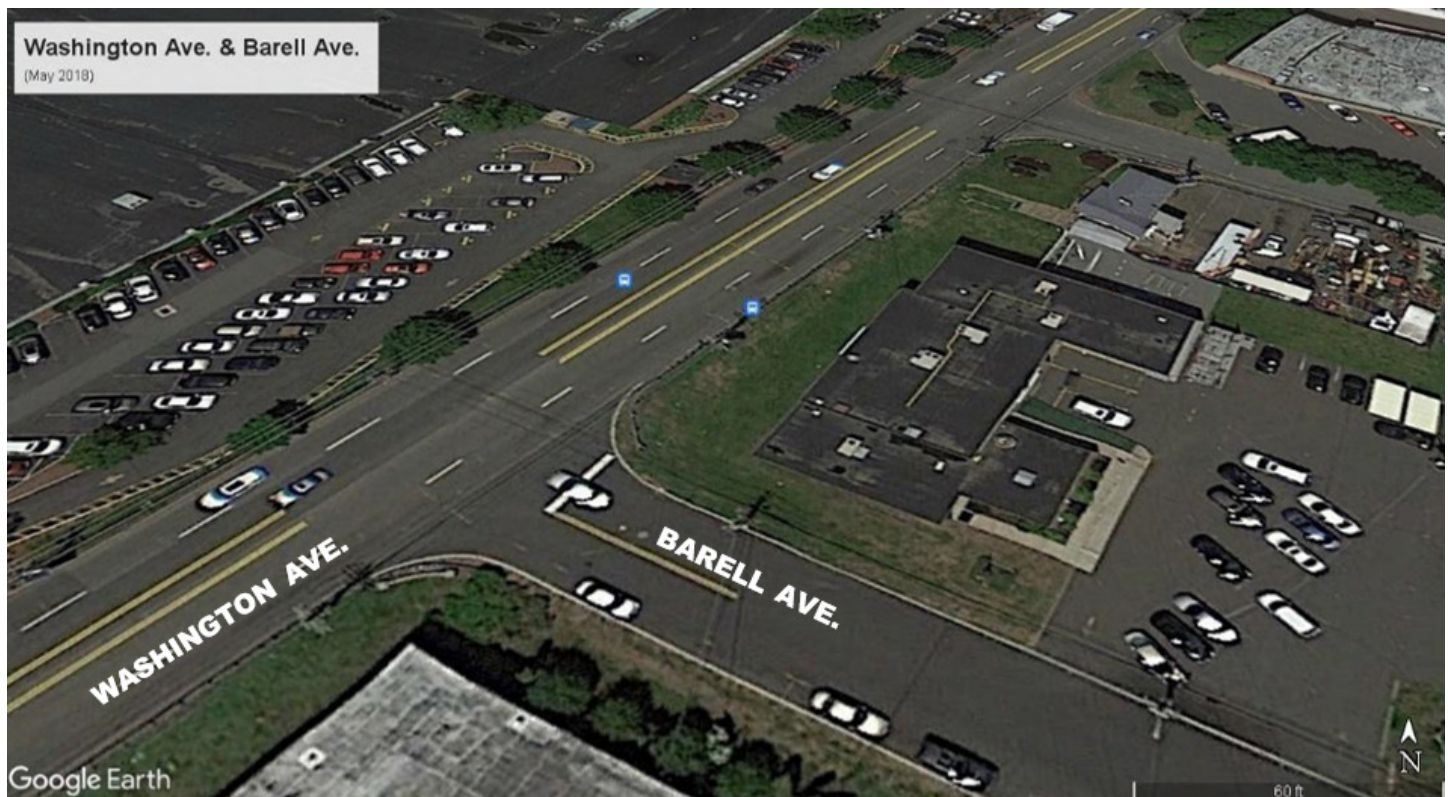
Figure 41 An aerial screenshot of the intersection from May 2018. Source: Google

An aerial photograph from May 2018 shows the intersection before improvements. There were no sidewalks, crosswalks, or any other pedestrian/bicycle infrastructure at the site. The aerial from November 2022 shows the various pedestrian improvements that were installed. They are identified on Figure 6 and explained in the table below.

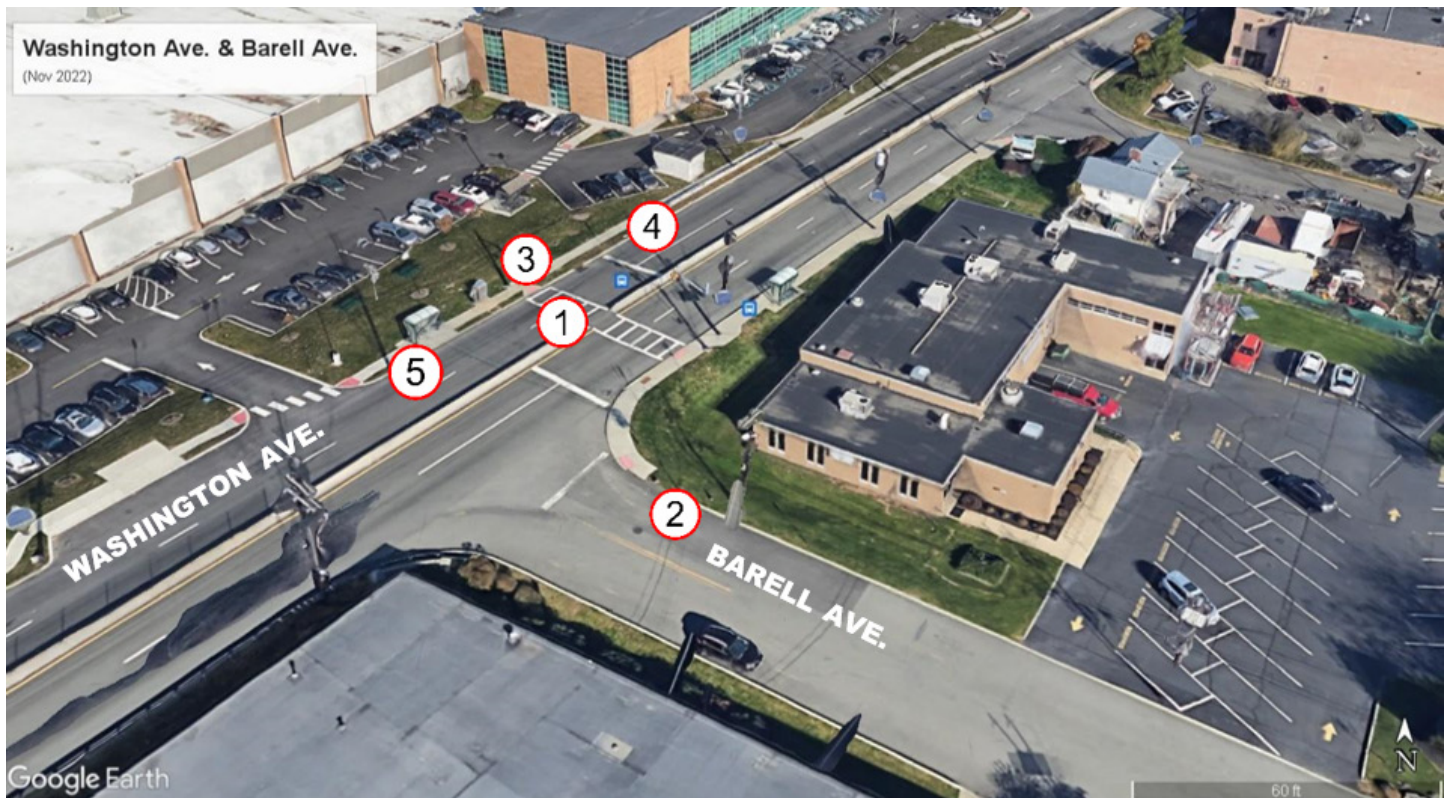
Figure 42 An aerial screenshot of the intersection from November 2022. Source: Google

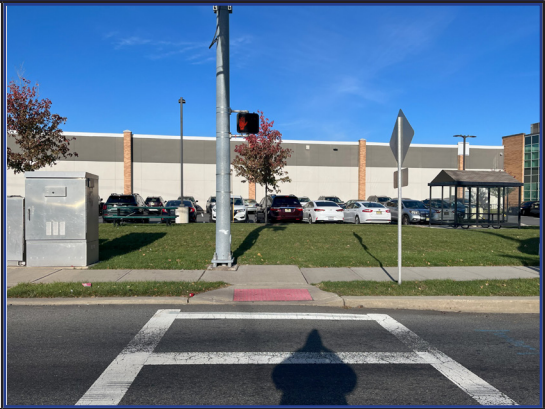
Explanation of Countermeasures from Figure 42		
1	<p>Sidewalks were added on both sides of Washington Avenue north of Barell Avenue. On the west side of Washington Avenue, there is now a planted strip between the sidewalk and the travel lanes, which makes walking more comfortable by creating distance between the pedestrian and vehicular traffic.</p>

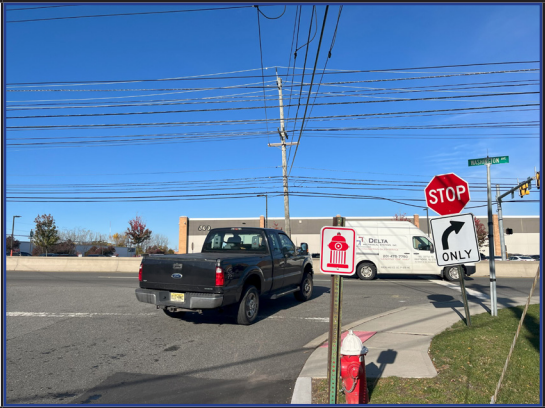
2	<p>Barell Avenue does not have any pedestrian facilities or striping. There is an ADA ramp that allows pedestrians to cross. Sidewalks continue north from this point.</p>

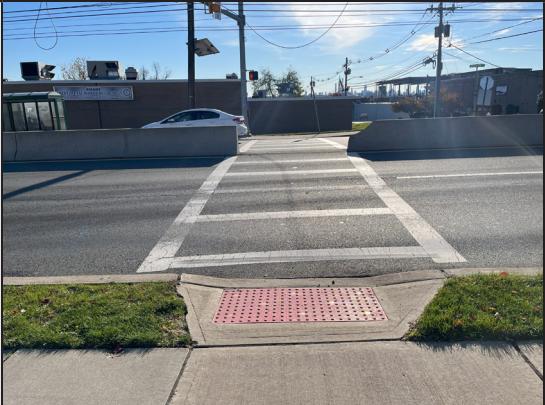
3	<p>A crosswalk with ADA curb ramps was also added, improving accessibility for those with mobility difficulties (shown facing east).</p>

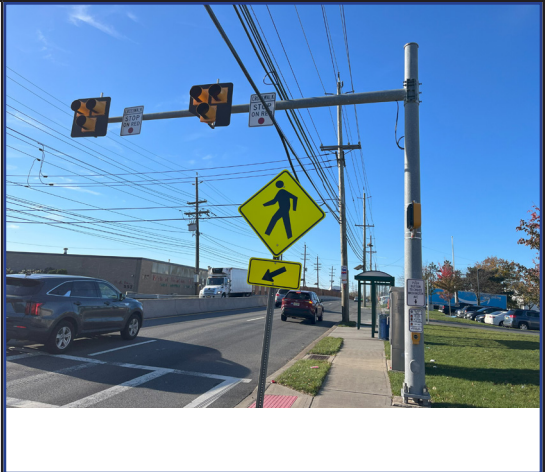
Explanation of Countermeasures from Figure 42		
4	<p>The intersection uses a HAWK signal with push buttons. This push-activated signal introduces signal control, allowing pedestrians to cross high-speed roads safely while also minimizing vehicle delay.</p> <p>After pressing the button, a voice recording states “Wait to cross Washington,” followed by beeping. The study team timed the duration of the pedestrian signal at 21 seconds; the countdown timer ran for 15 seconds</p>

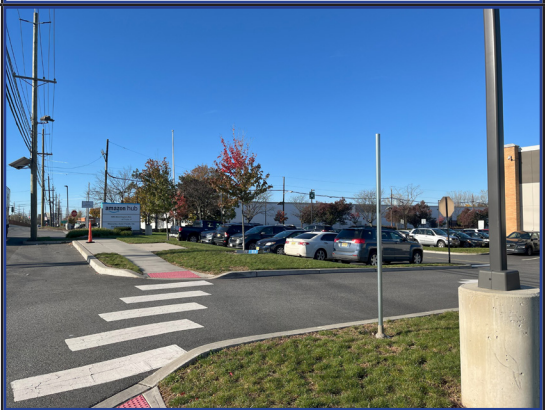
5	<p>On the west side of Washington Avenue, the sidewalk continues for approximately 150 feet until it reaches the edge of the Amazon warehouse parking lot.</p>

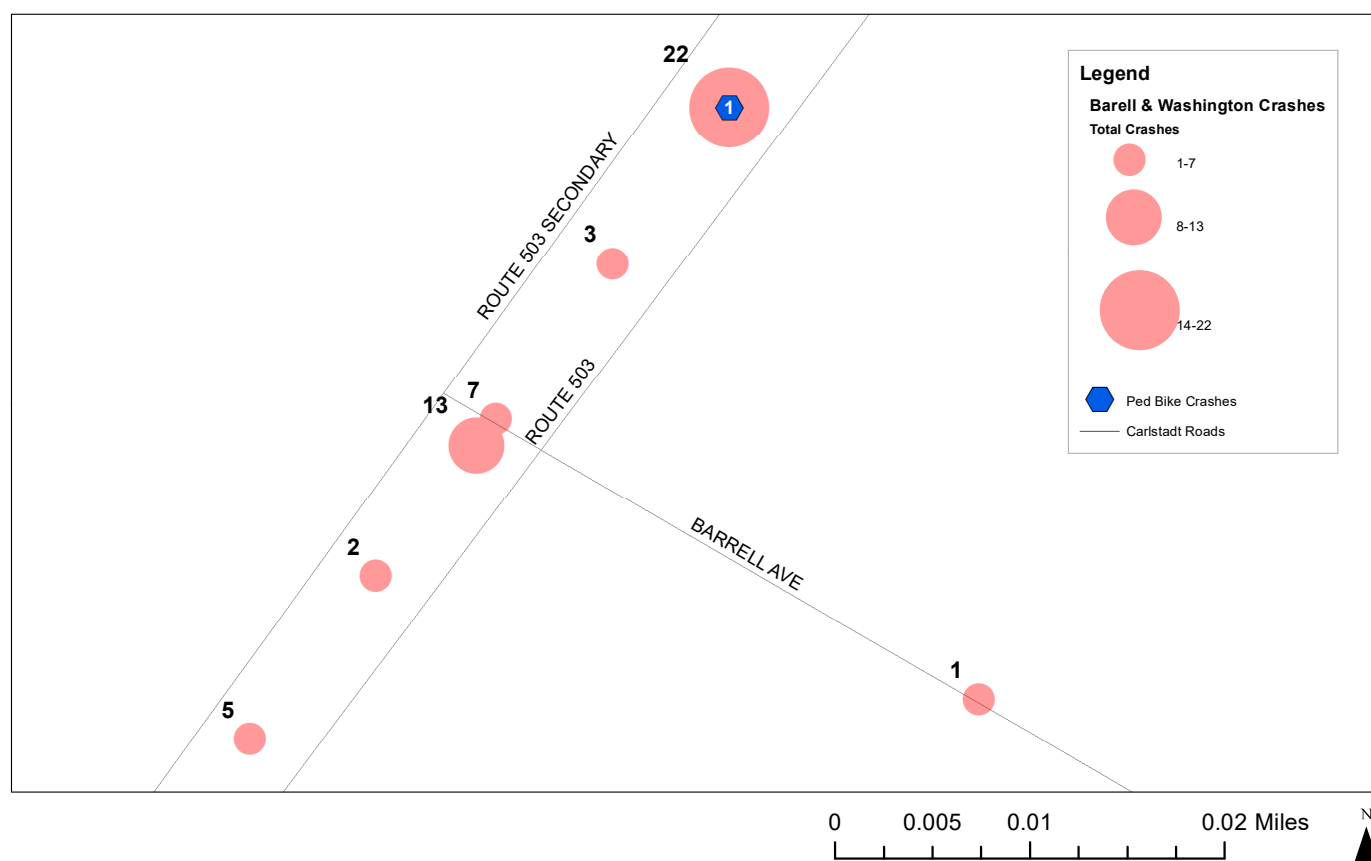
Figure 49 Map of reported crashes at the intersection of Washington and Barell Avenues. Source: Safety Voyager

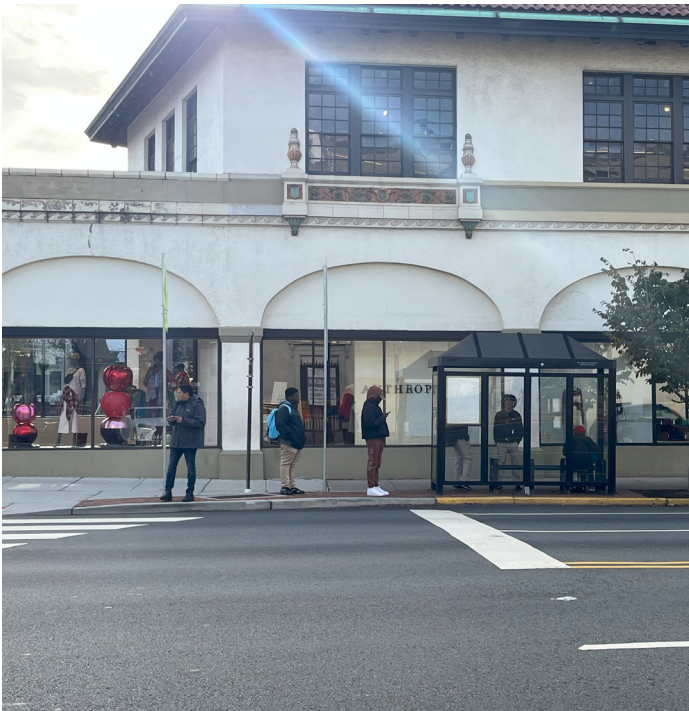
Figure 60 Photo of the Bloomfield Avenue at Church Street Bus Stop, which has a bus shelter. Source: SGB, LLC

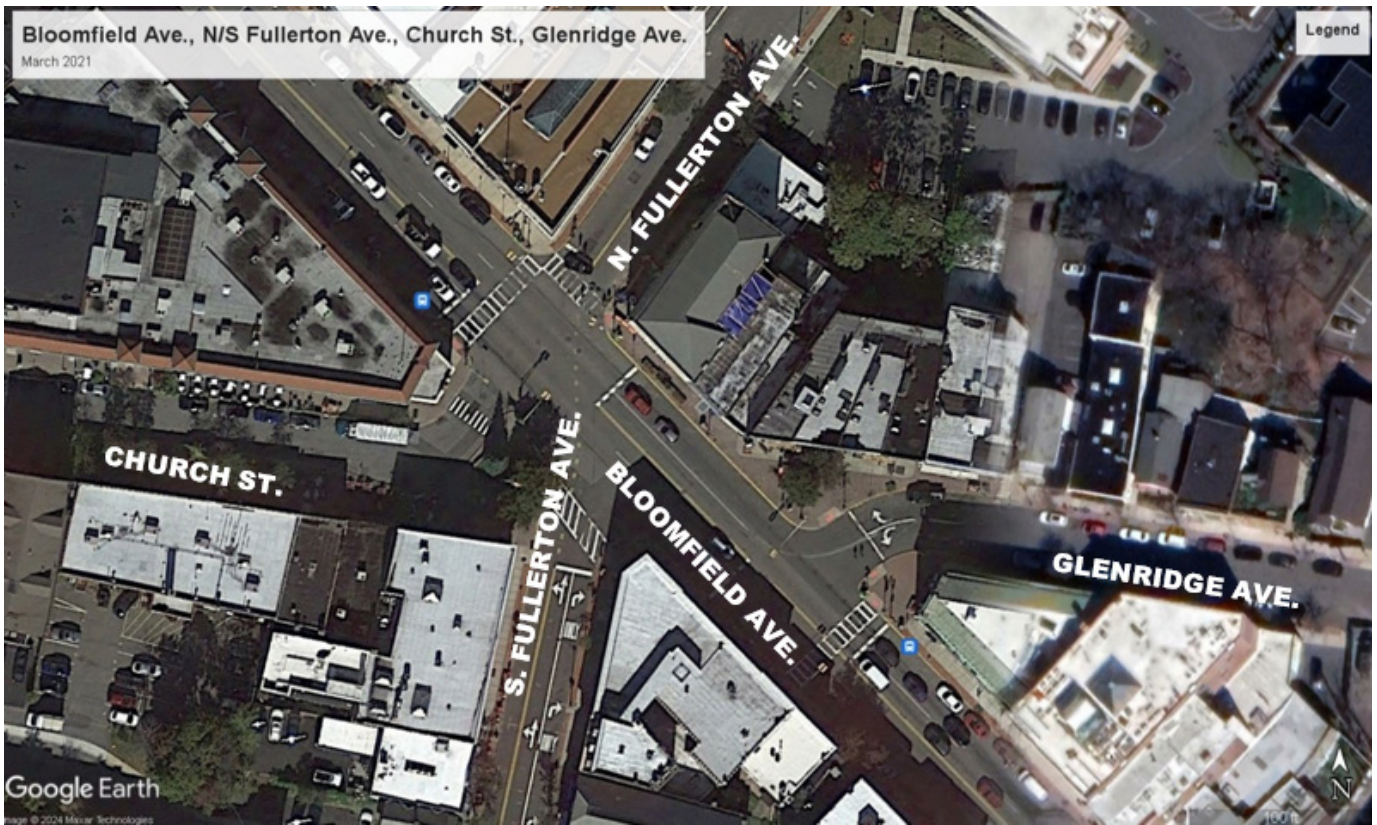
Figure 62 An aerial screenshot of the intersection from March 2021. Source: Google

Bloomfield Avenue is also known as County Route 506, and has a speed limit of 25 miles per hour. It is part of the “Five Corners intersection.” This intersection’s irregular geometry and complexity, was the main impetus for the roadway improvements in 2022. Figure 62 shows the intersection before improvements, while Figure 63 and the following table explain the roadway characteristics after improvements were made in detail.

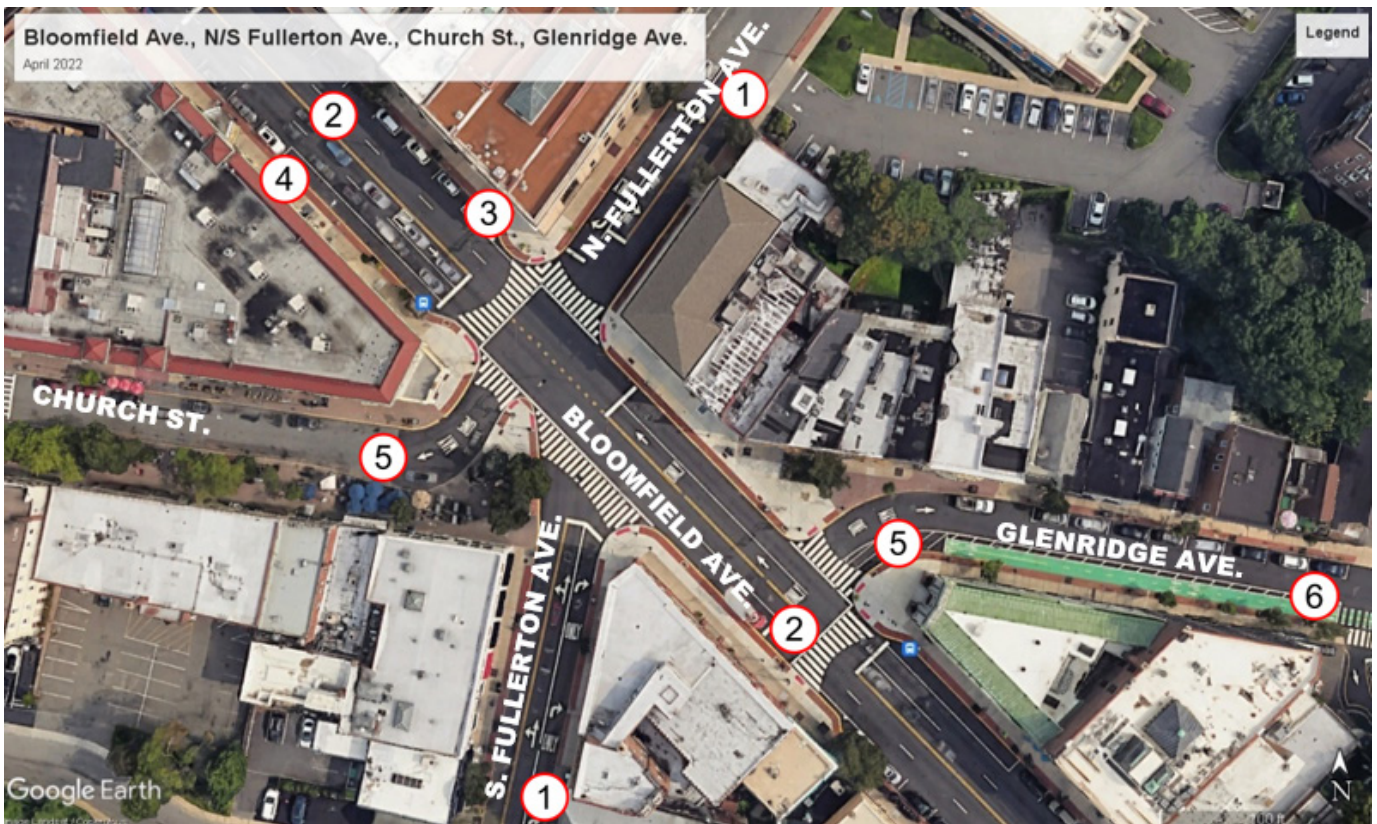
Figure 63 An aerial screenshot of the intersection in April 2022, after improvements were made. Source: Google

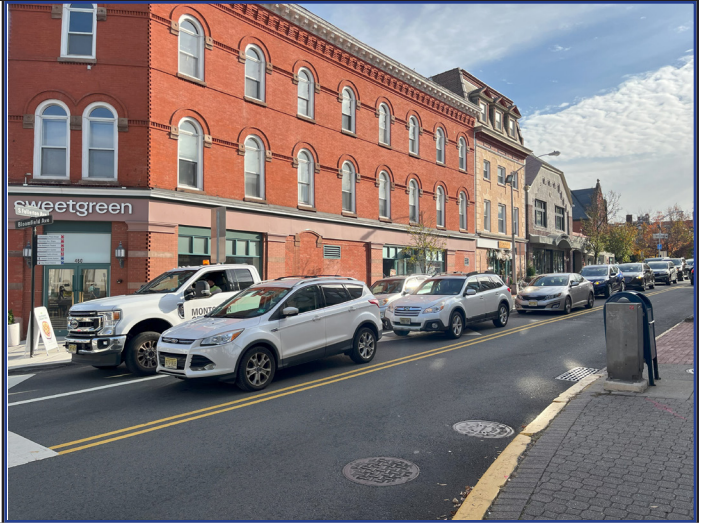
1 North and South Fullerton Avenue both have one lane in each direction, with a dedicated right turn lane. On-street parking is provided beyond the intersection.

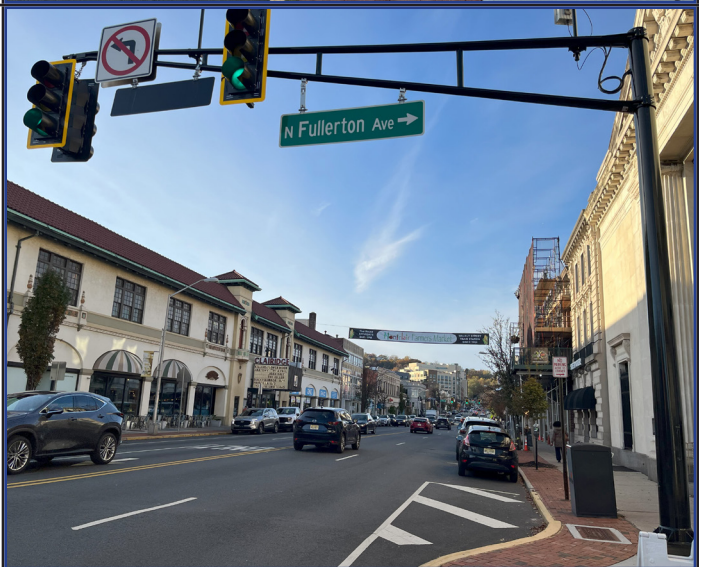
3 West of N/S Fullerton Avenue, Bloomfield Avenue has on-street parking on the north side, which can act as protection from vehicle collisions for pedestrians on the sidewalk.

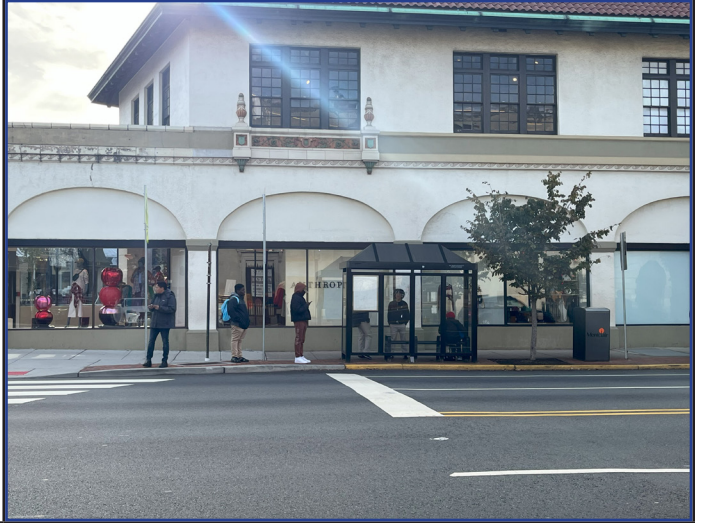
4 West of N/S Fullerton Avenue, Bloomfield Avenue has a bus stop with a shelter. The stop is identified via pavement markings on the south side of Bloomfield Avenue. To the west of the bus stop, there is on-street parking.

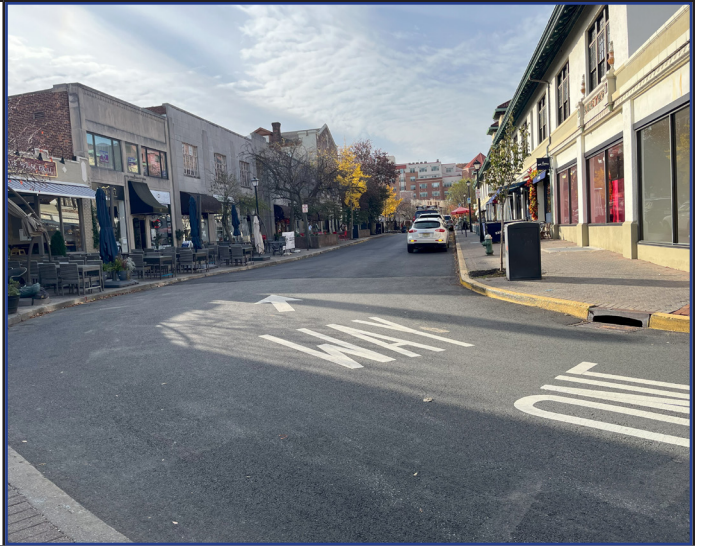
5 Church Street and Glenridge Avenue are both one-way streets that carry traffic away from the Bloomfield Avenue intersection. Glenridge Avenue was originally one-way towards the intersection, but this was changed as part of an infrastructure project to improve traffic flow. Both Church Street and Glenridge Avenue have on-street parking on one side.
