LOW-COST PEDESTRIAN SAFETY COUNTERMEASURES AT INTERSECTIONS AND CROSSINGS CASE STUDIES FROM NEW JERSEY

March 2025

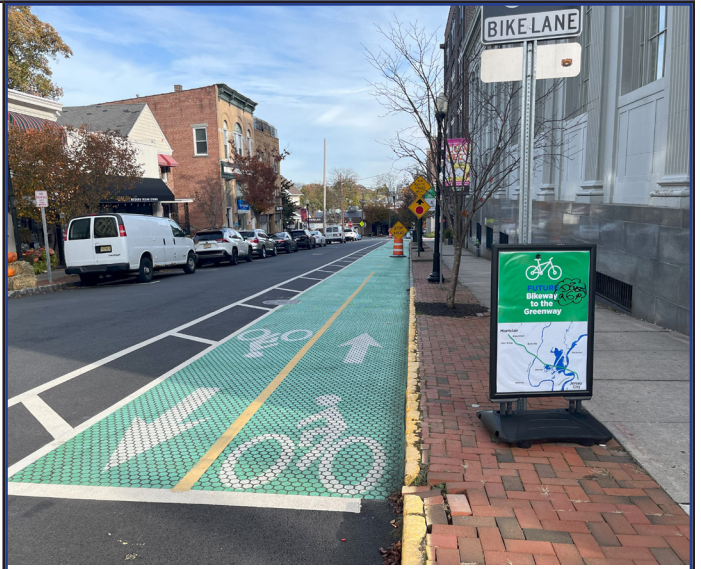
6 Glenridge Avenue has a buffered two-way cycle track along the right side of the road. The buffer creates distance from the bicyclist and the motorist, improving safety.

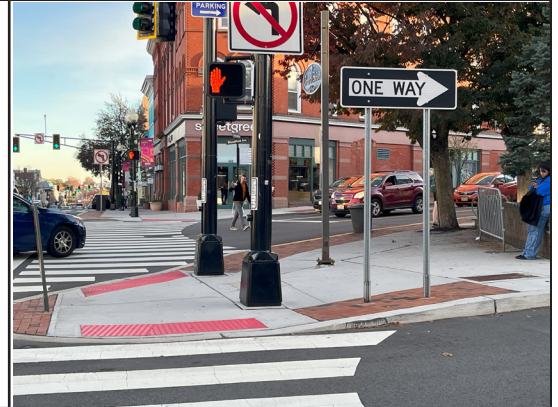
1
Curb extensions were added to shorten crossing distances and times.

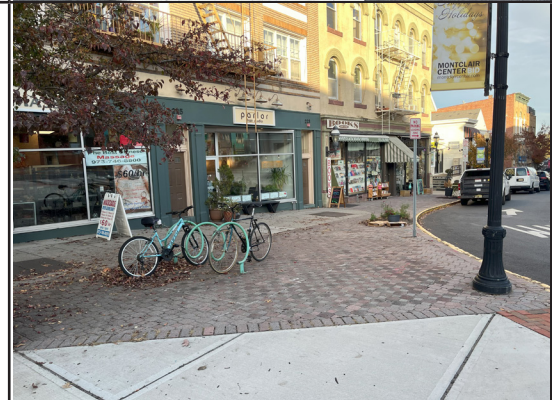
2
Glenridge Avenue has a small protected area with textured pavement and bicycle parking.

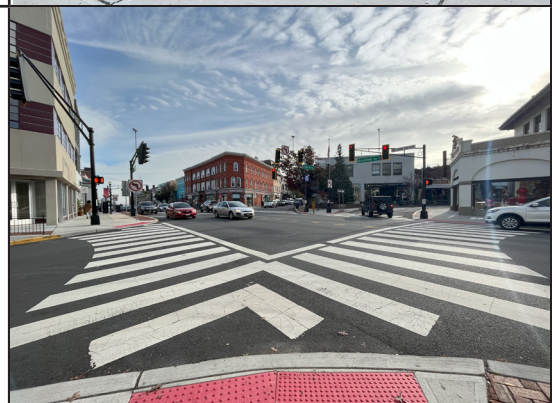
3
Ergonomic crosswalks were added at the intersection. These crosswalks reflect how people actually cross the street and can help address non-standard intersection geometry, especially in areas with high levels of pedestrian traffic.

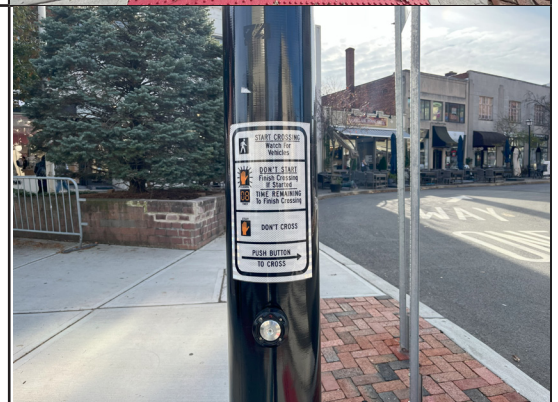
4
Pedestrian push buttons change pedestrian signals, which allow pedestrians to cross the street more safely.

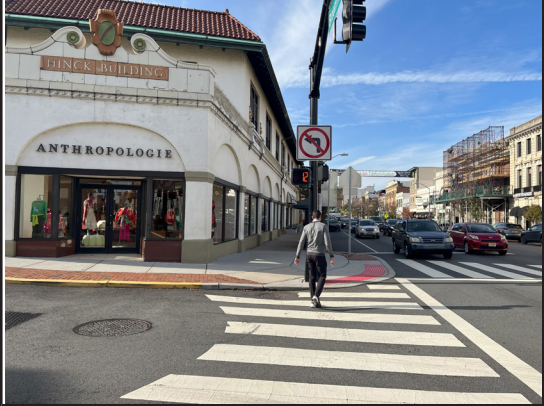
Explanation of Countermeasures from Figure 69	
5	<p>Pedestrian signal heads with countdown timers notify pedestrians how much time they have to cross the street before the signal changes.</p>

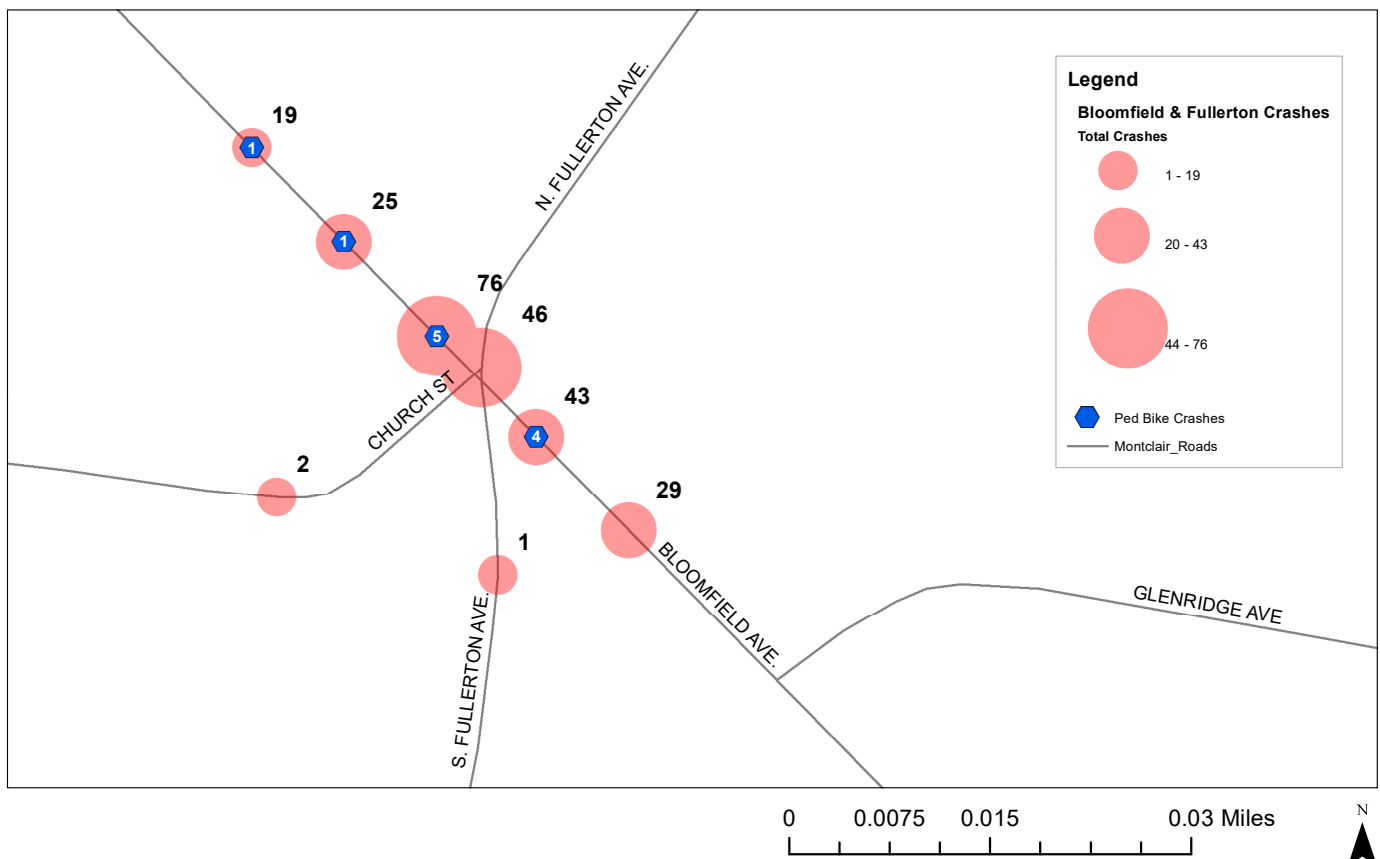
Figure 77 Map of reported crashes at intersection of Bloomfield Avenue intersection. Source: Safety Voyager

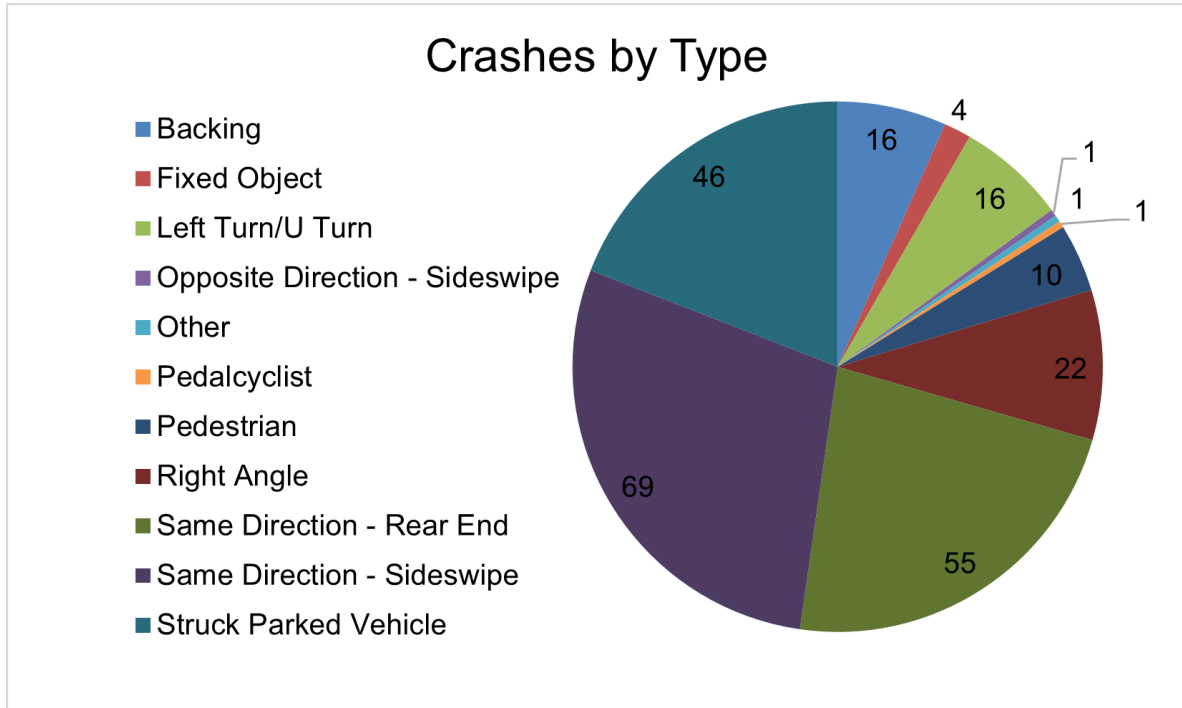
Figure 82 Graph Showing Percentage of Reported Crashes by Type

Between 2013 and 2022, there were 241 reported crashes, with sideswipes in the same direction being the most common (69 crashes, 28.6%), followed by rear end crashes in the same direction (55 crashes, 22.8%), and striking a parked vehicle (46 crashes, 19%). Of the 11 bike/ped crashes, 10 involved pedestrians, and one involved a bicyclist.
