Morris Avenue Complete Streets Concept Plan

City of Elizabeth, New Jersey

Prepared by the Alan M. Voorhees Transportation Center

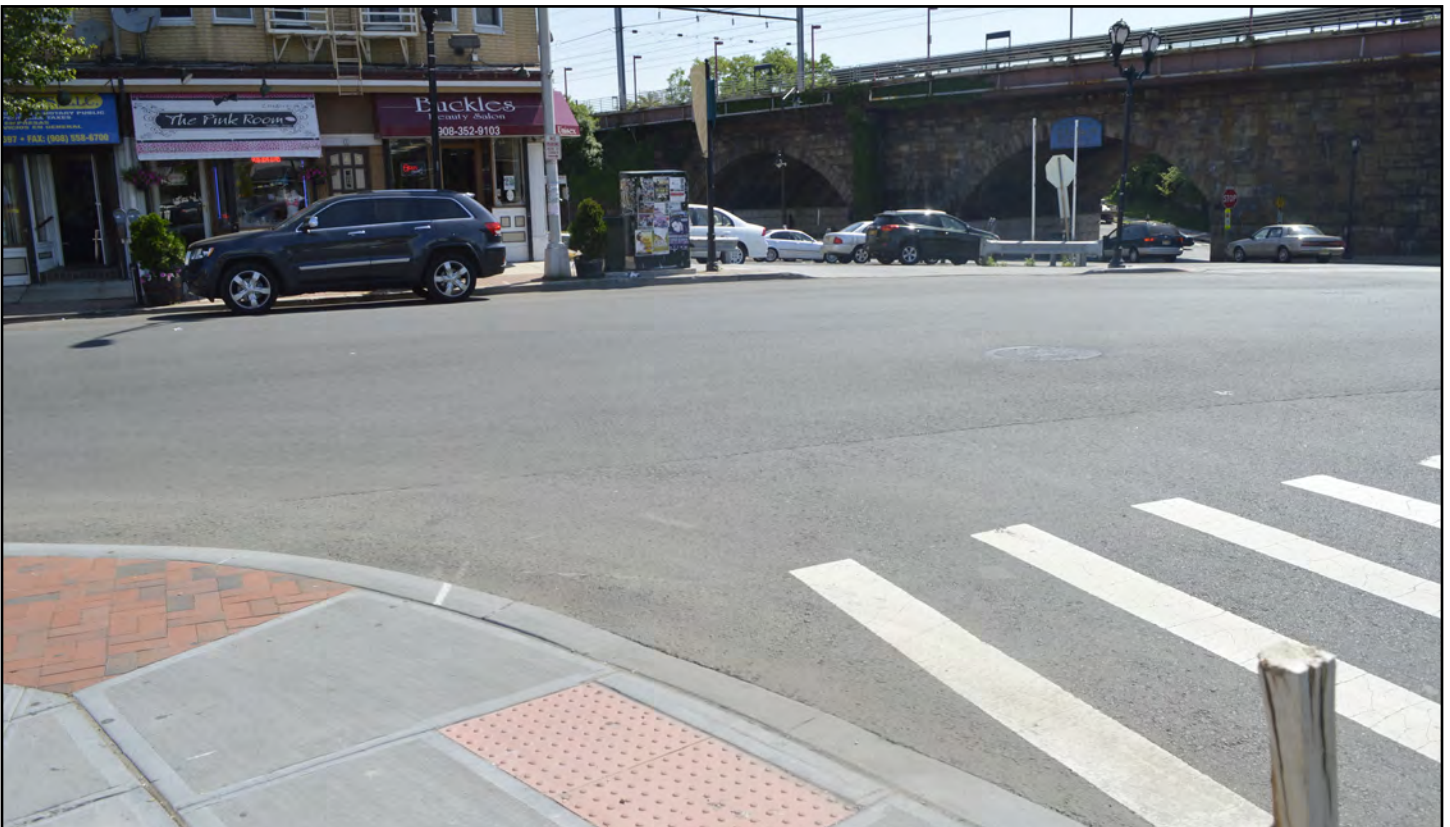
Morris Avenue and Julian Place intersection. Handicap ramps and truncated domes are properly placed parallel to the intersection.

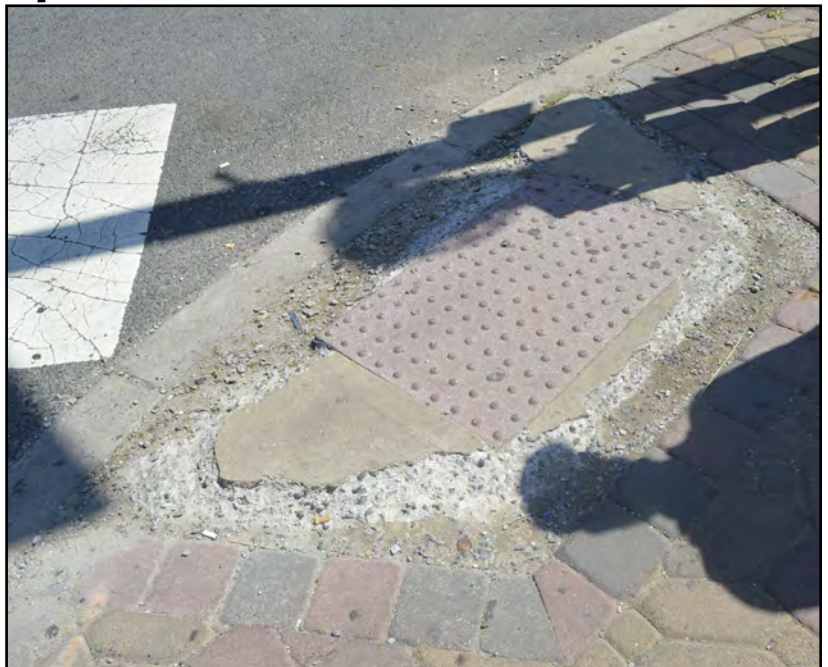
This curb at the Morris Avenue and Sayre Street is a safety hazard to pedestrians and wheelchair users.

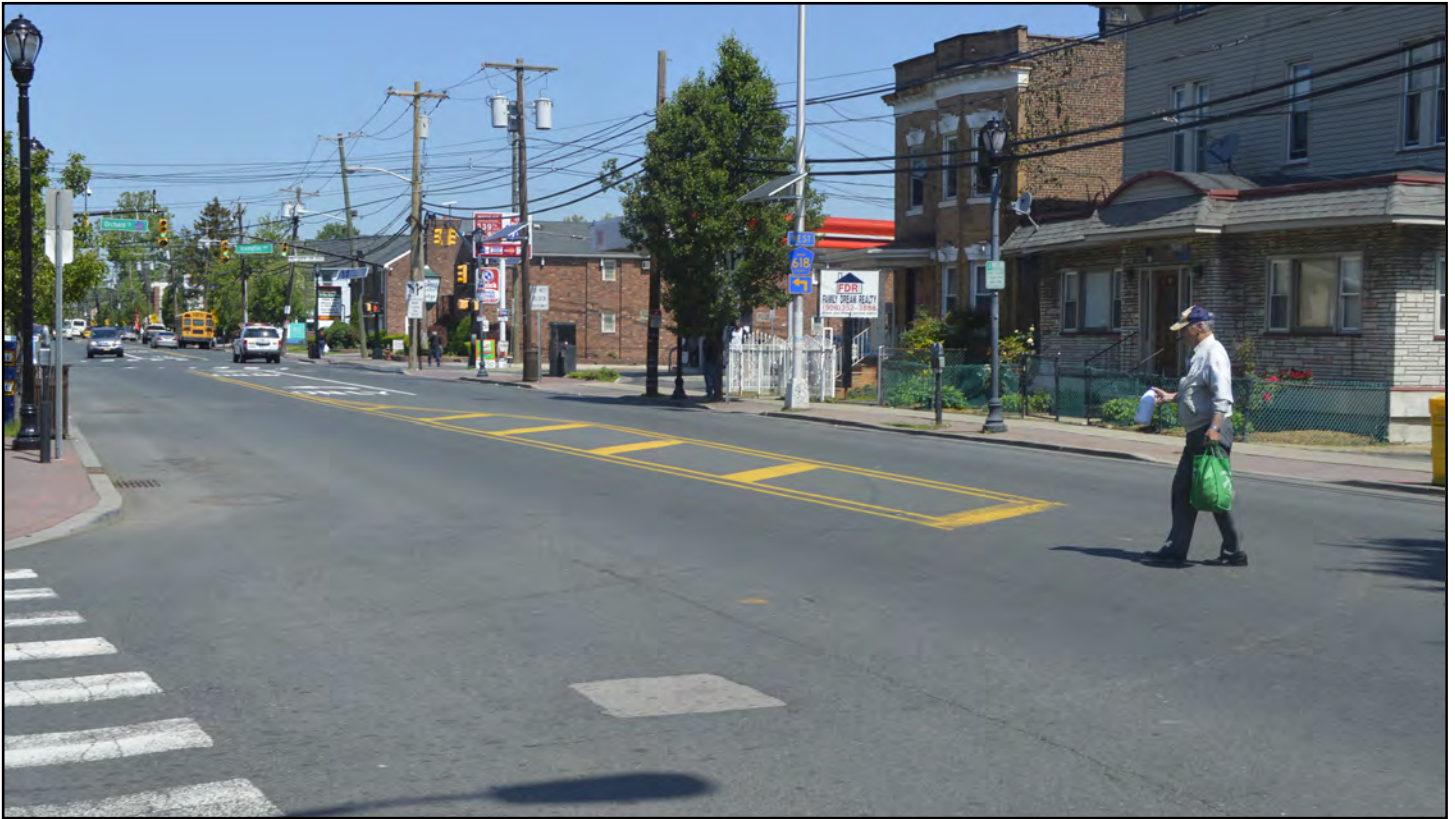
Pedestrian traveling on Morris Avenue between Westfield Avenue and Sayre Street. He is crossing at an unmarked but legal crosswalk would be made safer by a marked crosswalk.

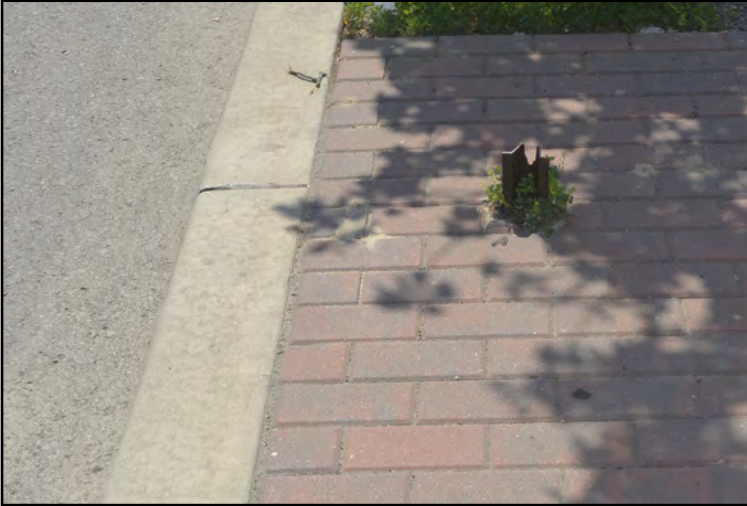
An old sign pole post presents a hazard to pedestrians.

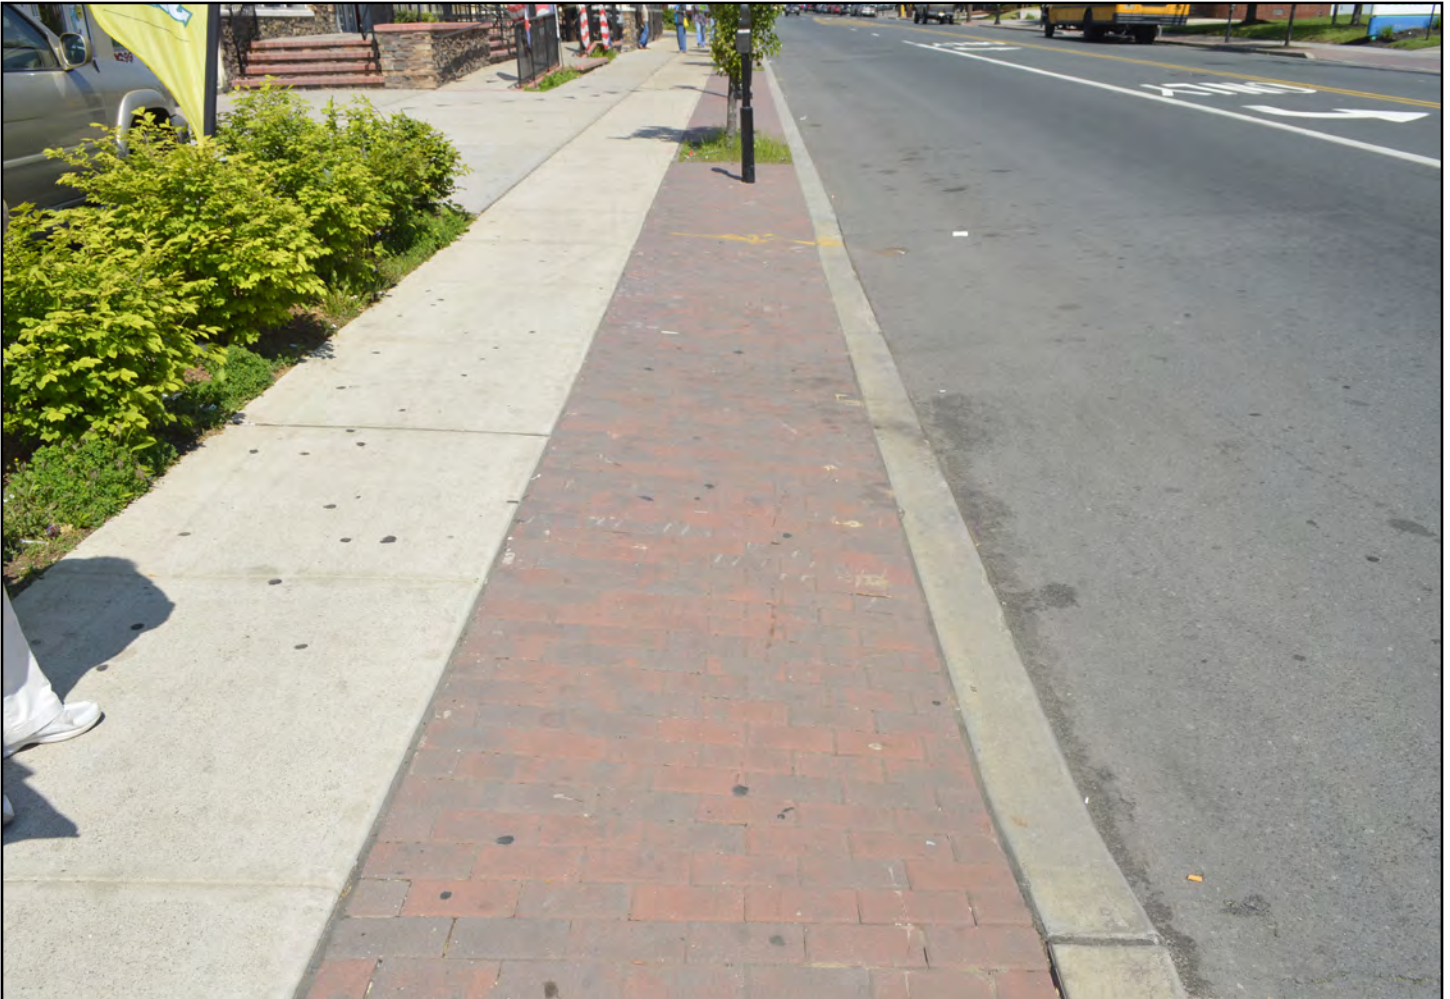
Old curb cut adjacent to Bravo. A vegetative buffer between the sidewalk and the parking lot is on the left.

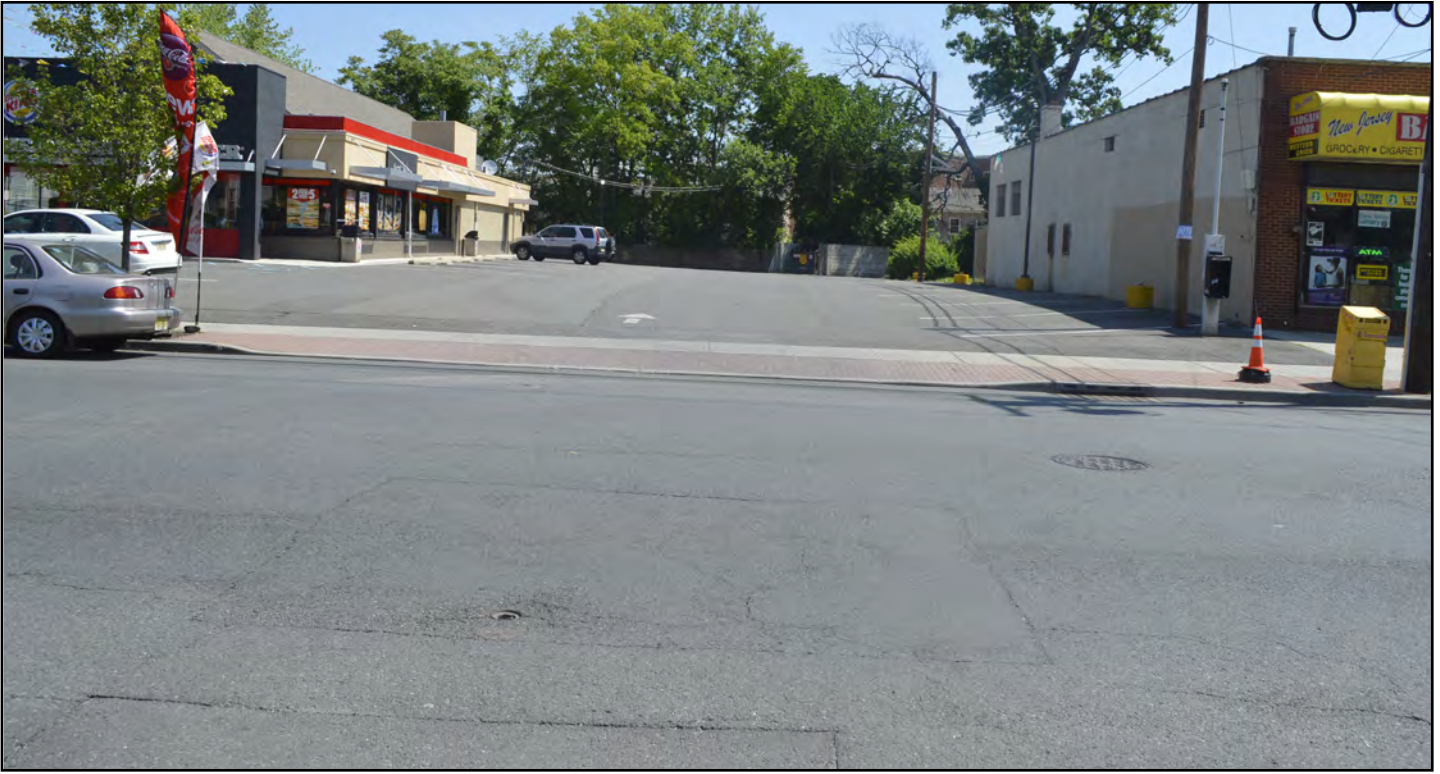
This wide, unprotected surface lot on Morris Avenue encourages drivers to speed while making turns.

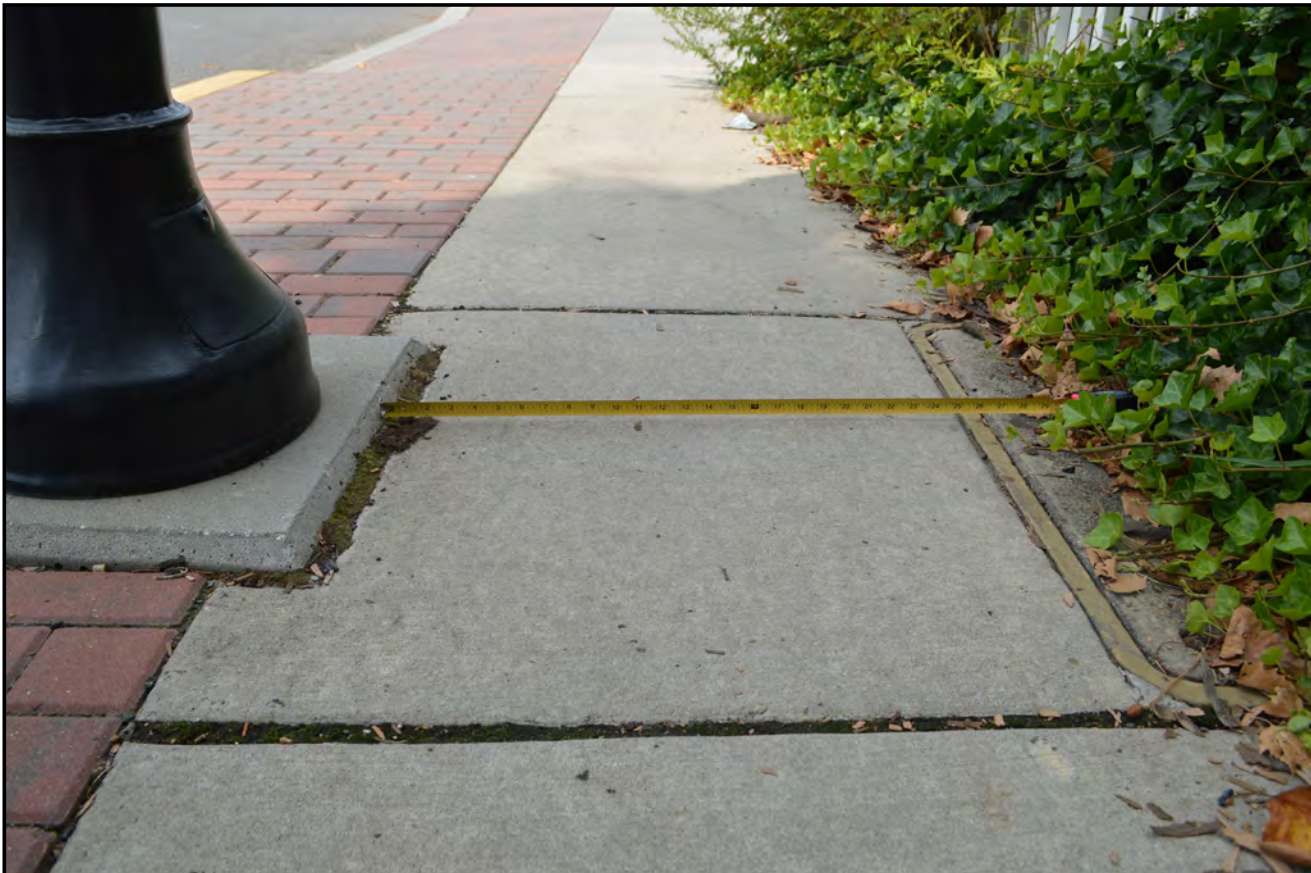
ADA law requires that sidewalks allow 36 inches of sidewalk space. A portion of the sidewalk between Cherry Street and Trotters Lane is 28 inches.

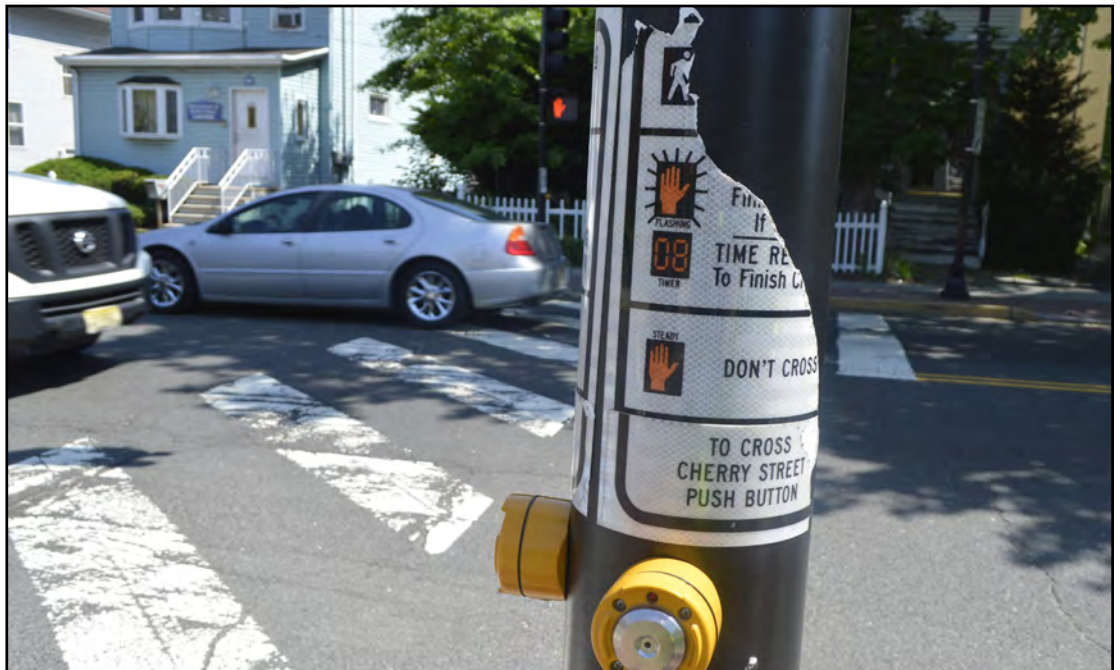
Torn pedestrian crossing instructions should be replaced; given the large Spanish-speaking community, instructions in Spanish are recommended.

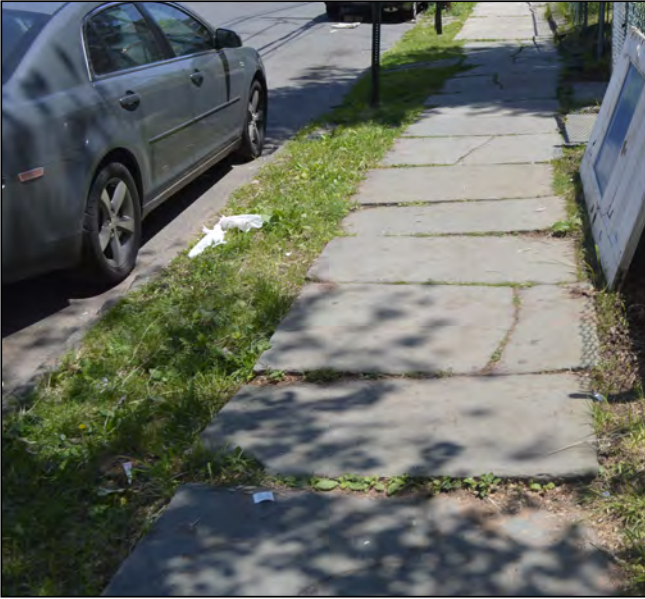
Uneven sidewalk on Sayre Street should be fixed for pedestrian safety and wheelchair accessibility.

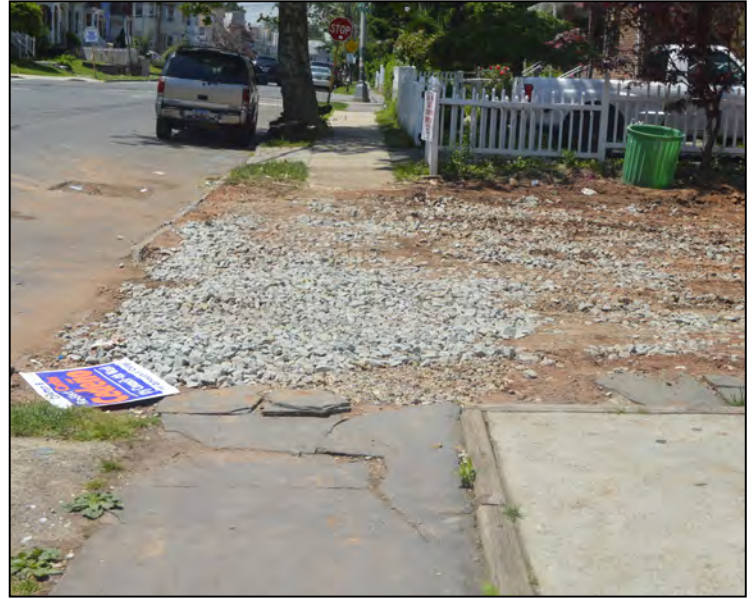
This gravel on this driveway Sayre Street poses a safety hazard to pedestrians and wheelchair users.

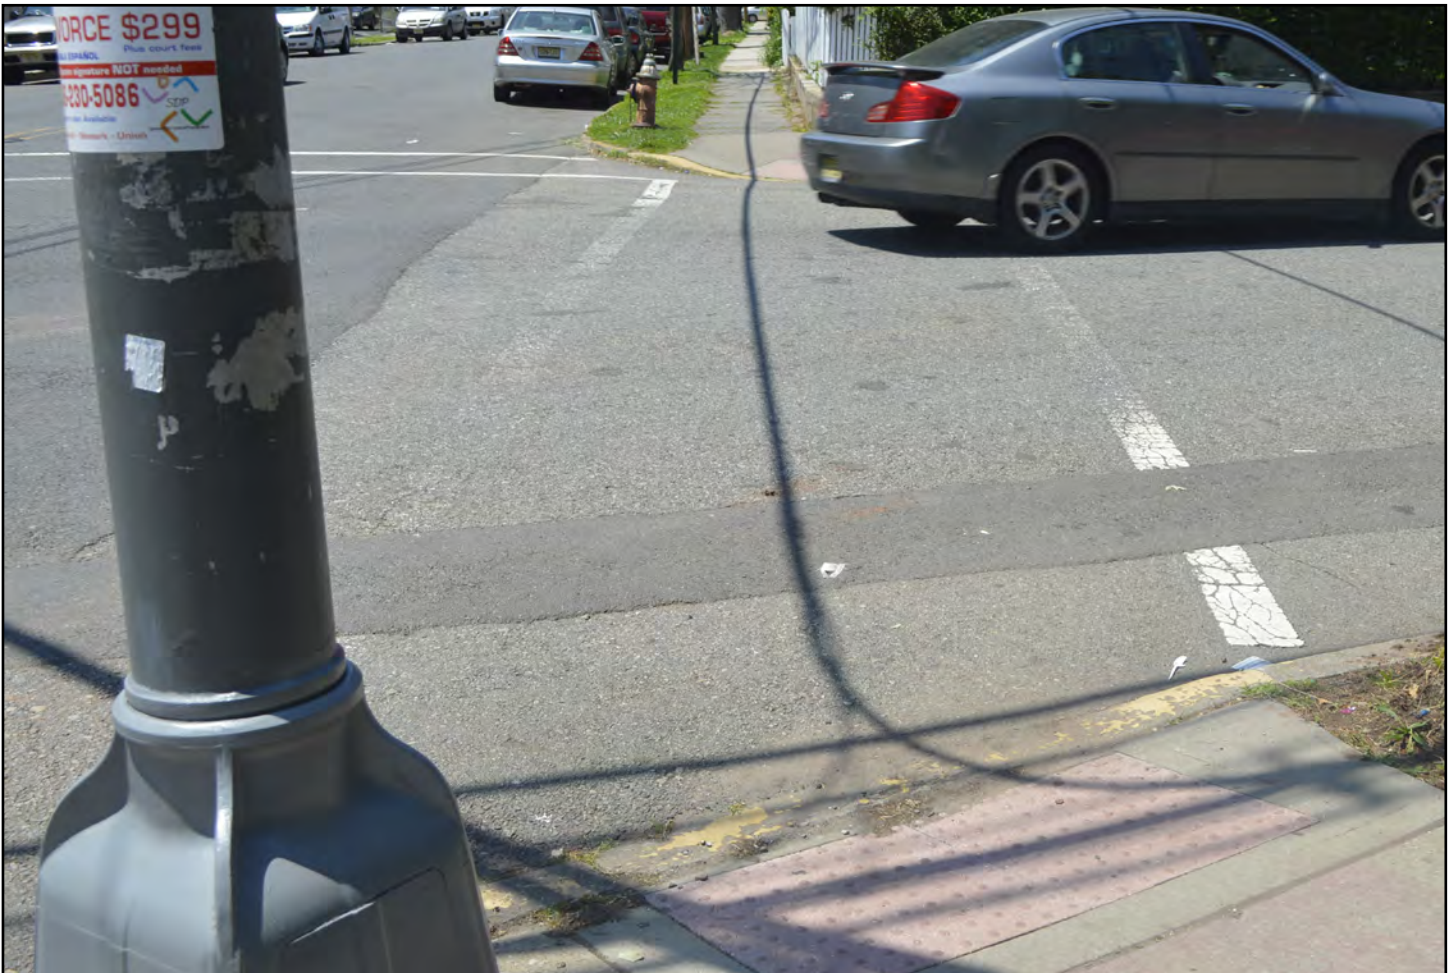
A faded crosswalk at the intersection of Sayre Street and Cherry Street should be repainted.

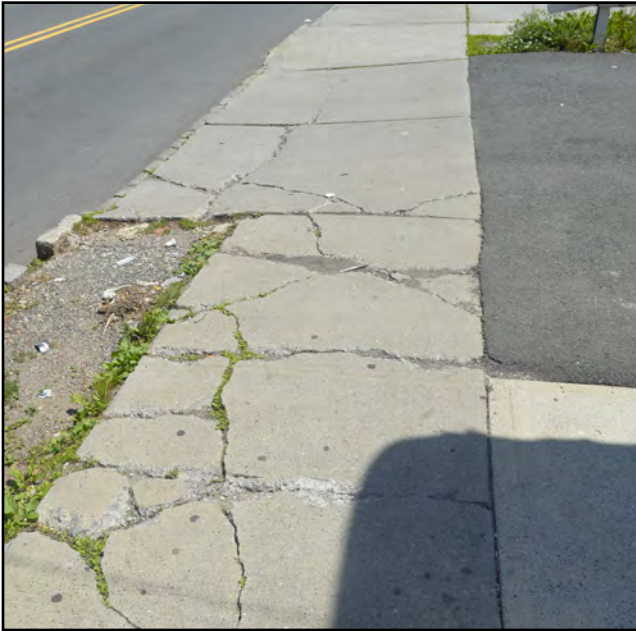
Cracked sidewalk on Orchard Street.

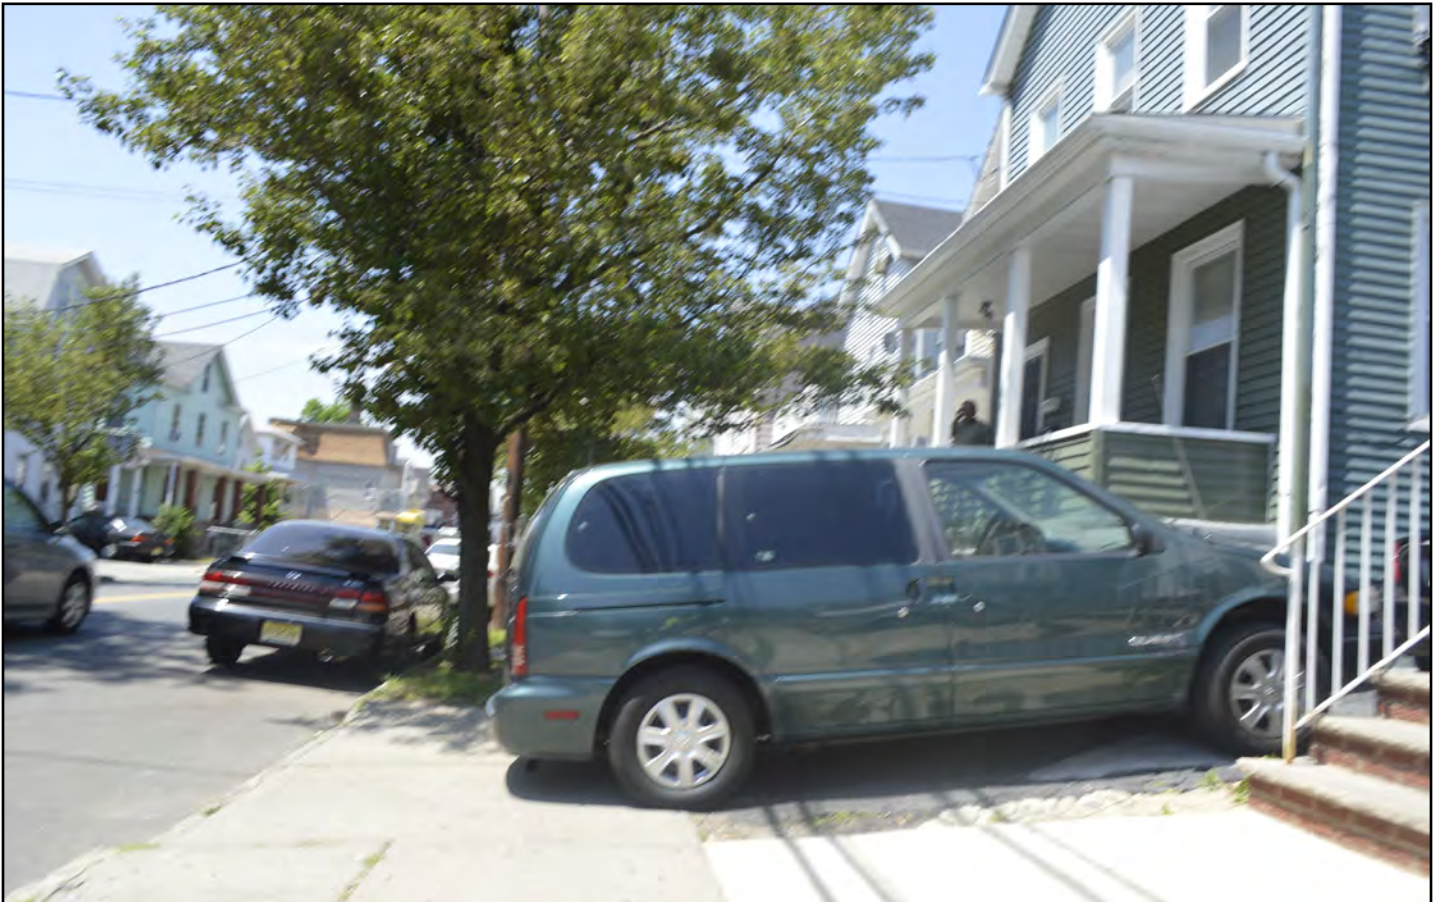
Education and enforcement is needed to prevent cars from being parked in a way that blocks pedestrian passage on the sidewalks on Orchard Street.

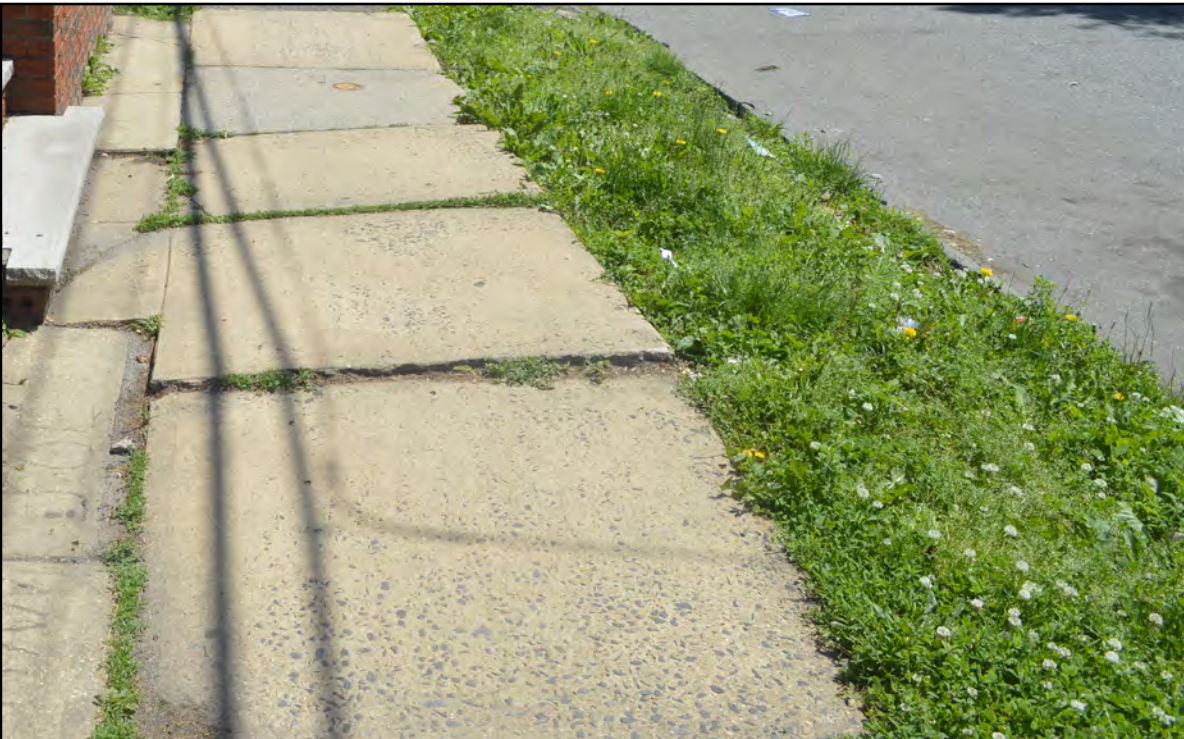
Uneven sidewalk on Elm Street.

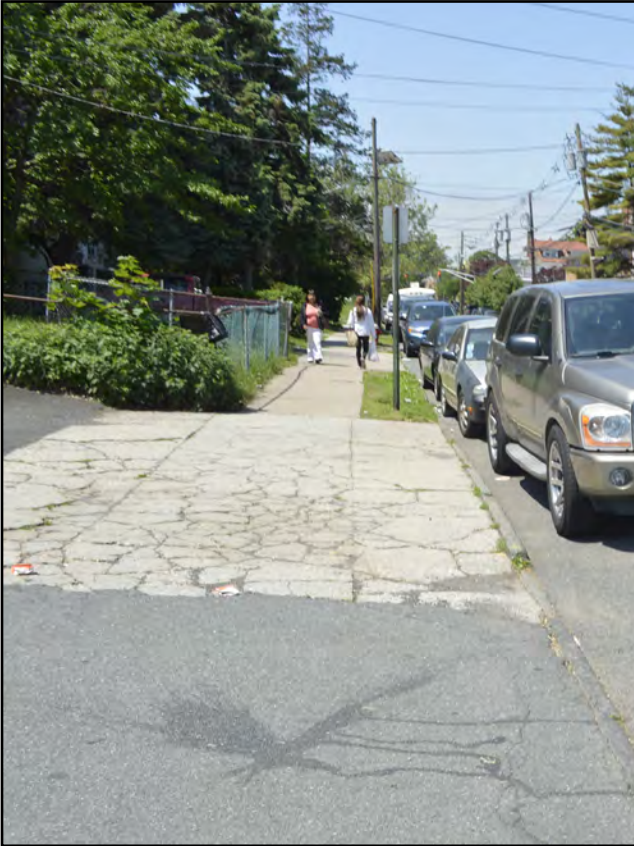
Cracked sidewalk on Stiles Street.

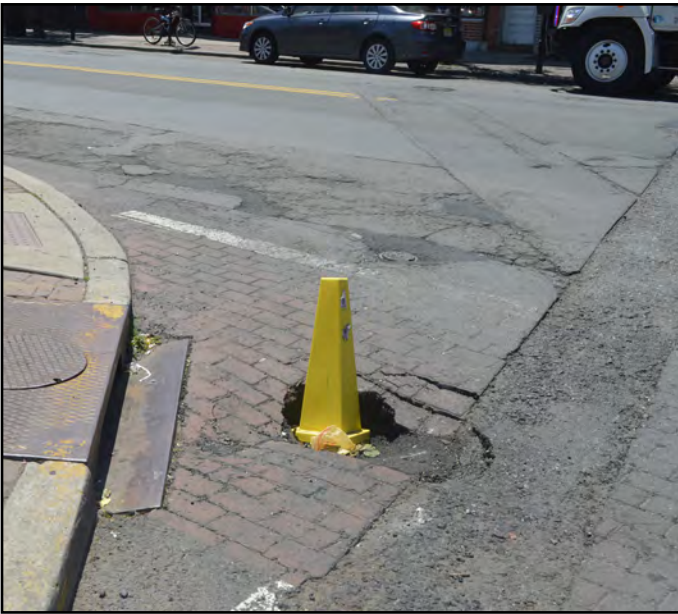
Pothole at the intersection of Morris Avenue and Union Avenue.

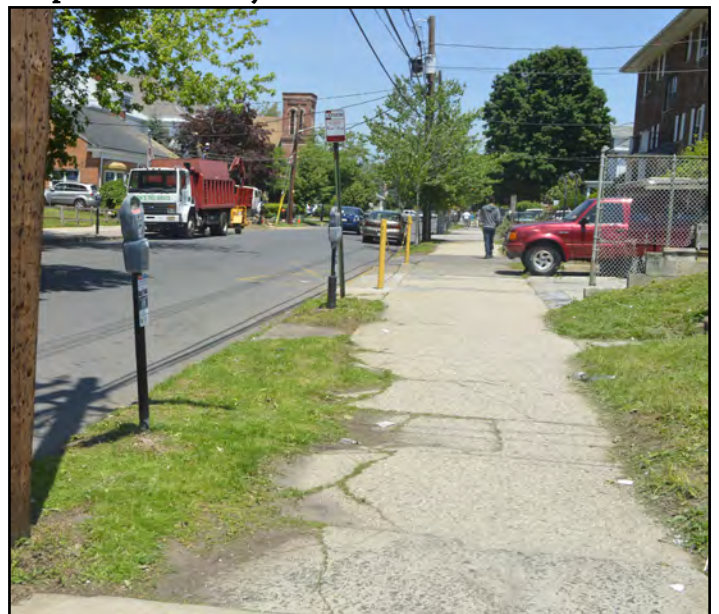
A cracked sidewalk on Union Avenue should be repaired for pedestrian safety.

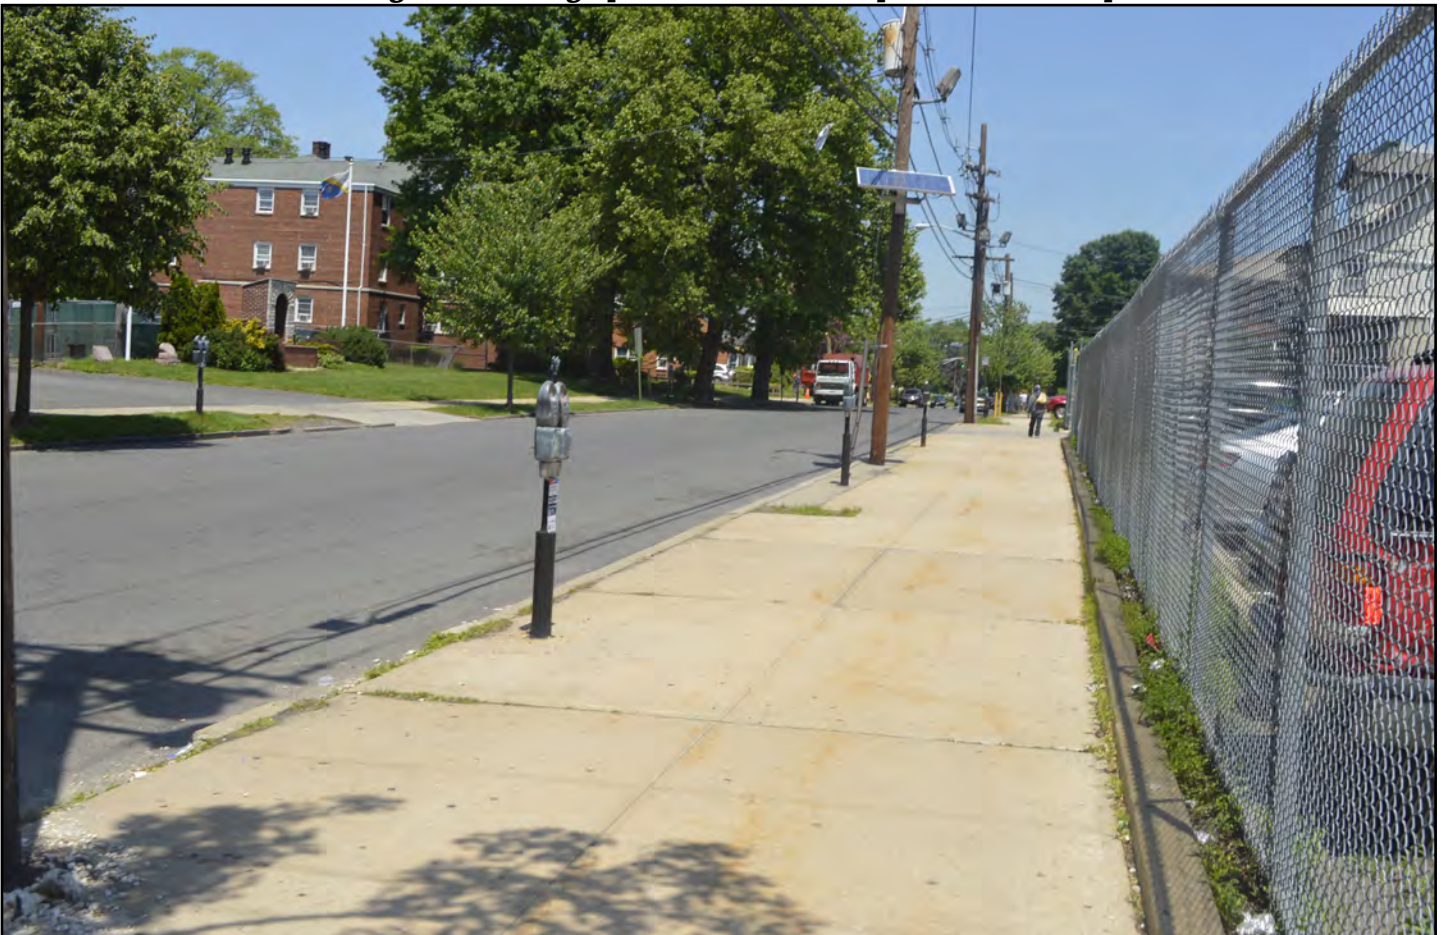
Sidewalk on Union Avenue facing north. Adding a planter zone would improve the walk for pedestrians.
