Complete Streets in the City of Trenton: Existing Conditions Analysis

May 2018

Prepared for:
The Trenton Health Team

Prepared by:
The Alan M. Voorhees
Transportation Center
Edward J. Bloustein School of
Planning and Public Policy
Rutgers, The State
University of
New Jersey

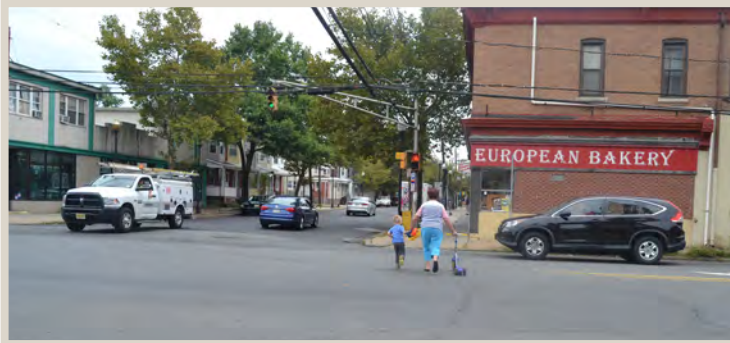
Brunswick Avenue and North Olden Avenue is a major intersection controlled by a traffic light. Although not delineated with multiple lanes, vehicles were observed forming two lanes at the signal. Crosswalks and stop bars are extremely faded (Figure 12). Although curb ramps exist, they do not meet ADA standards. Additionally, the ramps are oriented towards the center of the intersection,

Figure 12. Pedestrians crossing N. Olden Avenue, crosswalk not painted.

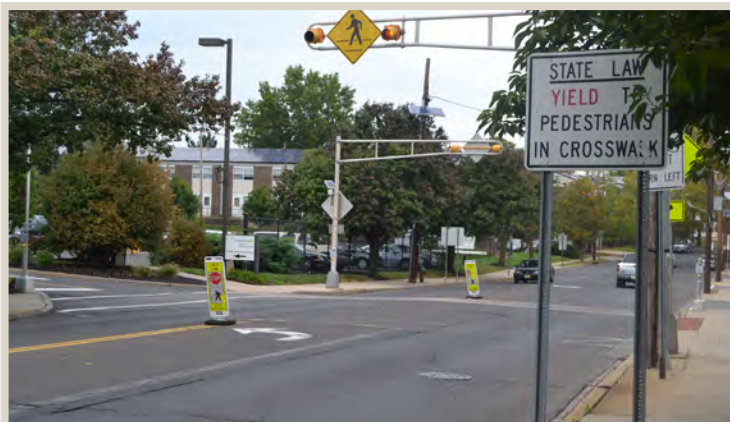
South of the intersection, the sidewalk loses the decorative brick pavers. Instead, the area adjacent to the curb has grass. Additionally, the historic-style street lights do not exist south of this intersection. Approaching the Capital Health Regional Medical Center there is a sign stating "Hospital Zone," a sign noting the 25 mph speed limit, and a sign warning of pedestrian crossings (Figure 14).

Figure 14. Crosswalk and pedestrian crossings signs by Capital Health Regional Medical Center.

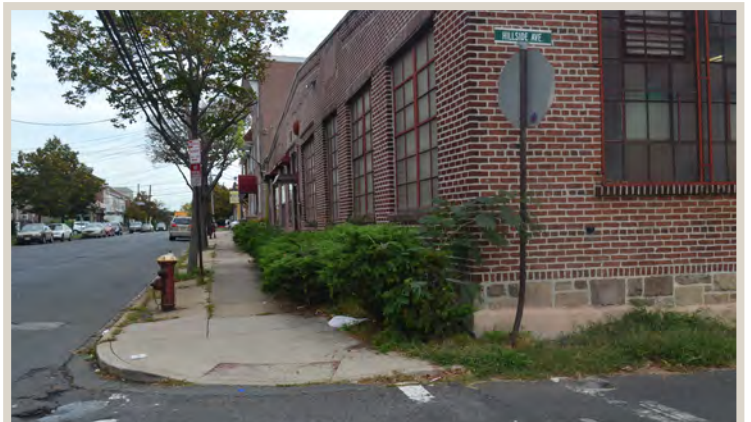
Figure 15. Building at corner of Brunswick and Hillside blocks sight lines for vehicles arriving at the stop sign.

Hillside Avenue is a very minor street which resembles an alley more than an avenue. It terminates at Brunswick Avenue with a stop sign. Due to the presence of a building, there is almost no visibility of the sidewalk and roadway for vehicles arriving at the stop sign (Figure 15).

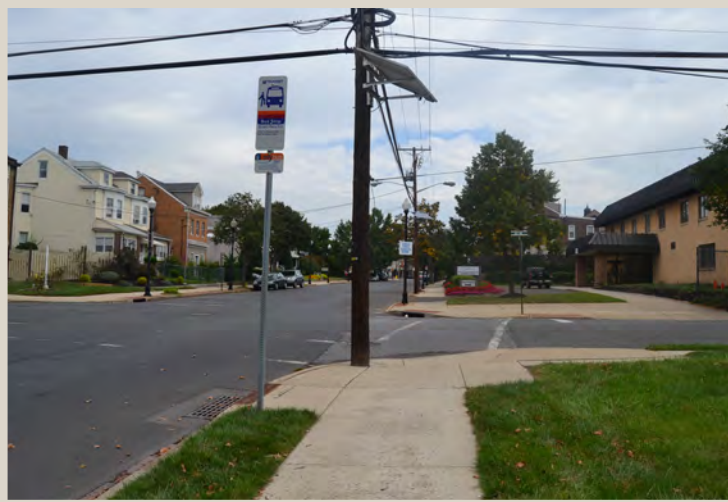
Figure 16. Bus stop with grass strip between sidewalk and curb.

East Paul Avenue and Sylvester Street both terminate at Brunswick Avenue within 50 feet, creating the appearance of a large intersection. Sylvester is one-way westbound, while East Paul is bidirectional. Once again, there are no crosswalks across Brunswick, and faded crosswalks across those secondary streets. There are NJ Transit bus stops just north of the intersection, and both have a strip of grass separating the sidewalk from the curb, creating a challenge for passengers with mobility devices (Figure 16).

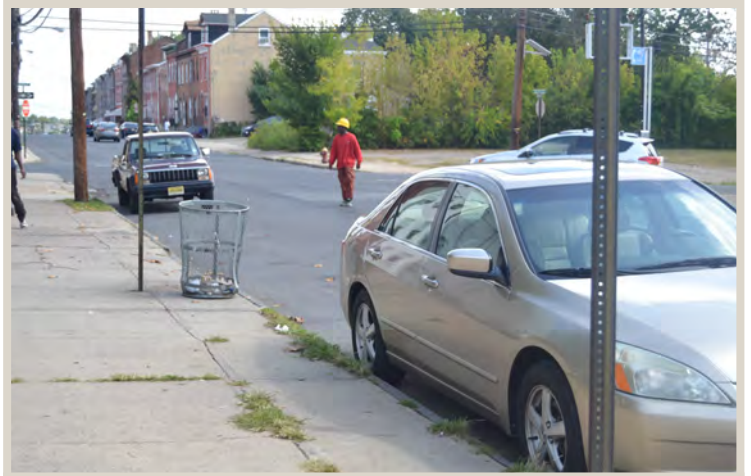
No transit stops are present along this segment of Brunswick Ave. No pedestrian amenities aside from one garbage can are present and there is a high volume of litter around the Sanford Street intersection (Figure 21). Additionally, the eastern section of this segment near the Sanford Street intersection has a high number of vacant properties.

Figure 21. A garbage can, a rare pedestrian amenity, near 217 Brunswick Avenue.

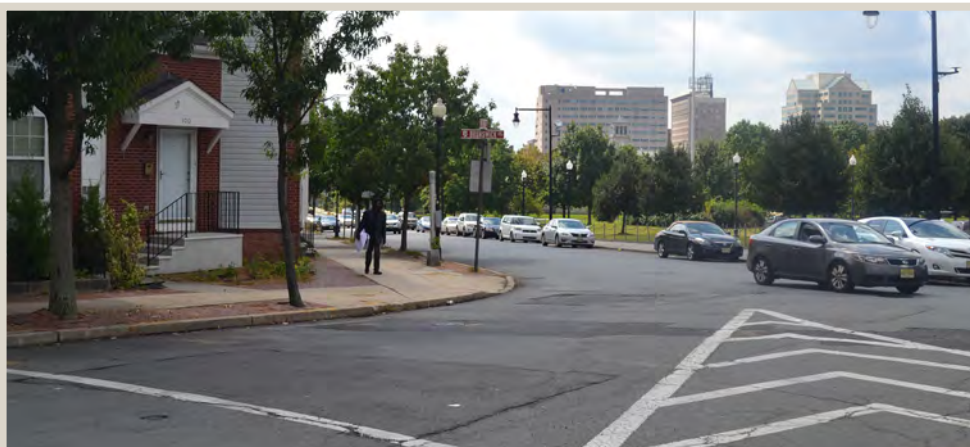
The Brunswick Avenue corridor ends at North Broad Street, adjacent to the Trenton Battle Monument. Drivers entering Brunswick Avenue do so at a curved angle, designed for higher speeds (Figure 22). There is a marked crosswalk across Brunswick Avenue, but none available for pedestrians to reach the monument.

Figure 22. Entrance to Brunswick Avenue corridor.

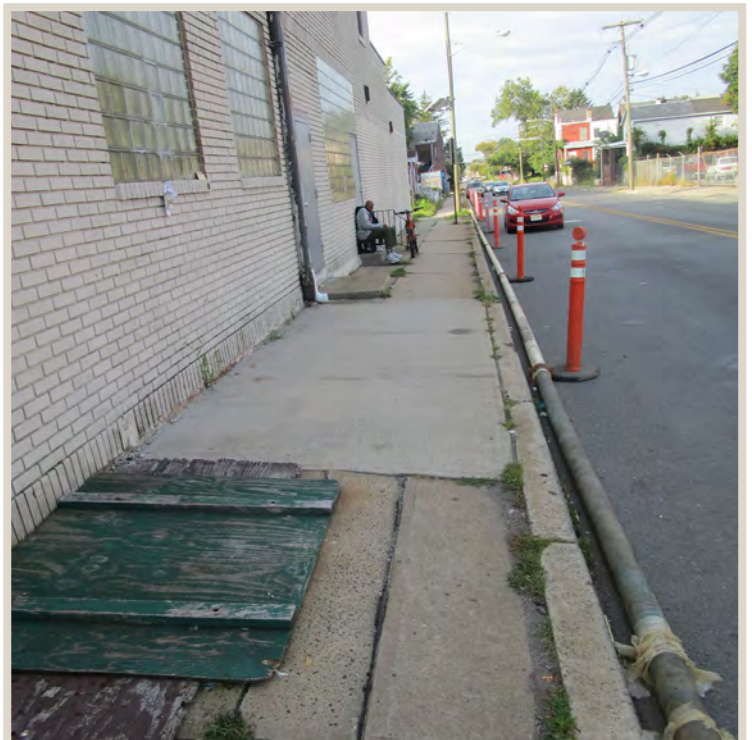
Figure 27. Steps making part of the sidewalk unusable.

South of the intersection, there is a seven-foot sidewalk adjacent to a vacant three-story building, although only half of it is fully usable due to steps leading into the building (Figure 27). Immediately after the building ends, the sidewalk narrows to about four feet with a one-foot planting strip, followed by a section where the sidewalk is immediately adjacent to the curb. The following property is a vacant detached home, and the sidewalk is in very poor condition. There is a driveway which is overgrown. Due to the presence of the corner building, vehicles exiting the driveway have no visibility of oncoming pedestrians.

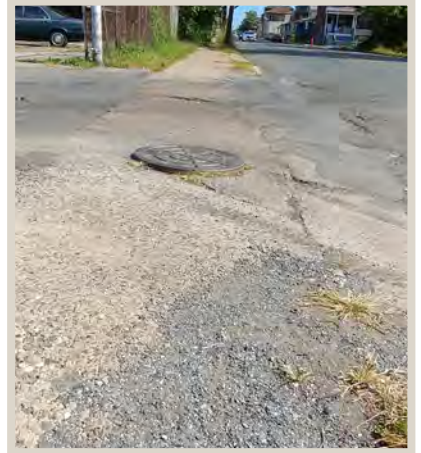
Figure 29. A sloping, uneven sidewalk.

South of Wayne Avenue, the sidewalk is in better condition on the east side. There is some vegetation, but it is generally passable and flat. On the west side, the sidewalk is very narrow and vegetation is overgrown. Additionally, there is some litter. Shortly before reaching New Rose Street, the sidewalk is broken up by frequent driveways. The sidewalk in this area also has many cracks, a slope, and an uneven manhole (Figure 29).

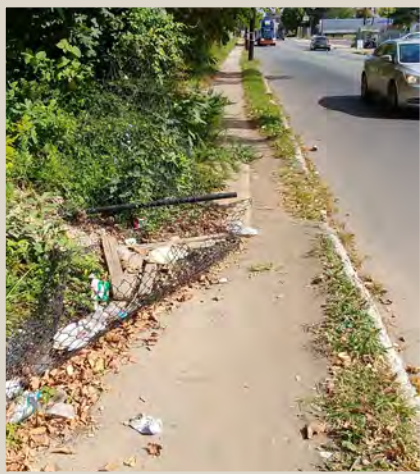
Figure 31. Fallen fence, litter and overgrown vegetation.

The west side sidewalk is in especially poor condition, with a fallen fence blocking most of the walkway. There is also a large amount of litter and vegetation (Figure 31).

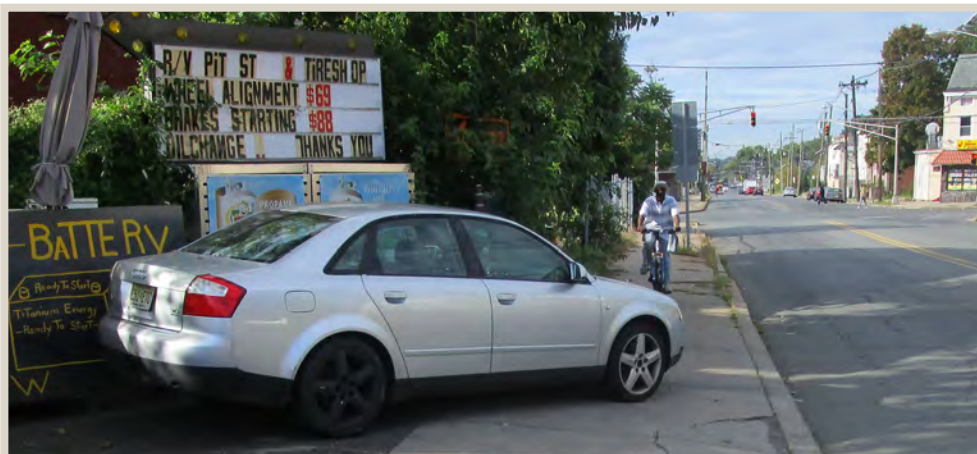
However, south of the intersection, sidewalks return to poor condition. An automotive business on the east side was observed blocking the sidewalk with their parked vehicles (Figure 34), a behavior that is likely frequent, as it was also confirmed using aerial imagery.

Figure 34. Parked car blocking sidewalk along Calhoun Street.

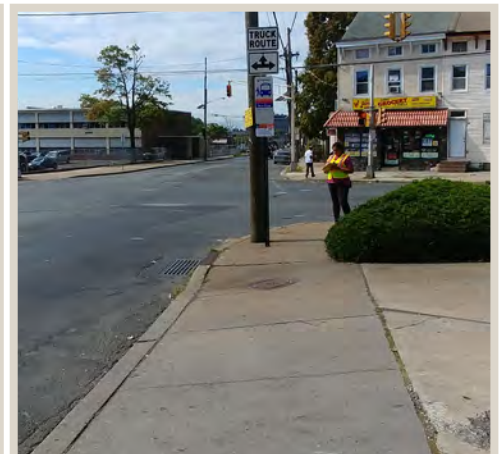
This section of the corridor does not have any amenities such as benches, bicycle racks, or trash cans. There is also no pedestrian oriented lighting, only overhead cobra lights. There is a southbound NJ Transit bus stop on the west side of Calhoun Street, just north of Pennington Avenue, adjacent to a gas station. The sign is at the corner, and any bus stopping there would discharge onto the gas station driveway. However, there is a sidewalk in good condition prior to the driveway where bus drivers could stop instead (Figure 35).

Figure 35. NJ Transit bus stop located at entrance to gas station.

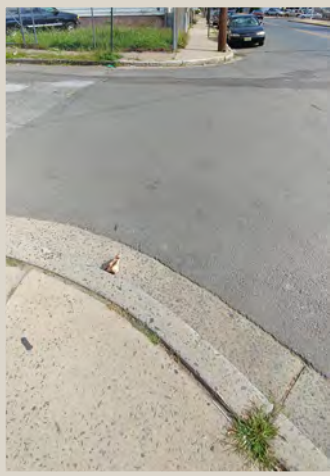
Figure 36. No ramps or crosswalks.

Wilson Street sits on the west side of Calhoun Street, running in one direction to the west. The sidewalks adjacent to this corner are in poor condition due to various vacant rowhomes. The corners lack ramps and there are no crosswalks painted in any direction (Figure 36).

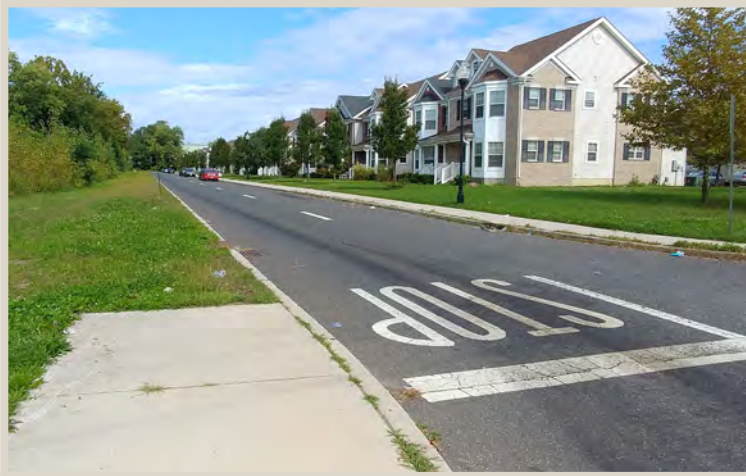
Figure 37. Improper white center striping along Dunham Street indicates that this roadway may be privately owned and maintained.

South of Wilson Street, sidewalks are in better condition on the east side, next to the 9th Grade Academy. There is litter and vegetation on the west side. Dunham Street sits on the west side, and appears to be privately maintained due to non-standard road striping; it is two-ways, but the center striping is white rather than yellow (Figure 37). The corner features ramps oriented across Dunham Street, with truncated domes and a striped crosswalk.

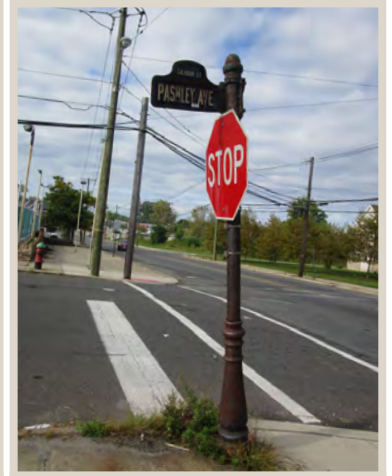
Figure 38. Intersection of Pashley Avenue and Calhoun Street.

Just south of Dunham Street, Calhoun Street intersects with Pashley Avenue, which meets Calhoun St. from the east (Figure 38). The corner ramps appear to be recently installed with a proper slope and truncated domes. However, they are oriented only across Pashley Avenue. There is a marked crosswalk across Calhoun Street on the southern leg of this intersection, but there is no ramp on the west side of Calhoun Street.

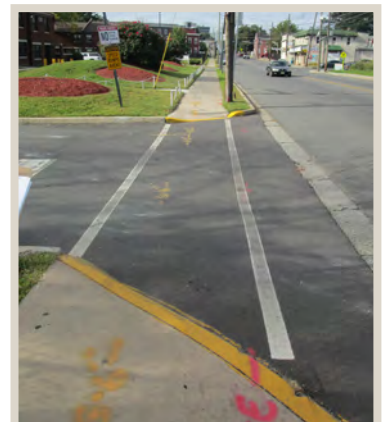
Fairway Drive is another privately maintained roadway that terminates at Calhoun Street, but it is narrower than the previous streets. There is a faded crosswalk and ramps, although they are not ADA compliant (Figure 39). There are NJ Transit bus stops on

Figure 39. Non-compliant ramps.

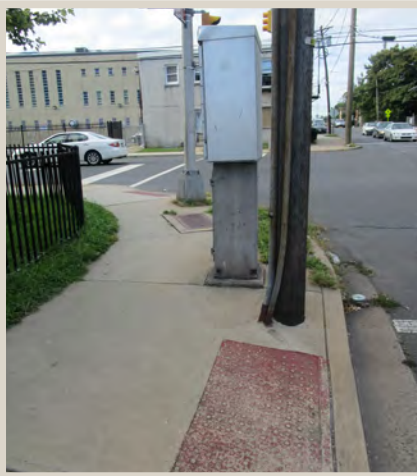
Figure 40. Electronic cabinet blocking pedestrians from drivers' sight.

Bellevue Avenue intersects with Calhoun Street at an intersection controlled by a traffic signal. There are no dedicated turn phases, and there are no pedestrian signals. All four corners have two ramps oriented into the crosswalks, which are painted but badly faded. The northwest corner has a wide turning radius, which may invite speeding. The northeast corner has an electronic cabinet next to the sidewalk ramp which blocks the view of pedestrians from turning vehicles (Figure 40). The same corner has a payphone, but it is not in working order (Figure 41).

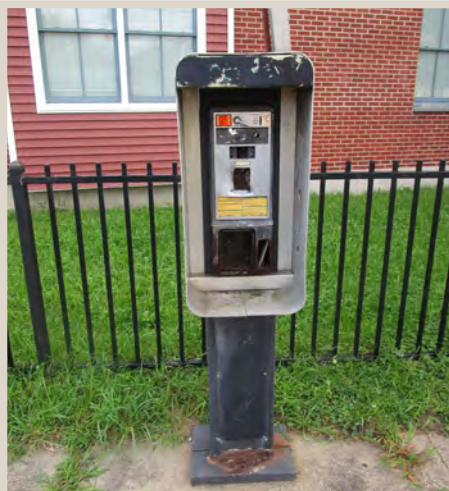
Figure 41. Dilapidated payphone.

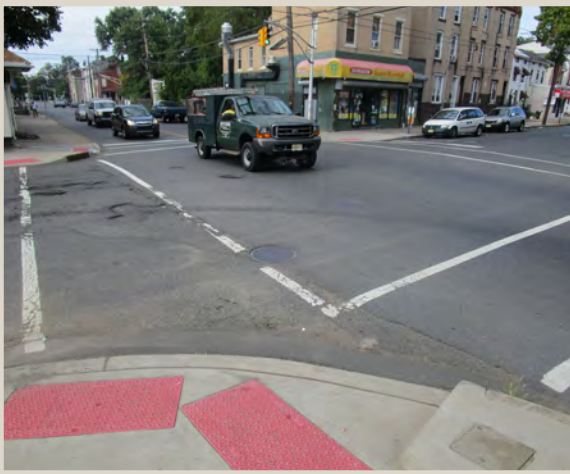
Figure 44. Updated ADA curb ramps, but missing pedestrian signals at Spring Street.

Spring Street is a standard four-way signal controlled intersection without dedicated turning phases. The traffic signals are old and do not have pedestrian signals. However, the corners have recently been rebuilt with ADA-compliant curb ramps leading into traditional parallel marked crosswalks (Figure 44). Due to the position of the traffic signal support, the southwest corner only has a single ramp. Although the crosswalk paint is in decent condition, the asphalt is not; the eastern crosswalk is especially full of potholes (Figure 45).

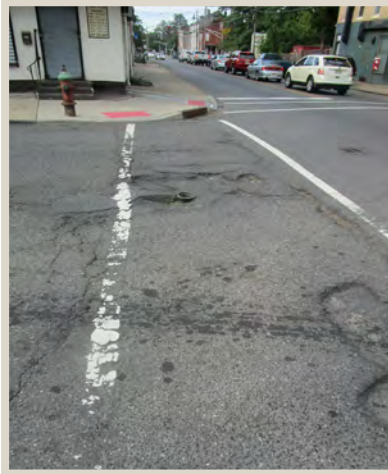
Figure 45. Uneven asphalt.

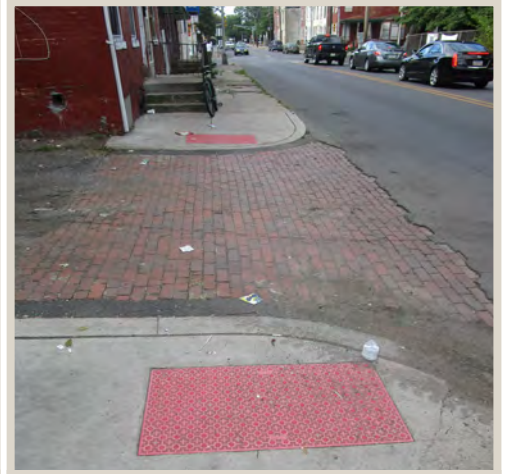
Figure 46. Small brick alley may create challenges for wheeled mobility devices.

South of Spring Street, the sidewalk continues in better condition on the east side of Calhoun Street than on the west side. The exception is at a small brick alley. While the sidewalk has modern ramps with truncated domes, the brick may present difficulty for those in wheelchairs (Figure 46). Additionally, the area around the alley had large amounts of litter during the audit. Past the alley, sidewalk conditions deteriorate significantly in front of a vacant building (Figure 47), leading to the next intersection.

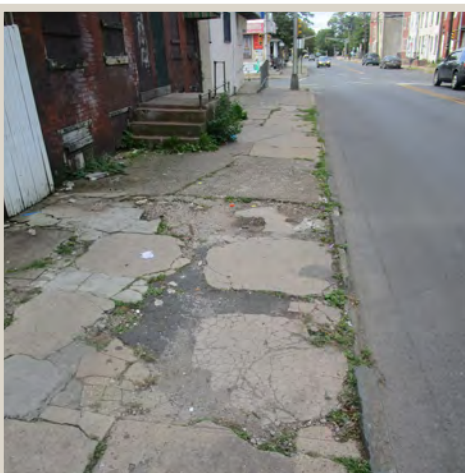
Figure 47. Significantly deteriorated sidewalk conditions.

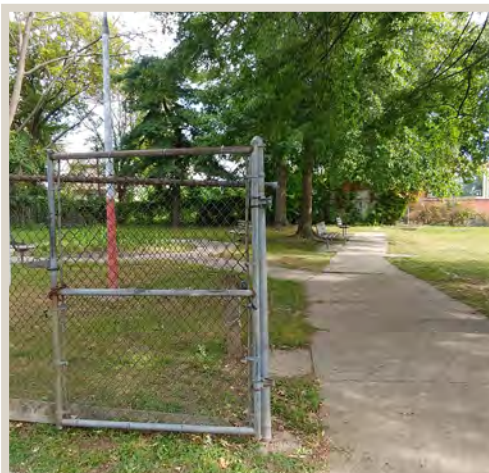
The intersection of Calhoun Street and Passaic Street is controlled with a traffic signal that lacks pedestrian signals. There are four painted crosswalks that are extremely faded, with the west crosswalk being barely visible. Each corner has a single ramp facing into the intersection, but none are ADA compliant. Only the southeast corner has a functioning business, a liquor store. The northeast corner has a closed market, while the southwest corner has a series of damaged buildings. The northwest corner has a park that is in active use, but does not look welcoming due to the chain-link fencing (Figure 48).

Figure 48. Uninviting park entrance.

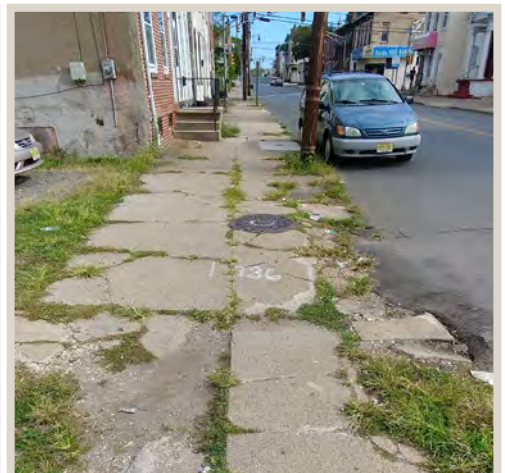
Moving south from the Passaic Street intersection, the eastern side of Calhoun Street is in better condition than the western side. While litter was observed on both sides, the sidewalk in front of the vacant buildings on the west side is broken, with vegetation growing between the cracks (Figure 49). This poor condition is further compounded by a driveway, which results in the entire sidewalk being sloped. Google Maps notes an NJ Transit bus stop on the east side of the street, but there is no signage indicating this at that location. Although the

Figure 49. Vegetation growing along large cracks in the sidewalk.

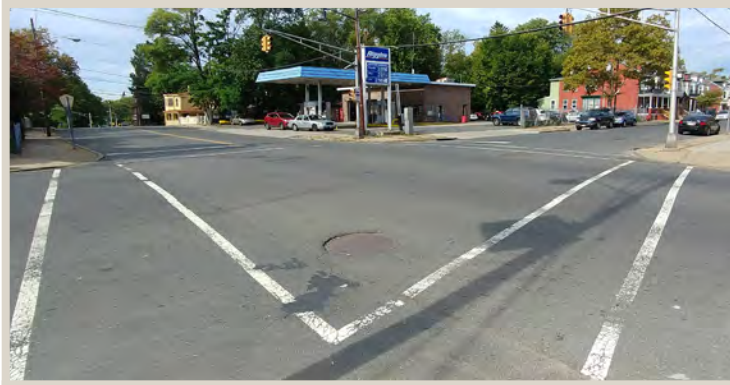
Figure 50. Intersection lacks pedestrian signals and ADA ramps.

Calhoun Street intersects with Hanover Street at a signalized intersection lacking pedestrian signals and ADA-compliant curb ramps (Figure 50). There are four painted crosswalks in decent condition. The intersection feels especially wide, as two corners contain gas stations, and a third is a parking lot. The fourth corner contains an attractive but boarded up three-story building.

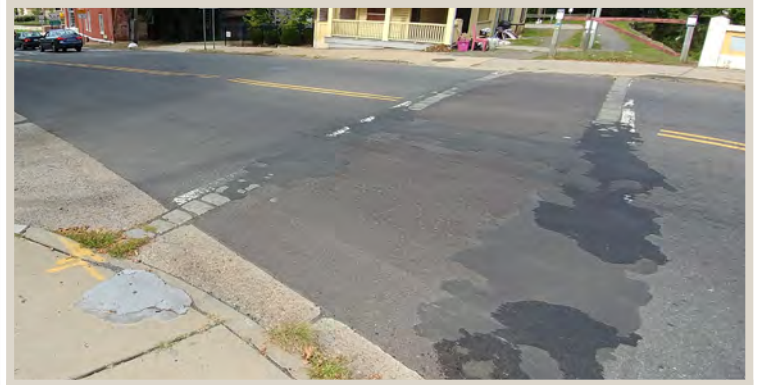
Figure 51. Asphalt-covered pavers along crosswalk.

On the final segment towards West State Street, Calhoun Street crosses over the D&R canal. The sidewalks are in good condition here, with the exception of the corner of Capitol Street, which terminates on Calhoun Street from the east. There are no curb ramps at this crossing. There is however, a crosswalk with curb ramps and faded striping across Calhoun Street, as a branch of the canal trail crosses Calhoun at this location. Aside from faded paint, the crosswalk is marked with stone pavers, although many have been covered with asphalt (Figure 51).

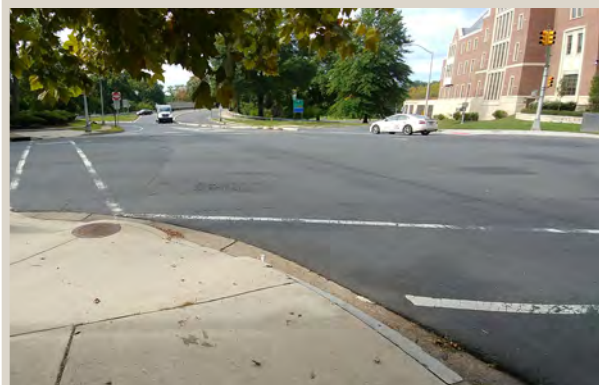
The intersection is controlled by traffic signals, all of which have modern pedestrian signals. There are also standard crosswalks painted in all directions, with the paint on the southern leg being in especially good shape (Figure 53), and the western leg having faded striping. However, very wide turning radii and many lanes make for lengthy crossings for pedestrians, with the southern crossing being over 100-feet long. Additionally, there is no crosswalk painted across the entrance to the NJ-29 on-ramp. Due to the presence of the Mercer County Clerk office tower on the northeast corner and Thomas Edison State University on the southwest corner, this intersection probably sees the most pedestrians of any along the corridor. However, this intersection appears to have been designed as an extension of the highway, and so is the most hostile to pedestrians along the corridor.

Figure 52. Large intersection at West State Street.

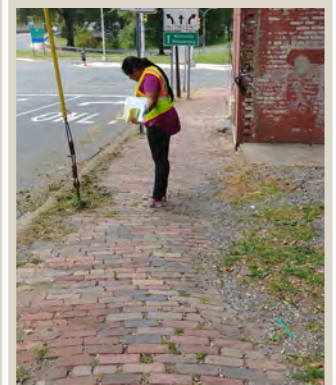
The sidewalk on the northwest corner is unique as it is paved with brick (Figure 54). Although the brick is attractive and historical, it poses a hazard to pedestrians, especially those in wheelchairs. The other corners feature newer sidewalks with ramps, although only the ramps on the southwest corner are fully compliant. There are two bus stops on West State Street on the east corners of the intersection. These bus stops include shelters for waiting riders. There are multiple cobra-style lights pointed towards this intersection, but due to the width, the lighting may not be adequate.

Figure 54. Brick sidewalk.

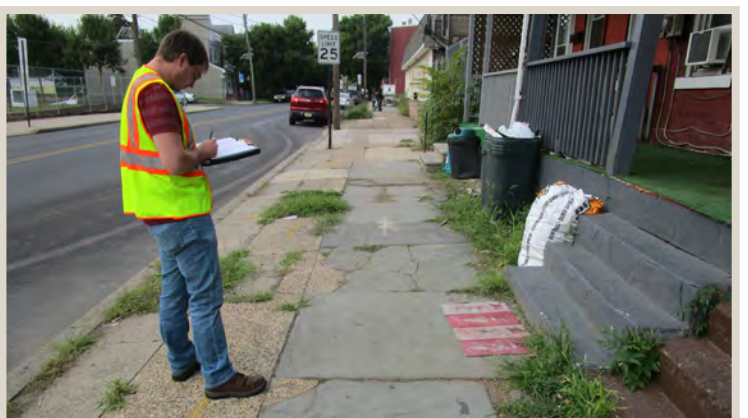
North of Logan Avenue, outside of Trenton, East State Street's traffic is divided by a single dashed yellow line (Figure 57). Upon entering Trenton, the striping switches to a solid double yellow line, possibly to indicate a change in urban character. However, there are no other signs or indications that travelers have entered Trenton aside from a 25 mph sign in the southbound direction (Figure 58).

Figure 58. No signage signifying entrance into Trenton.

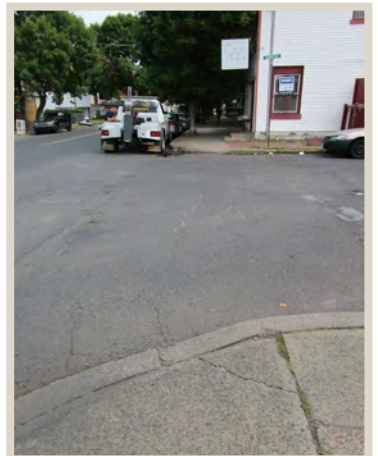
Figure 60. Missing curb ramps.

Garfield Avenue is another minor roadway that terminates on East State Street. There are no striped crosswalks in any direction. The only curb ramps are oriented across Garfield Avenue, and they are not compliant (Figure 60). The ramp surfaces are in poor condition as there is cracking, unevenness, and weed growth. There is one

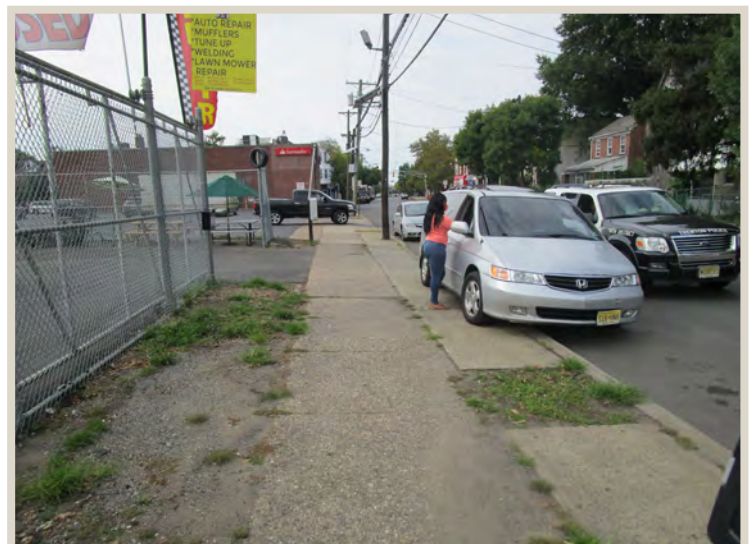
South of Garfield Avenue, the east side of the corridor becomes commercial in nature. The sidewalk extends to the curb, so there are no trees. A tire business surrounded by chain-link fencing creates visibility, but is not particularly pedestrian friendly (Figure 61). South of that business, there is a large barren asphalt parking lot for a Santander Bank. While the bank extends to the sidewalk and creates an attractive street wall, the parking lot has two very wide driveways and lacks trees. A bus stop is positioned so that any bus stopping will block the bank driveway.

Figure 61. This highly visible sidewalk is not pedestrian friendly.

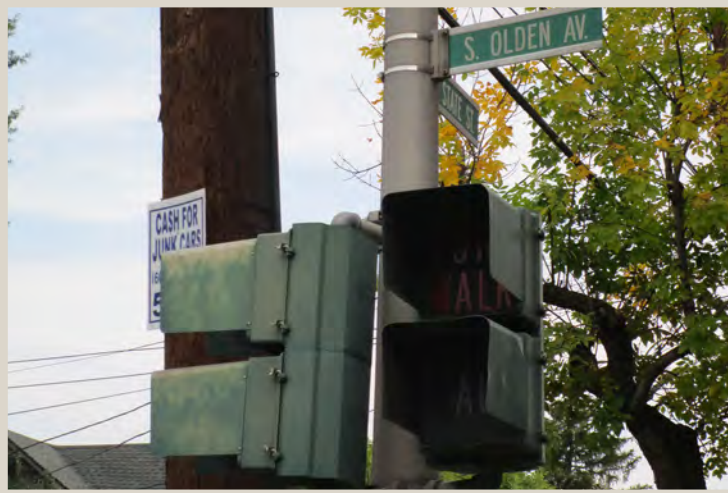
Figure 62. Dim and outdated pedestrian crossing signals.

The intersection of East State Street and North Olden Avenue is controlled by a traffic signal. There are no left turn lanes or signals in any direction. There are automated (no button) crosswalk signals in the older ‘Walk/Don’t Walk’ style, but they are dim and difficult to read (Figure 62). Although the signals face all four directions, there are only painted crosswalks and ramps for three of the four legs. The northern leg is missing a crosswalk (Figure 63).

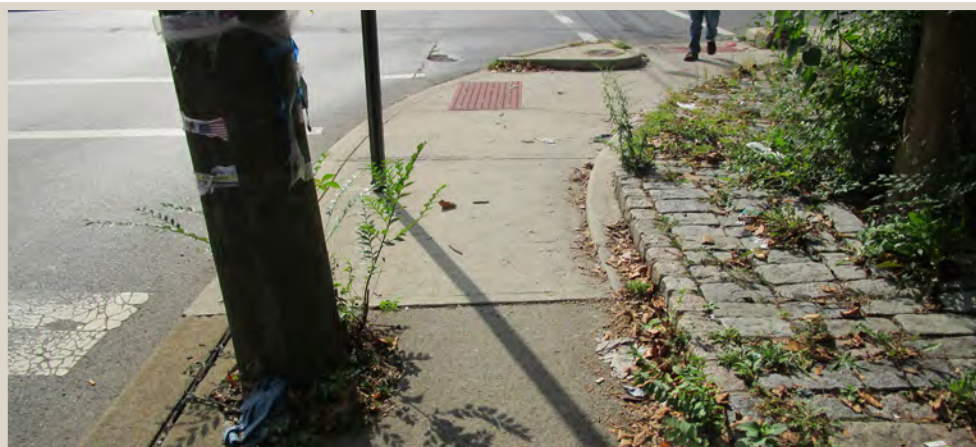
The southwest corner has two ramps that are oriented and installed correctly. However, immediately after the ramp, the sidewalk on North Olden Avenue narrows to just twelve inches due to a utility pole, making it non-compliant (Figure 64). The northwest corner has a single ramp, which feeds into a very narrow sidewalk. The design of the corner may make navigation in a wheelchair very difficult (Figure 65).

Figure 64. Utility pole drastically minimizes available walking space for pedestrians.

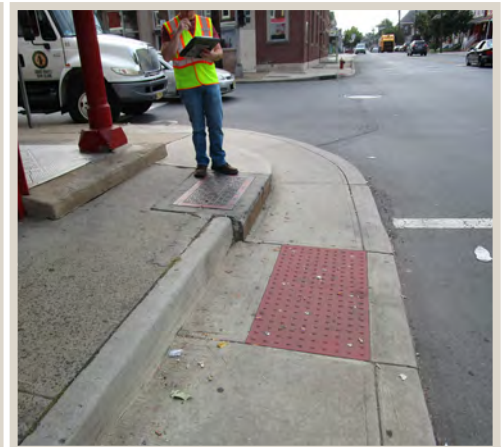
Figure 65. Challenging curb design.

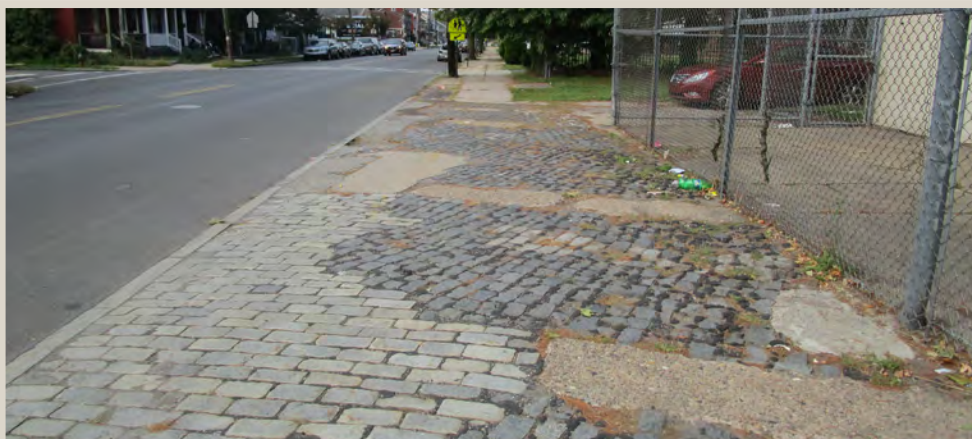
quality varies, with the worst conditions being in front of vacant properties. On the west side, the sidewalk in front of Hutchinson Industries becomes a very long sidewalk paved with bricks. The inconsistent layout of the brickwork may make it difficult to traverse this area in a wheelchair (Figure 68).

Figure 68. Uneven brickwork along East State Street.

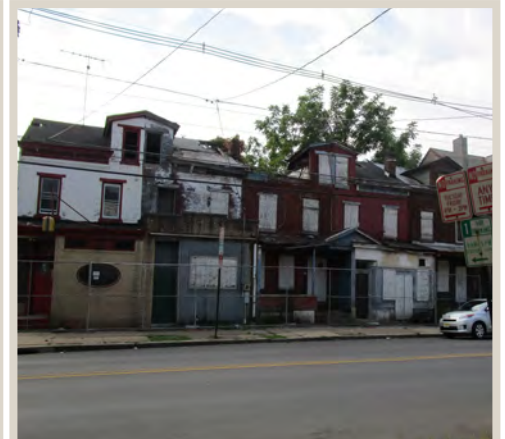
This block has a large cluster of vacant homes, which make the segment feel more isolated than the previous ones (Figure 69).

Figure 69. Abandoned homes.

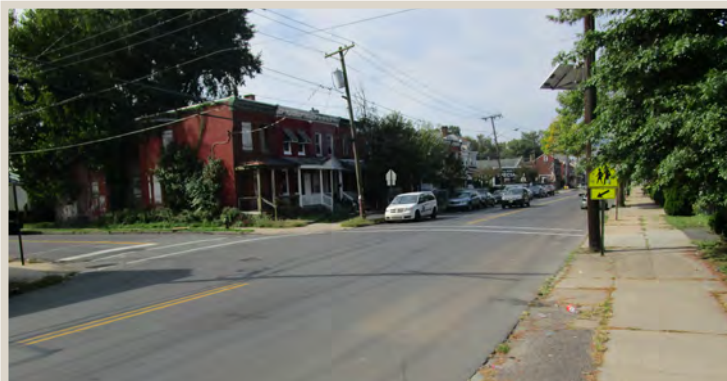
Figure 70. Visible crosswalk signage along East State Street.

a single crosswalk painted to cross East State Street on the southern leg of the intersection (Figure 70). There is crosswalk signage visible in both directions and each of the crosswalks has a ramp with truncated domes. However, the domes are very faded and barely visible. There is an overhead light at the intersection.

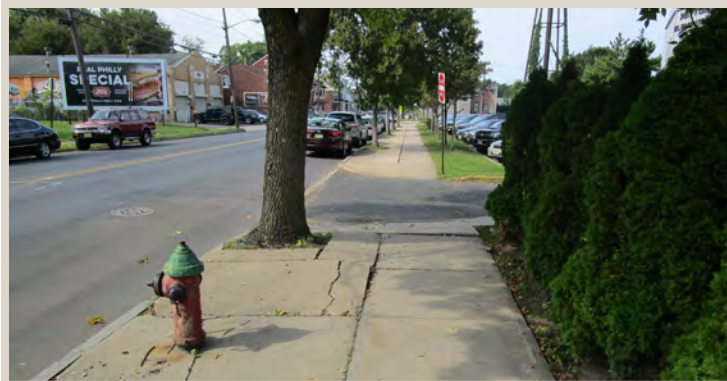
South of Cuyler Avenue, the sidewalk is in better condition on the west side along P.J. Hill Elementary School. The school is set back behind a large lawn and the sidewalk is separated from the campus with a fence and landscaping. The sidewalk is interrupted by a driveway to a small parking area and the curb ramps to cross the driveway are lacking truncated domes. Additionally, the sidewalk immediately before the driveway has been lifted by a tree. Vegetation blocks view of the sidewalk for motorists exiting the parking area (Figure 71).

Figure 71. Shrubbery blocking driver's visibility of sidewalk.

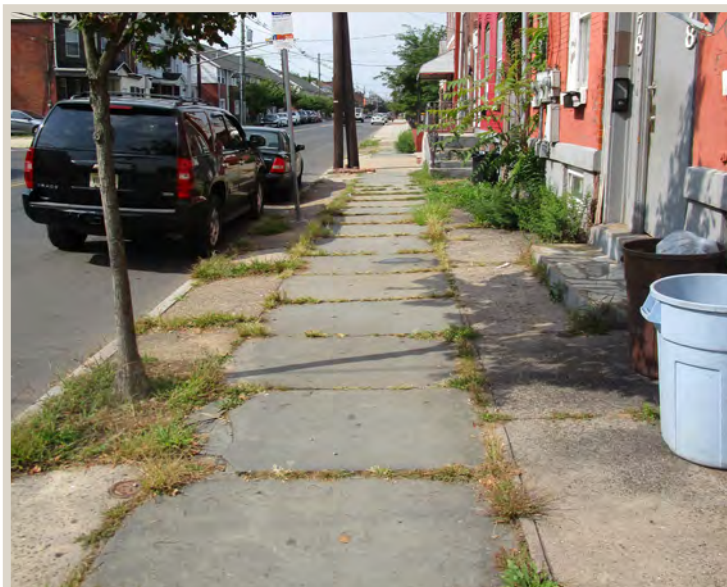
South of Cook Avenue, on the west side of East State Street, there are four residential properties and a small church. The sidewalk is in poor condition due to vegetation growing in the large gaps between the concrete sidewalk panels (Figure 73). Past these properties, the sidewalk is in excellent condition in front of Greg Grant Park (Figure 74). However, while the wide entrance to

Figure 73. Vegetation growing between sidewalk panels.

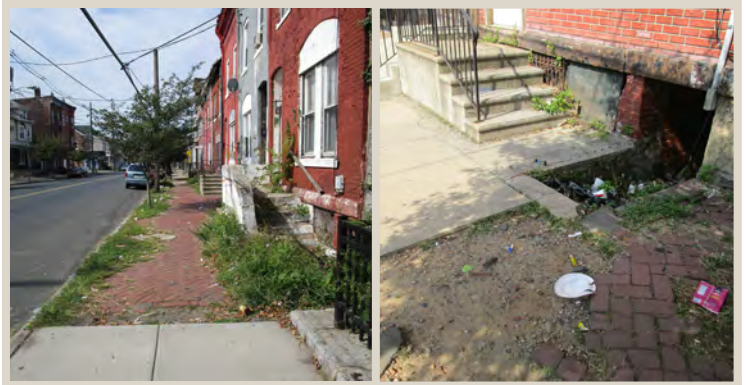
Figure 75. Gaps between varying sidewalk materials.

the park seems like a natural location to cross East State Street, no crosswalk is provided. South of the park, the sidewalk alternates between brick and concrete, with gaps between the different paving types (Figure 75).

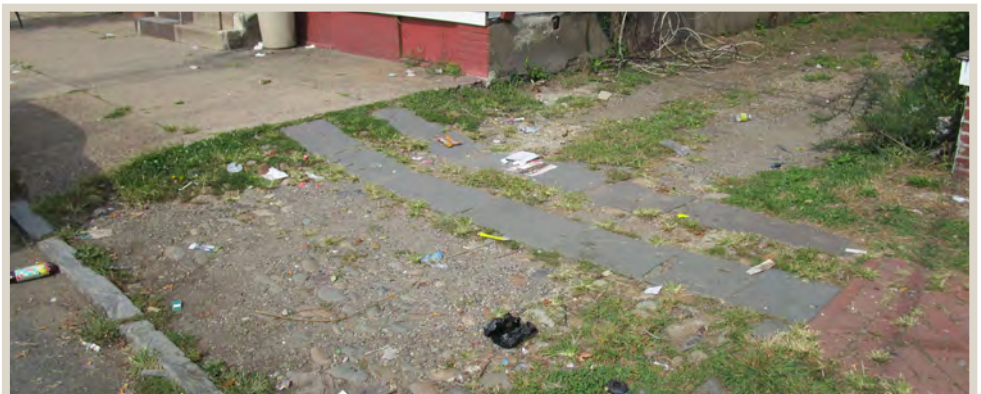
The next block has denser housing development than the previous stretches, with multiple three-story brick apartment buildings. The housing stock appears to be in poor condition, but most appear to be inhabited. Litter was observed throughout this stretch. On both sides of the street, the sidewalk is in decent condition, except for where it changes from concrete to another material such as brick or stone. Additionally, there is a driveway that interrupts the sidewalk on the west side (Figure 77).

Figure 77. Driveway interrupts sidewalk.

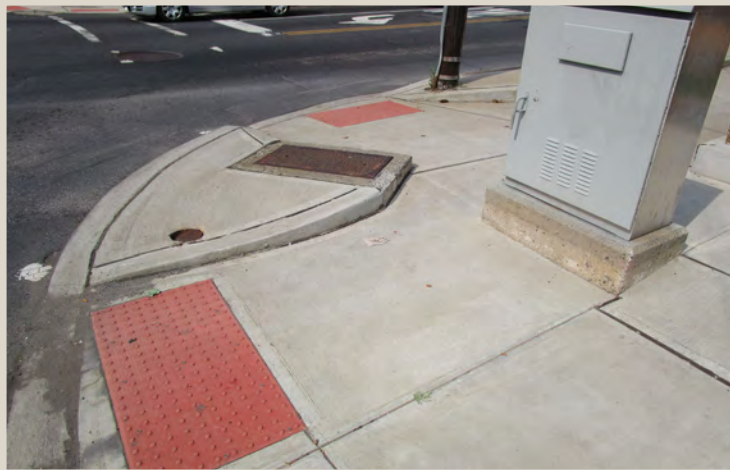
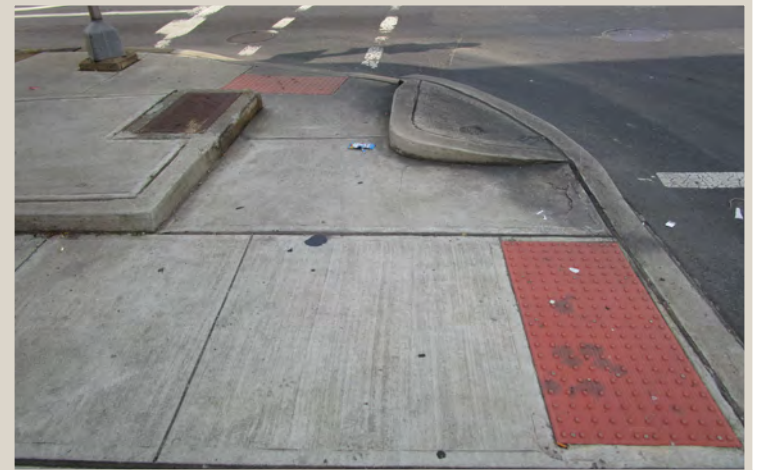
All four corners have curb ramps which appear relatively new. However, these ramps were retrofitted into an intersection with existing utility poles, drains, and electrical substations. As such, the ramps may not be ADA compliant because they feature odd slopes and lack the appropriately sized landing pads for wheelchair users (Figure 79). All four corners have significant features

Figure 79. Retrofitted curb ramps at the Chambers Street intersection.

that narrow the sidewalks. Any improvements would likely require completely replacing the traffic signals and widening sections of the sidewalk into the parking lane. Standard crosswalks are painted in all directions that match the orientation of the ramps.

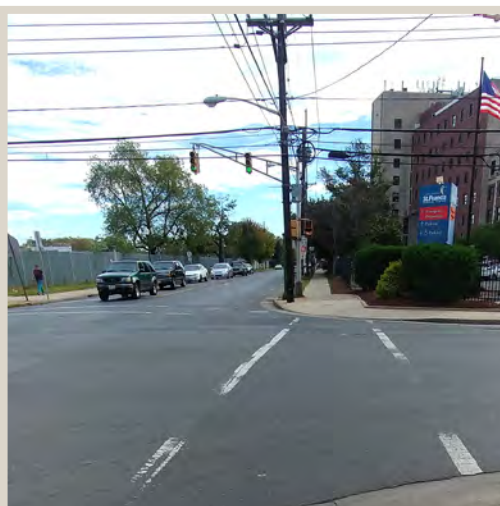
Figure 82. Faded crosswalks near hospital.

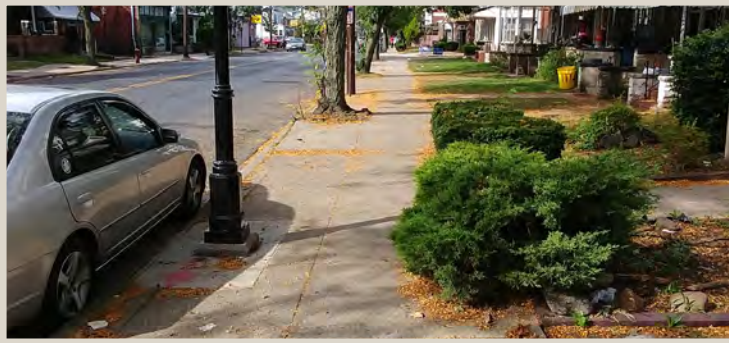
Figure 85. Five-foot wide sidewalks in generally good condition.

West of this intersection, Hamilton Avenue is lined with well-kept residences, some with professional services on the first floor. The sidewalk continues to be five feet wide and in generally good condition except where a tree has raised a concrete block (Figure 85).

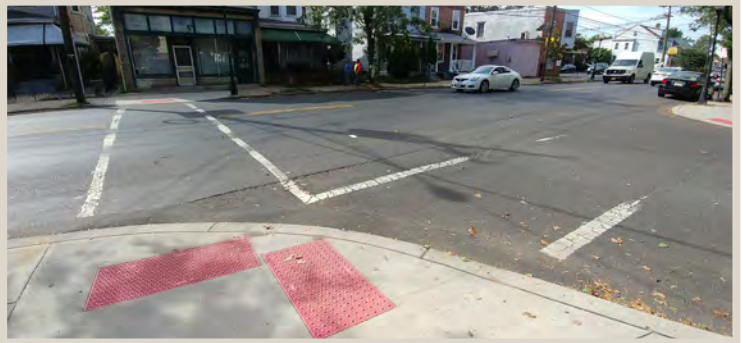
Figure 86. Faded crosswalk at Cuyler Avenue intersection.

Cuyler Avenue arrives from the north, terminating on Hamilton Avenue. There is a crosswalk across Cuyler, and also a single crosswalk across Hamilton Avenue, on the eastern leg (Figure 86). The crosswalk is accompanied by recently installed curb ramps that appear to be fully ADA compliant. An overhead light sits directly above the crosswalk; however, the crosswalk striping is faded and there are no crosswalk signs in either direction. NJ Transit bus stops are located on both sides of this intersection and have suitable sidewalks for boarding passengers.

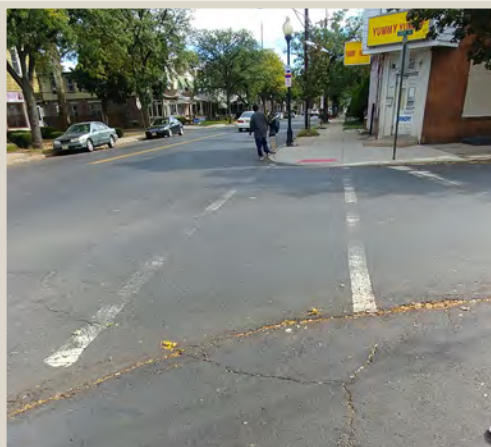
Park Avenue meets Hamilton Avenue just 125 feet to the west of the Cuyler Avenue intersection. The intersection has one parallel crosswalk to cross Park Avenue but no marked crosswalk across Hamilton Avenue. The southeast corner has a recently built ADA compliant ramp with correctly positioned truncated domes. The southwest corner has no sidewalk at all, but instead a continuous asphalt surface from an auto repair business parking lot. While pedestrians can use the parking lot to walk, it is likely that cars are frequently parked in the way (Figure 87).

Figure 87. Missing sidewalks along Hamilton Avenue.

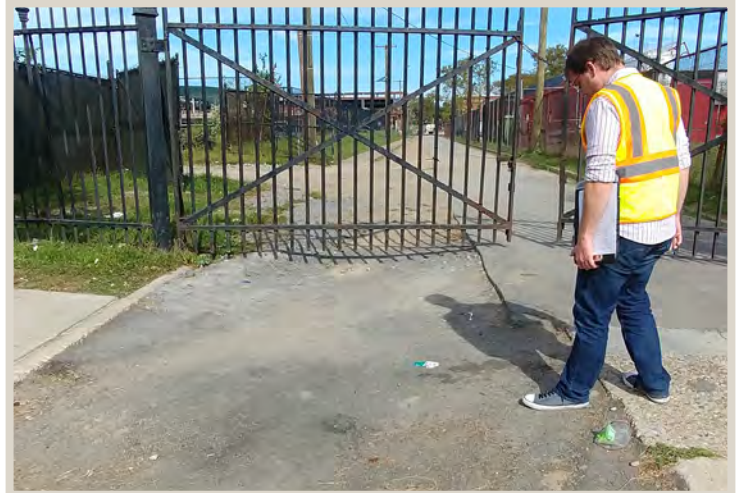
Further west, the homes on the south side of Hamilton give way to a parking lot for the St. Francis Medical Center. In combination with the high school athletic fields, the road appears to be wider and emptier as there are no buildings on either side. Across from the parking lot there is an alley that separates the school grounds in two, although it is fenced. The sidewalk at this alley is uneven (Figure 90).

Figure 90. Uneven driveway.

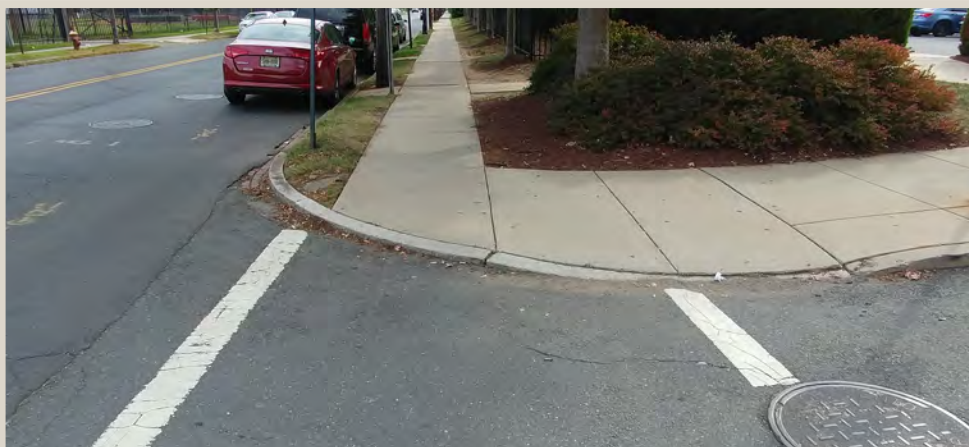
The hospital parking lot is separated from the main complex by Bert Avenue, which runs one-way southbound. Unlike the previous intersections, the curb ramps have not been rebuilt and are not compliant with ADA, due to their slope and lack of truncated domes

Figure 91. Non-compliant ADA ramps.

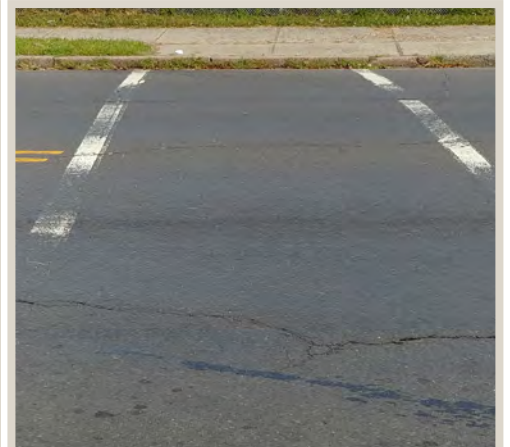
Figure 92. Faded crosswalk.

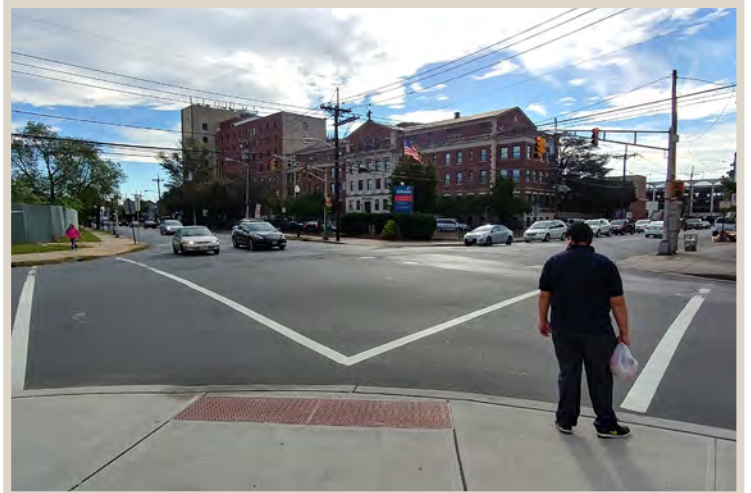
Figure 94. Only one ramp at intersection meets ADA standards.

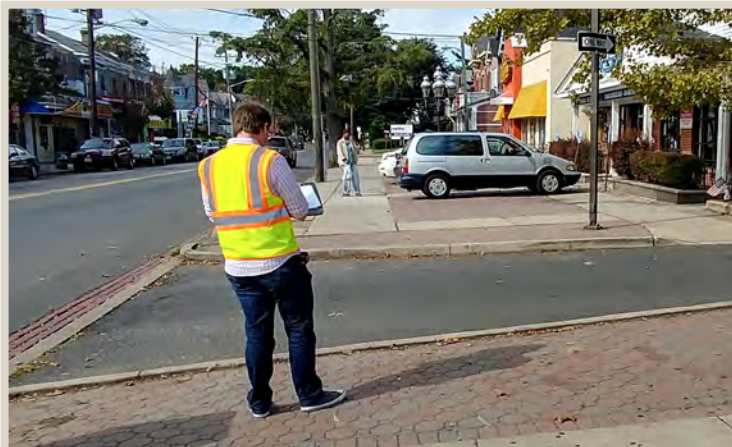
of small businesses that have parking spaces between the sidewalk and the building. Although the sidewalk is appropriately sloped, vehicles that do not pull in all the way block the walkway (Figure 95). The south side of Hamilton has mixed-use buildings with small shops on the first floor. The sidewalk is slightly wider, and the landscape area has been paved with brick.

Figure 95. Parking between sidewalk and storefronts.

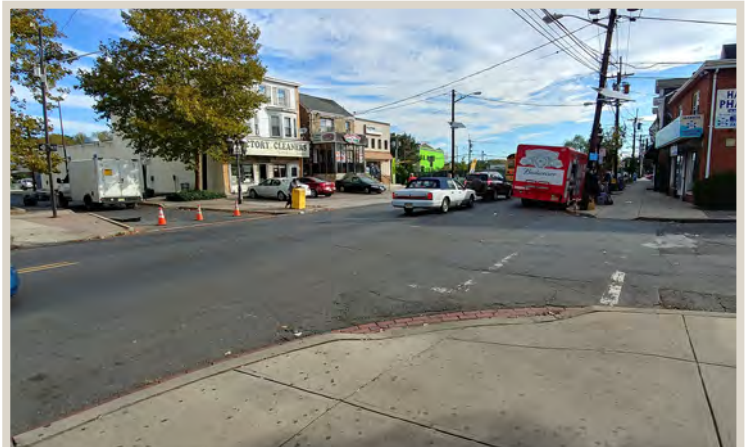
Franklin Street meets Hamilton Avenue from the south. There are curb ramps in decent shape, but they are not ADA-compliant due to their slope and lack of truncated domes. A crosswalk at this location is extremely faded, with no crosswalk over Hamilton Avenue. Across the street, Franklin Street appears to continue as a private driveway into a parking area (Figure 96). The curb ramps are set back around 20-feet, and are not ADA compliant.

Figure 96. Franklin Street intersection.

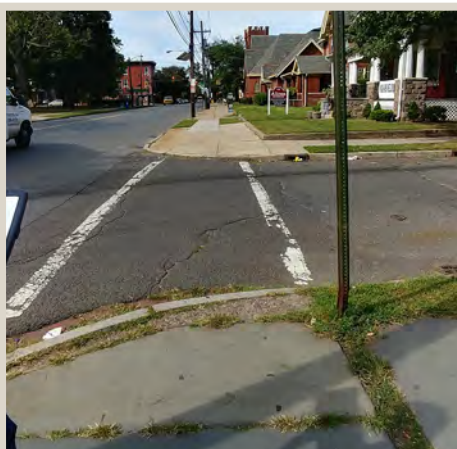
ADA compliant (Figure 98). The southwest corner has a brick sidewalk to mark the entrance to Columbus Park, and the concrete sidewalk running along the park is in good shape. Additionally, there is a wide asphalt multi-use trail inside the park. Across from the park, Hanford Place begins as a one-way northbound street. There is a faded crosswalk across Hanford Place, but no crosswalk across Hamilton Avenue. The intersection has no curb ramps (Figure 99).

Figure 99. Missing curb ramps.

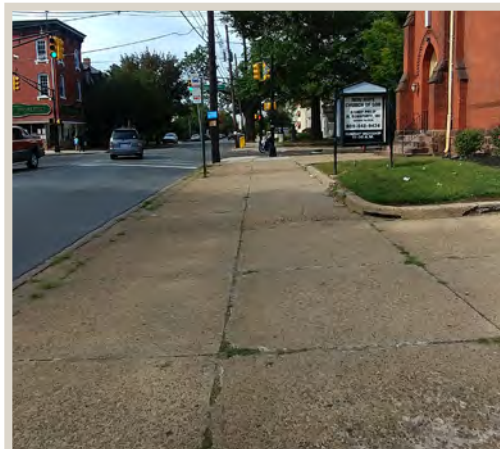
To the west, the sidewalk widens in front of a church, but the condition of the concrete is poor. There is an NJ transit bus stop for westbound traffic that fronts the wide sidewalk (Figure 100). There is a trash can, but no additional amenities. Across the street, the eastbound bus stop is not accessible due to a grass landscape strip. Additionally, the sign for the bus stop is adjacent to a utility pole, trash can, newspaper box, and hospital sign, which may hinder access to the bus door (Figure 101). There is a 25 mph speed limit sign visible to traffic.

Figure 100. Wide sidewalks along Hamilton Ave.

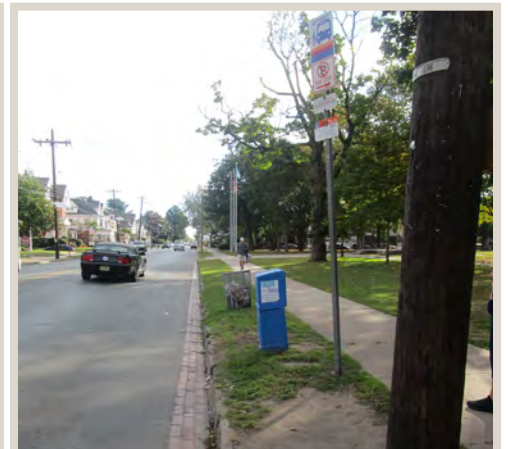
Figure 101. Bus stop with challenging access.
