Complete Streets in the City of Trenton: Existing Conditions Analysis

May 2018

Prepared for:
The Trenton Health Team

Prepared by:
The Alan M. Voorhees
Transportation Center
Edward J. Bloustein School of
Planning and Public Policy
Rutgers, The State
University of
New Jersey

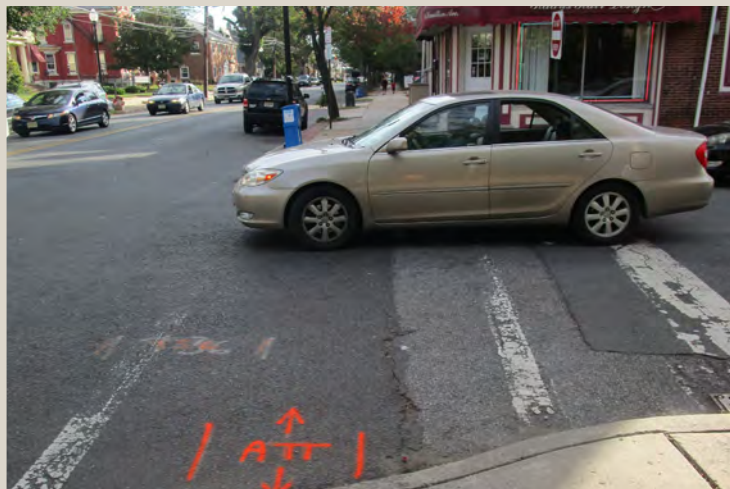
Figure 102. Drivers often block the crosswalk at this intersection.

Whittaker Avenue arrives from the south, carrying traffic one way. There are curb ramps in good condition, but they are not fully ADA compliant. A badly faded crosswalk is marked across Whittaker Avenue, but not Hamilton Avenue. Poor driver behavior was observed

here, as most drivers completely blocked the crosswalk while they waited for a chance to turn onto Hamilton Avenue (Figure 102). A westbound NJ Transit stop sits on the north side of Hamilton. Although the sidewalk does extend to the curb, there are two empty tree wells that may present a tripping hazard. There is no corresponding eastbound bus stop.

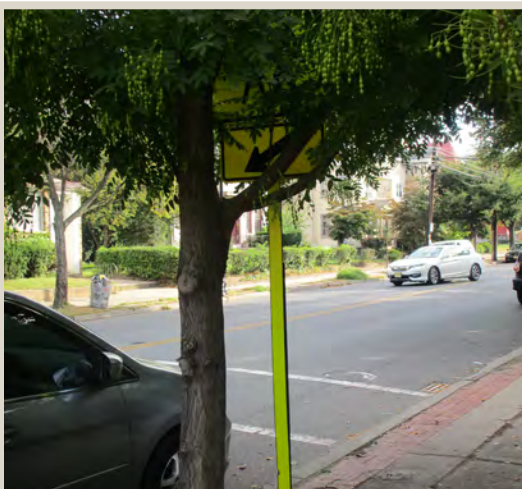
Just 125 feet to the west, Benton Street begins on the northern side of Hamilton Avenue. Here there is a single marked crosswalk across Hamilton Avenue, but it does not have curb ramps on either end (Figure 103). There are two signs marking the traffic, but they are only visible to eastbound traffic. Additionally, one of the signs is almost completely enveloped by a tree canopy, and a driver was parked illegally, further blocking the view of the crosswalk (Figure 104). At the time of the audit, a crossing guard was posted.

Figure 104. Poorly placed crosswalk sign.

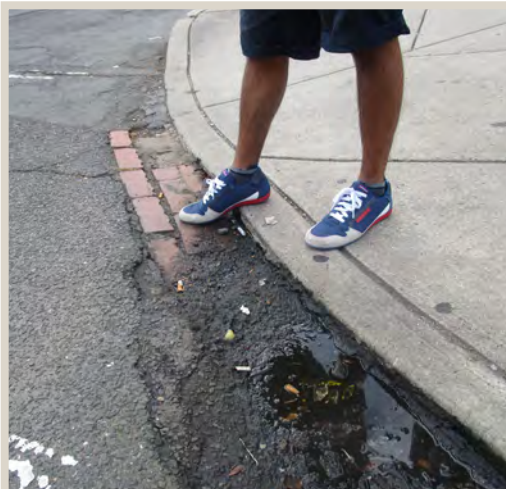
Figure 105. Compromised curb ramp.

Adjacent to the church, Hudson Street runs one-way south from Hamilton Avenue. There are curb ramps across Hudson Street that are in good condition, but lack truncated domes. The curb ramp on the southwest corner is further compromised by asphalt that has eroded, exposing brick (Figure 105). The pavement

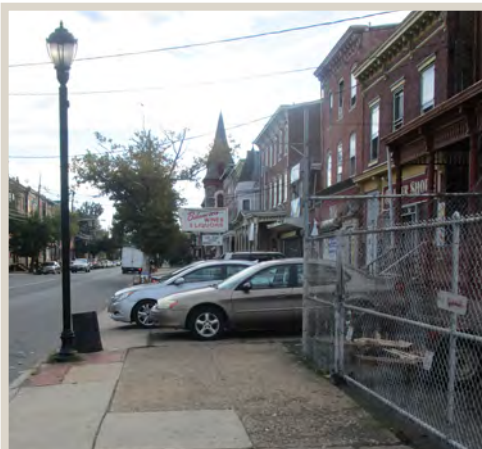
On the south side of Hamilton, there is a small section where the concrete sidewalk has been reduced to gravel. Just past this section, there are a series of businesses that are set back from the street, but use the sidewalk as parking. This results in blockage of the entire sidewalk (Figure 108). Further down the block, a couple of vacant properties have large quantities of litter in their vicinity.

Figure 108. Cars fully blocking sidewalk.

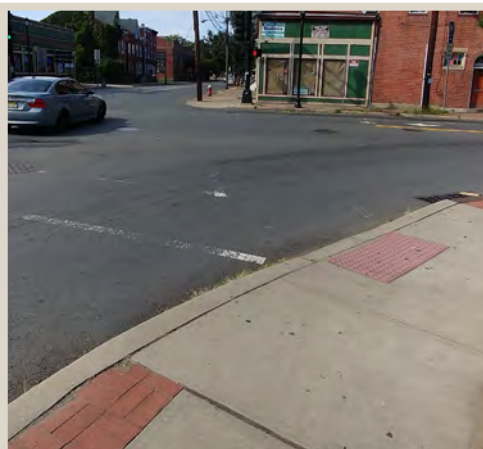
The intersection with South Clinton Avenue is controlled by a traffic signal. All four directions have a left turn lane with a dedicated left turn signal. Additionally, large street name signs are suspended on the traffic signal, making navigation easy at this intersection. All four directions have modern pedestrian signal heads. The buttons to activate the signals on the southeast corner were installed facing the wrong direction. The crosswalk striping is in very poor condition in all directions and is entirely missing on the southern leg. The southeast corner has two curb ramps with truncated domes, but the concrete is cracked. The northeast corner has only a single ramp and a very wide turning radius (Figure 109). The northwest corner has a single curb ramp, and the southwest corner

Figure 109. Wide turning radius.

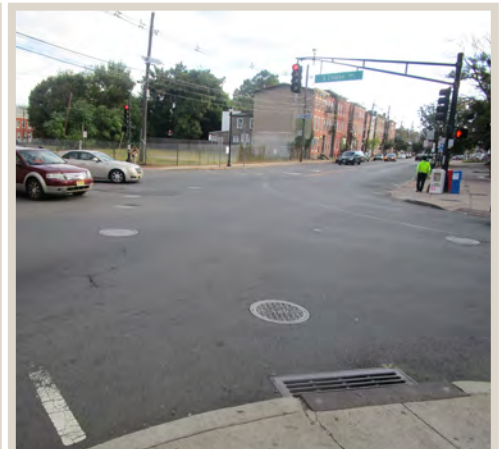
Figure 110. Non-compliant ramps.

has two, none of which are compliant (Figure 110).

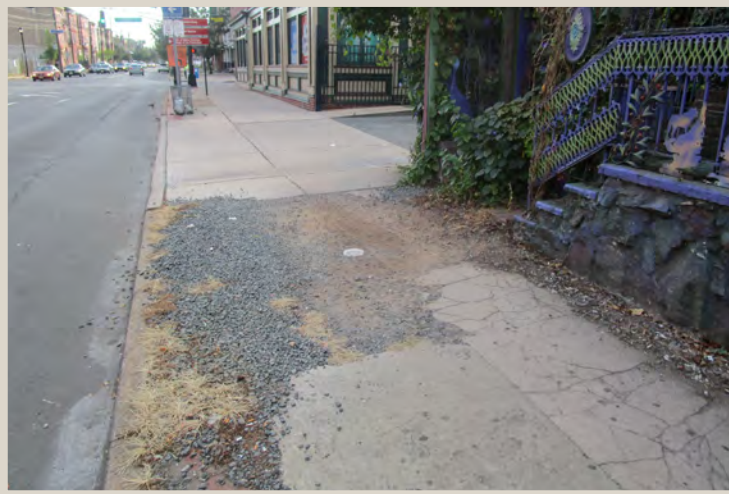
Figure 111. Sidewalk reduced to gravel.

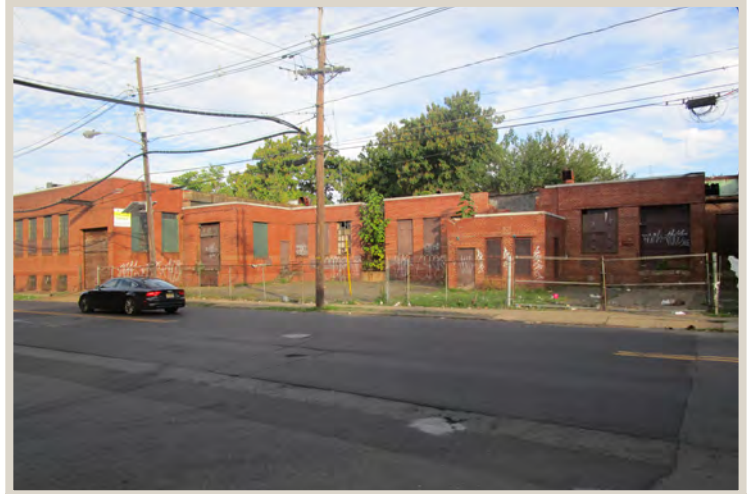
Figure 112. Vacant buildings are common in this section.

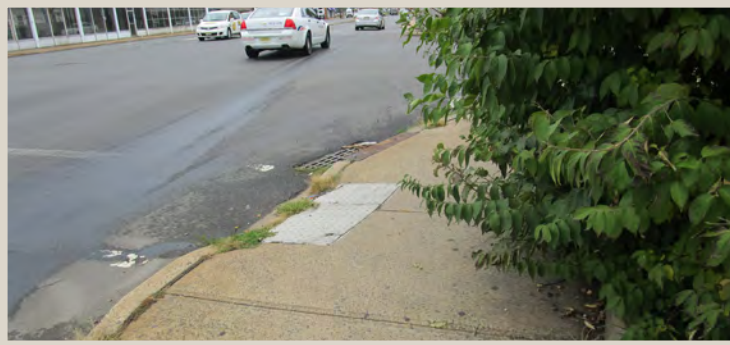
The northern leg of the intersection has no infrastructure for pedestrians. There is no painted crosswalk, no curb ramps, and no pedestrian signal heads. A small traffic island, where pedestrians could theoretically wait, is instead filled with a utility pole, a traffic signal pole, and an electrical control box. The western leg of the intersection does have pedestrian signals and curb ramps, but no striped crosswalk. When built, the curb ramps were likely ADA-compliant, but a lack of maintenance means they are no longer fully accessible.

Figure 115. Non-compliant ramp with a bush blocking visibility.

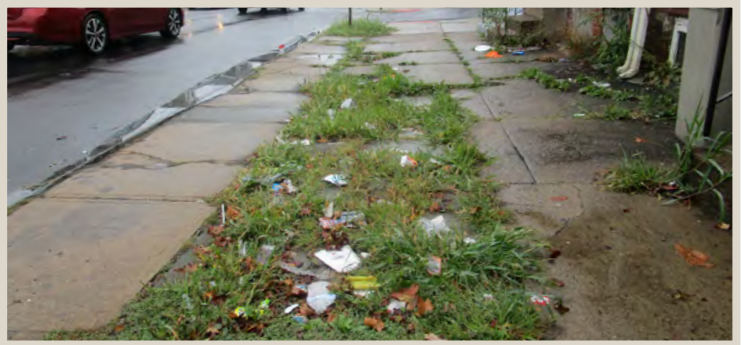
Figure 116. Missing sidewalk with litter.

sections completely missing on the west side (Figure 116). Additionally, plants from an inhabited home have been allowed to completely overgrow the sidewalk on the east side (Figure 117). Lighting is provided by standard overhead cobra fixtures.

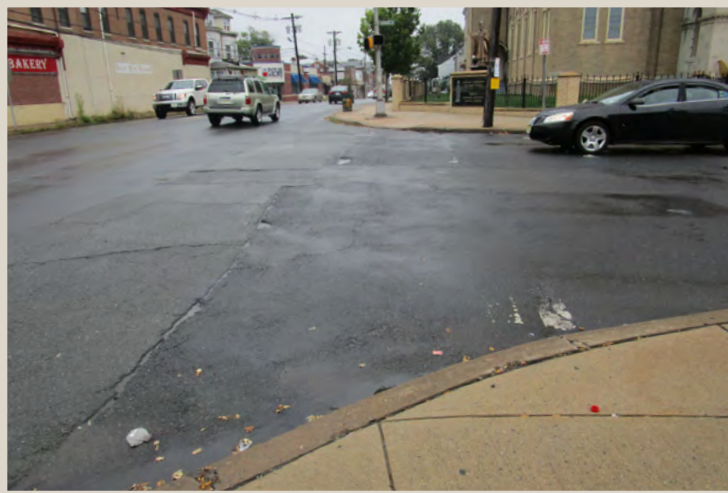
Figure 118. Severely faded crosswalk and stop lines.

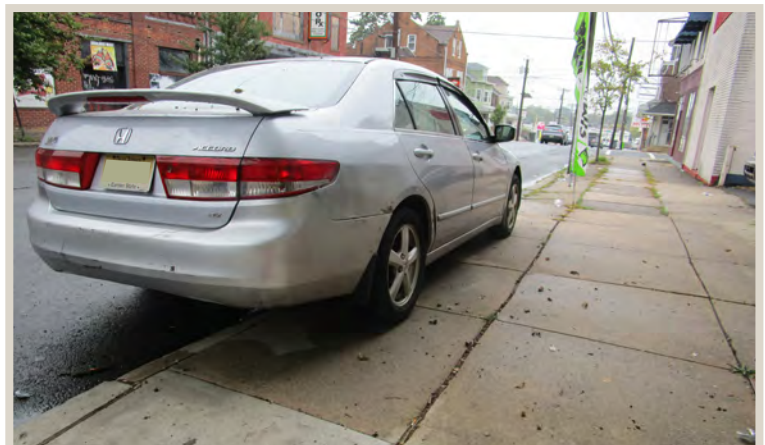
Although the width of the roadway has not changed, parking is legal in some sections, but signage is very inconsistent as to where it is allowed. Because of the sub-standard roadway width, drivers continue to park partially on the sidewalk so their car does not get hit by other vehicles (Figure 120). Another alley, Burgner Alley, crosses North Olden Avenue. On the east side, there are curb ramps and a crosswalk, while on the west side, the sidewalk continues across the alley. There is no signage indicating if the alley is one-way or bi-directional.

Figure 120. Cars regularly park on the sidewalk.

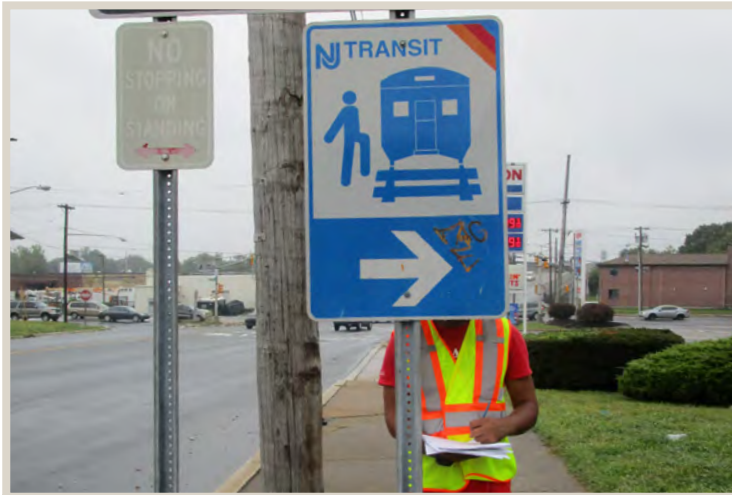
Figure 121. Faded and low-set signage.

The intersection of North Olden Avenue and New York Avenue is very wide and lacks the dense urban neighborhood feel of previous intersections along the corridor. For southbound traffic, North Olden Avenue widens to three lanes: a left turn lane, a through lane, and a right turn lane. Additionally, northbound traffic is only striped as one lane, but is three lanes wide, thanks to a right-turn slip lane from New York Avenue. All four directions of traffic have dedicated left turn signals. The New York Avenue slip lane is not signalized, and is yield controlled. To the west, New York Avenue has an on-ramp to southbound Route 1, and an off-ramp from northbound Route 1. To the east, there is an off-ramp for traffic going southbound on Route 1. As such, it is likely that this intersection sees heavy traffic. A sign placed before the intersection directs drivers towards the Trenton Transit Station, via Route 1 (Figure 121). A “no parking” sign on the same post is badly faded.

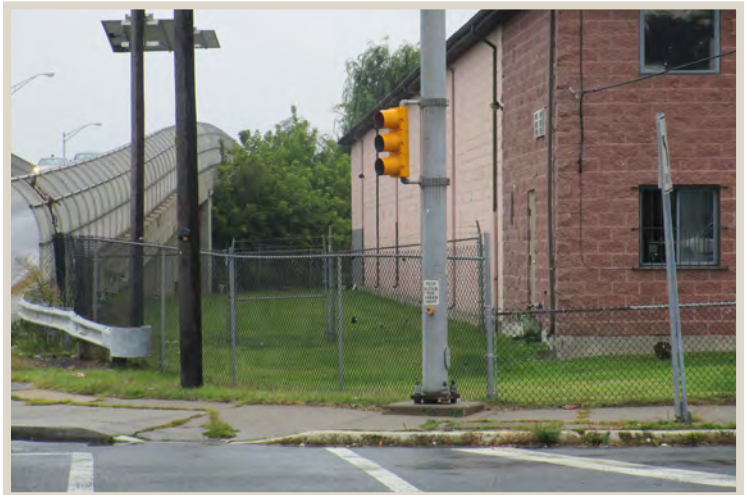
Figure 122. Busy intersection lacks pedestrian signals.

button that says it will provide a green light (Figure 122). Each crosswalk has a curb ramp, but none of them are ADA compliant (Figure 123). The turning radius on all corners is wide, encouraging higher speeds. Overhead lighting is not adequate for the width of this intersection.

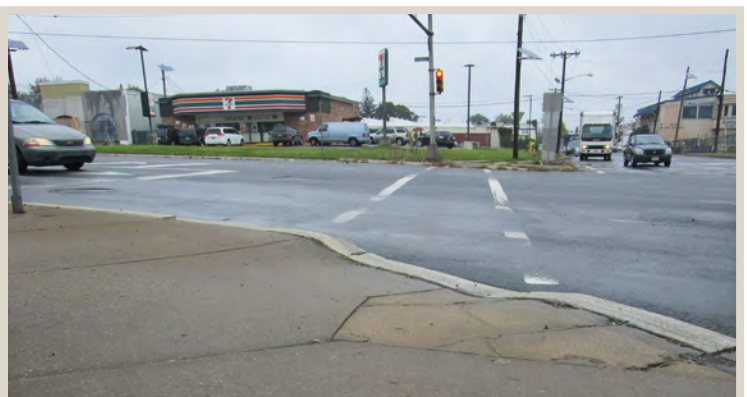
Figure 123. Non-compliant ramps and a turning radius that encourages high speed turns.

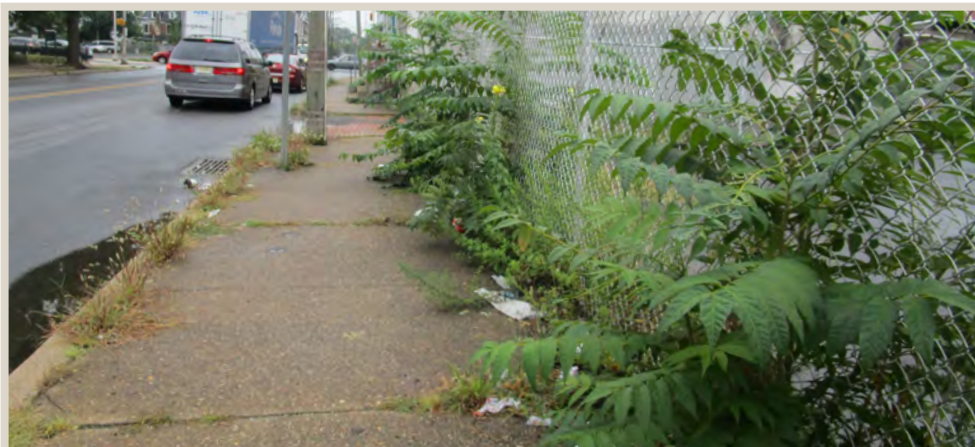
Prince Street, while not as freshly paved as St Joes Avenue, has a suitable road surface, a painted crosswalk, and appropriate curb ramps. South of the intersection, a school crossing sign is posted for southbound traffic next to an empty lot. There is overgrown brush blocking parts of the sidewalk from this same lot (Figure 126). Past this lot, Agnes Avenue, an alley, arrives on both sides of North Olden Avenue. Instead of a painted crosswalk, the end of this alley is paved in a bright red brick, in contrast to cobblestone used further down the alley (which is mostly covered in asphalt patches). While the brick is visible, there are no curb ramps for pedestrians (Figure 127).

Figure 126. Overgrown brush blocking portions of the sidewalk.

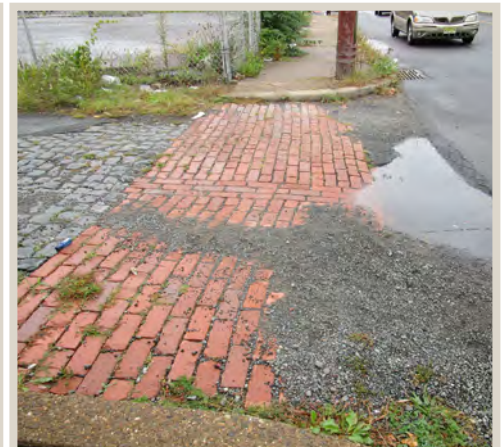
Figure 127. Missing curb ramps.

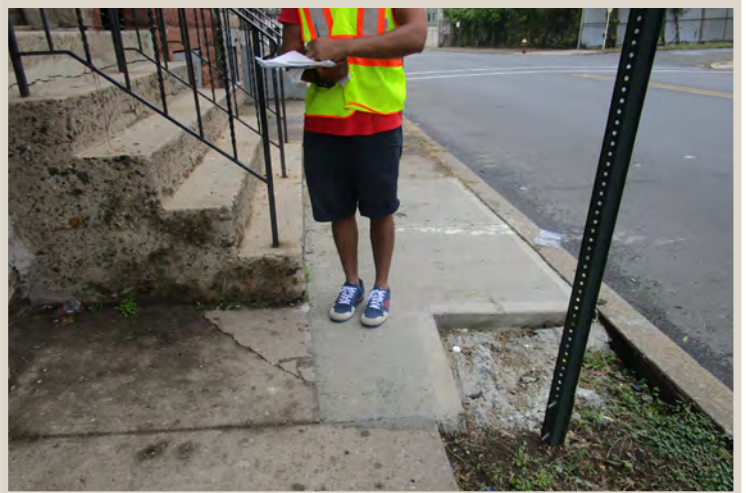
Figure 129. Signage and stairs create a narrow walkway.

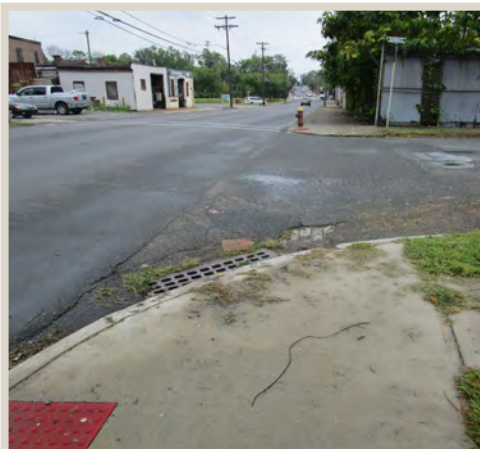
Figure 130. Missing curb ramps.

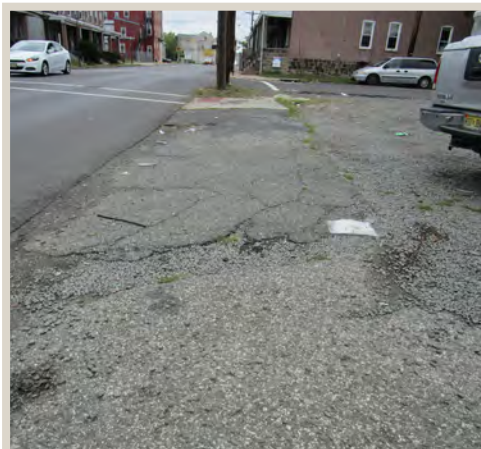
Figure 131. Missing sidewalk.

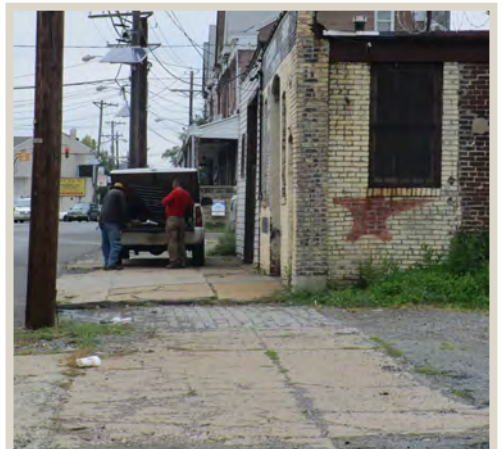
Figure 132. Cars regularly park on the sidewalk.

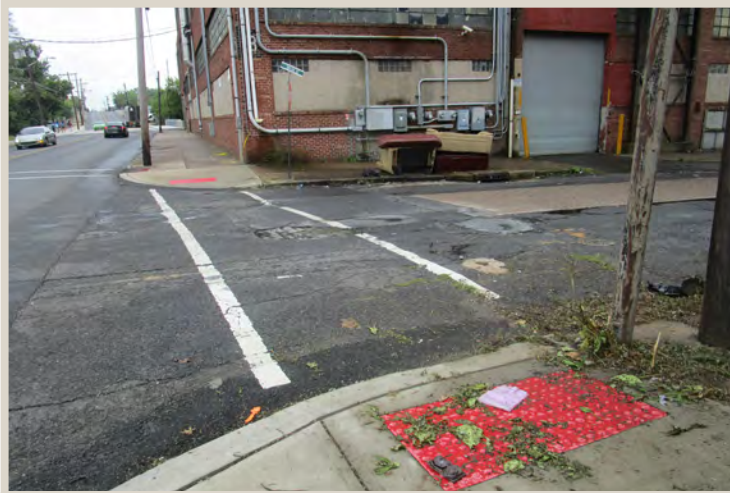
Figure 133. Grass clippings cover truncated dome across from abandoned building.

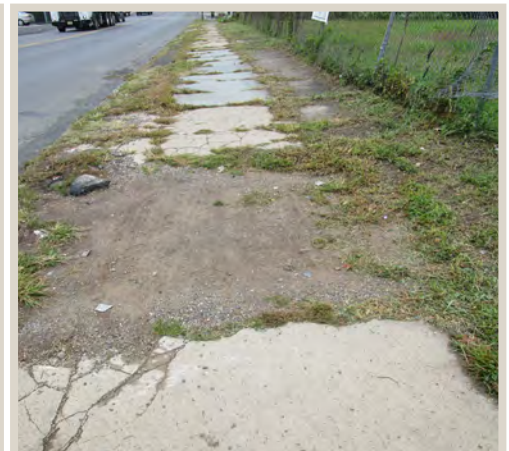
Parker Avenue is a one-way road that arrives from the east. There is a crosswalk across Parker Avenue and a single crosswalk across North Olden Avenue. Both have suitable curb ramps, and there is a light directly above the crosswalk. Beyond the intersection, sidewalk quality decreases again, with many cracks, grass, and litter (Figure 136). The intersection with East State Street is discussed in that section.

Figure 136. Missing sidewalk.

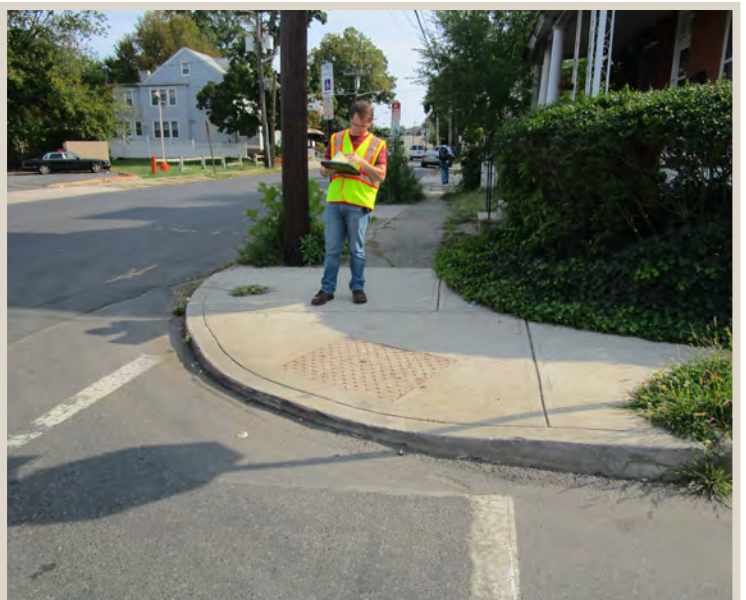
Figure 140. Large gap between bottom of ramp and roadway.

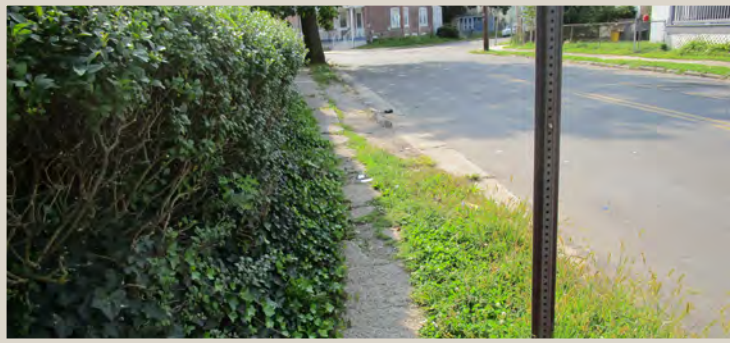
Figure 141. Overgrown plants blocking sidewalk.

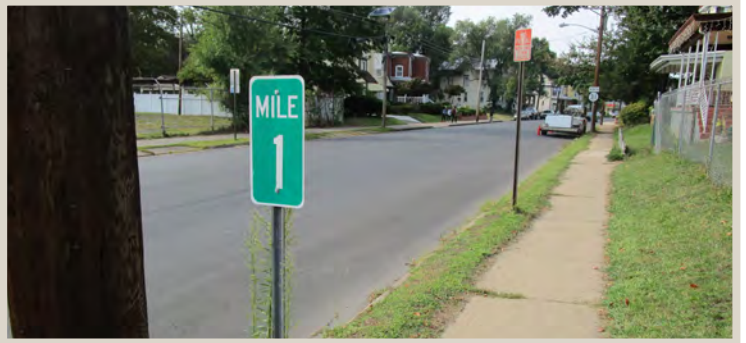
Figure 142. Roadway promotes lower vehicular speeds.

Continuing south, both sides of the street have residential duplex units. The sidewalk conditions vary from property to property and the design of the sidewalk is very inconsistent. In front of some properties, the sidewalk is set back with a planting strip. In other sections, it is next to the curb. Along with the poor pavement conditions and uplifted sections, plants have been allowed to cover much of the sidewalk space (Figure 141). However, there are no street trees in the planting strip. There is no centerline striping in the roadway, which gives the corridor a lower-speed feel (Figure 142).

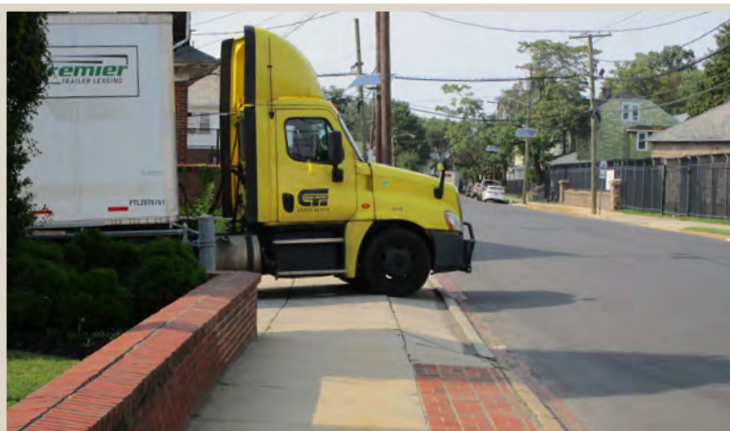
A tenth of a mile to the south, Pennington Avenue intersects with Arlington Avenue on the east side and Coolidge Avenue on the west side at an offset intersection. There are no marked crosswalks in any direction. On the Arlington Avenue side, there are no curb ramps. There are two diagonal curb ramps on the west side that are ADA compliant except for large amounts of gravel at the base of the ramps. Sidewalk conditions improve south of the intersection, but are still inconsistent from property to property. Vehicles parked in residential driveways were observed blocking the sidewalk (Figure 143). The sidewalk is in excellent condition in front of the Courtney Temple.

Figure 143. Vehicles frequently park blocking the sidewalks.

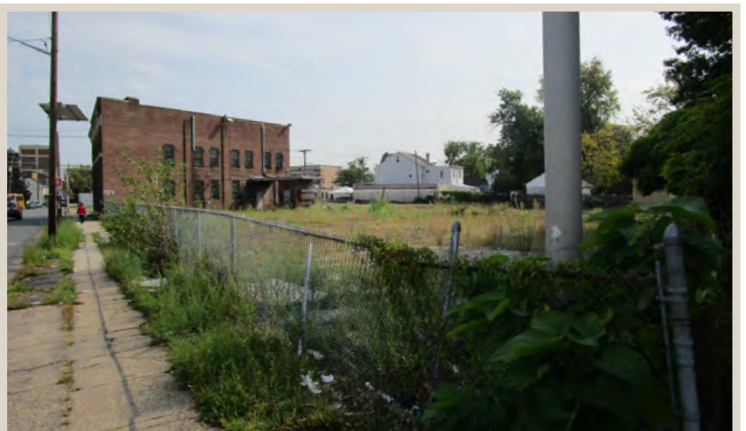
Just south of that facility is Norman Avenue. As with Mellon Street, the intersection has two curb ramps only on the west side, with a faded crosswalk and stop bar. Entering Norman Avenue, the sidewalk is obstructed by overgrown bushes. Alden Avenue, the next street, is very similar, except that it runs one-way into Pennington. South of Alden Avenue, the sidewalk conditions deteriorate in front of a vacant parcel (Figure 144).

Figure 144. Overgrown vegetation by vacant parcel.

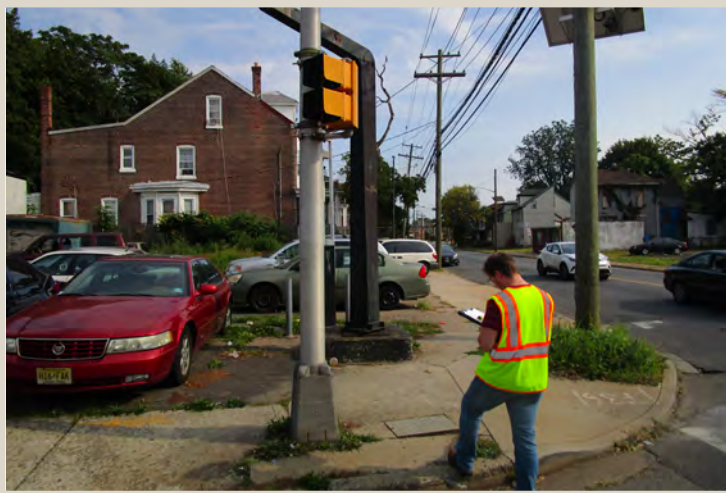
Figure 145. Older, text-based pedestrian signals.

onto Pennington Avenue in both directions. Automatic pedestrian signals are placed in three of the corners, with a mixture of older text based signals and newer models (Figure 145). The northeast corner does not have pedestrian signals and the amount of time given to cross in the other direction did not appear to be adequate.

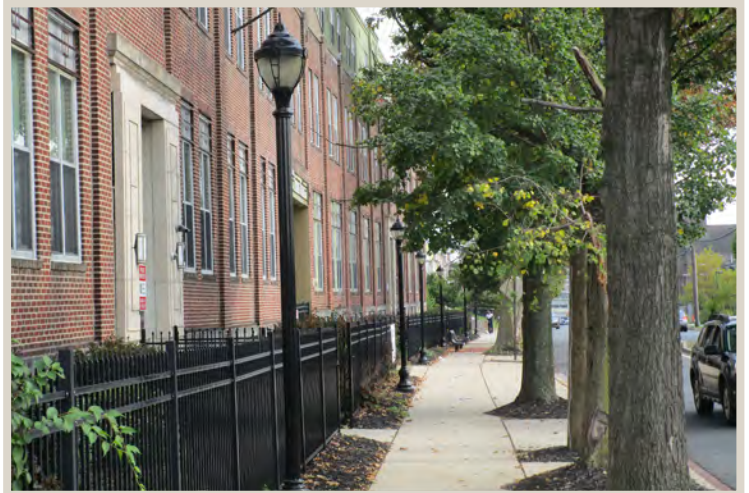
Figure 150. Excellent sidewalk conditions.

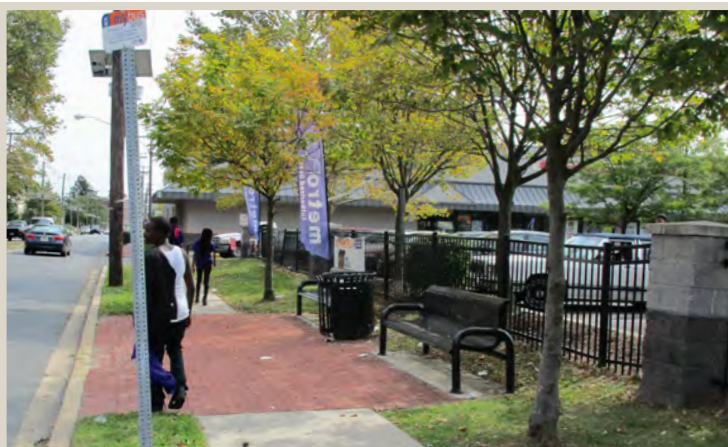
Figure 151. Bus stop with pedestrian amenities.

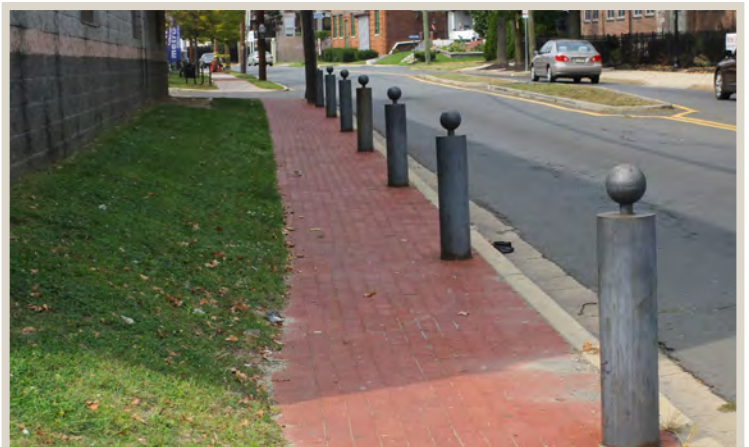
Pennington Avenue narrows slightly where the driveway for the commercial center is located. There is a center median to block left turns both into and out of the center. A curb cut was built into the median to allow pedestrian crossing, even though no crosswalk was painted and the curb ramps are not compliant. However, there is a pedestrian crossing sign visible to northbound traffic. Just south of the median, the sidewalk on the west side is protected by bollards (Figure 152).

Figure 152. Sidewalk protected by bollards.

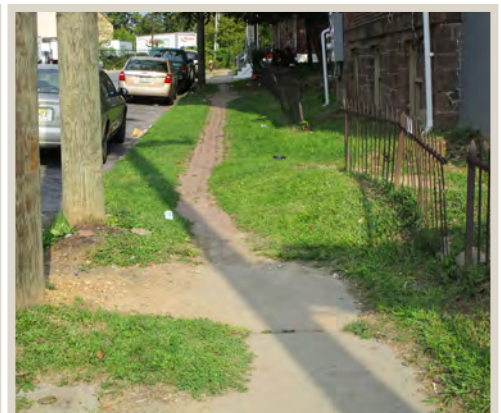
Reservoir Street meets Pennington Avenue at a standard four-way intersection, where Pennington Avenue has the right of way. Only the northwest corner has a modern curb ramp, although it is oriented diagonally into the intersection (Figure 155). The other three corners have curb ramps, but they are not ADA-compliant. There is a faded crosswalk on the western leg, but the other crossings are unmarked. There is only a single overhead light and there is no crosswalk signage. The northbound bus stop is south of the intersection, adjacent to a sidewalk in good condition. The sidewalk along Reservoir Street, continuing east, is in very poor shape (Figure 156).

Figure 156. Sidewalk in poor condition.

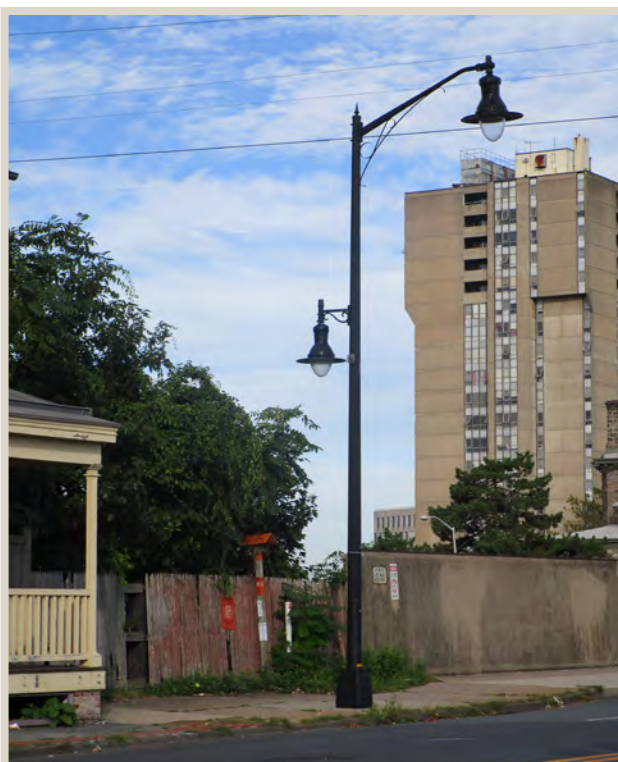
Figure 159. Street light oriented for cars and pedestrians.

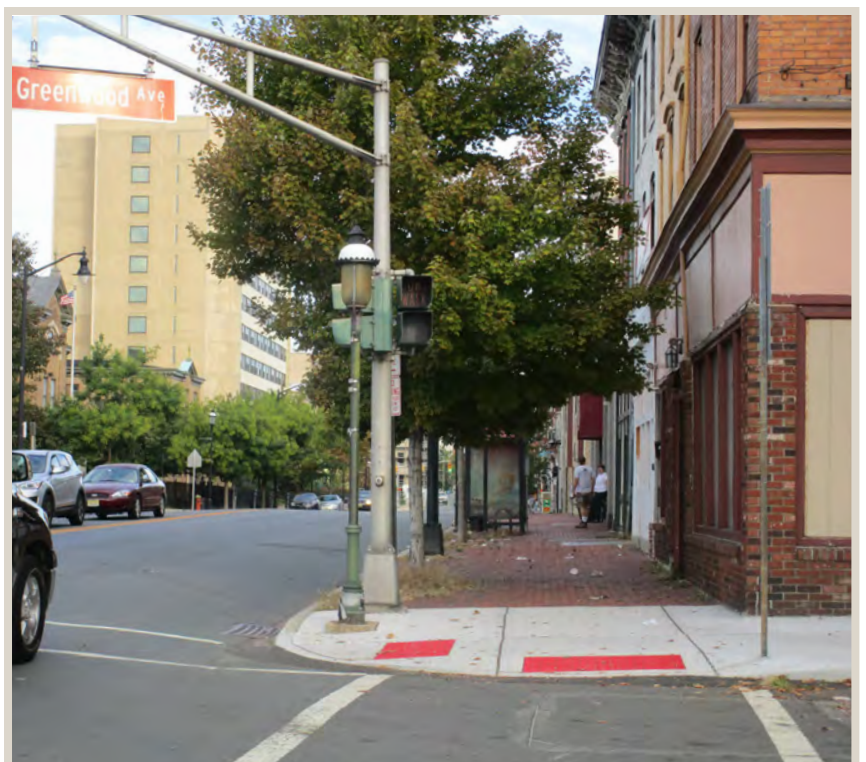
Figure 160. Additional pedestrian lighting.

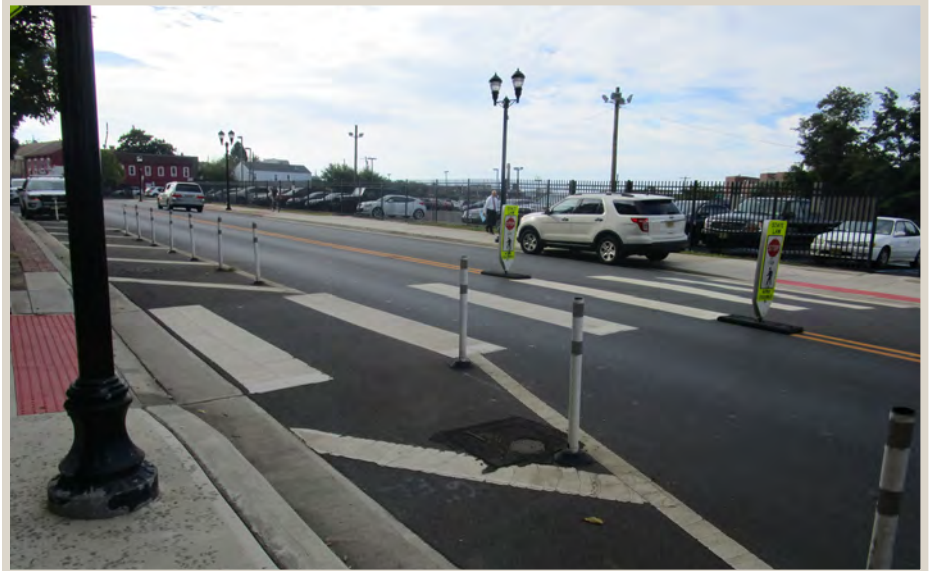
Figure 164. High quality crosswalk with bollards to shorten crosswalk length.

There are bus stops in both directions after Elmer Street, although only the eastbound stop has a shelter. The sidewalk is in excellent condition on both sides. There is a midblock crossing connecting the Mercer County Administration Building and its parking lot across South Broad Street. This crosswalk features continental striping, push-activated flashing lights, ample signage, and bollards that narrow the travel way and prevent illegal parking (Figure 164).

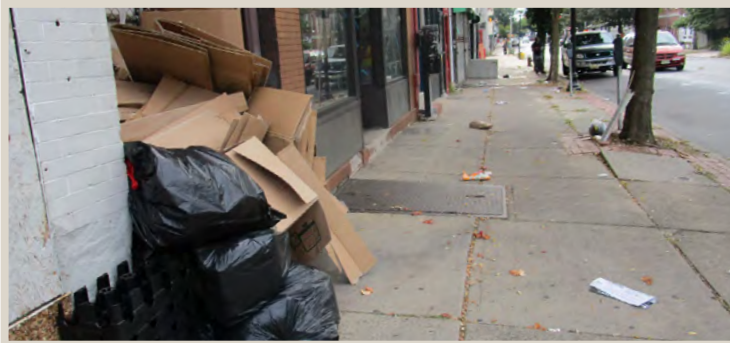
Figure 165. Despite trash cans, litter is found along sidewalk.

is a different style of historic streetlights in this section, although they are very frequent. The north side continues to have a wider sidewalk than the south side, but both are in average condition. Although there is a trash can, litter was observed (Figure 165).

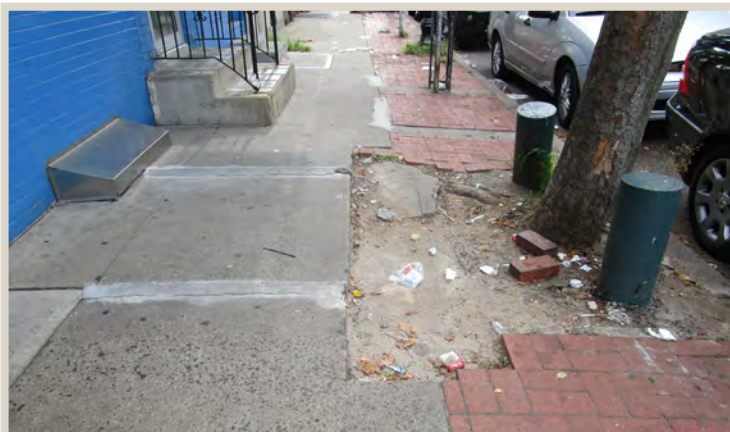
The sidewalk continues in the same manner east of the intersection, although it is the same 5-foot width on each side. There are mature trees, but most tree wells are empty. In a few spots, the sidewalk narrows due to steps from buildings (Figure 167). Watson Street begins

Figure 167. Sidewalk narrows due to unmaintained tree well and stairs.

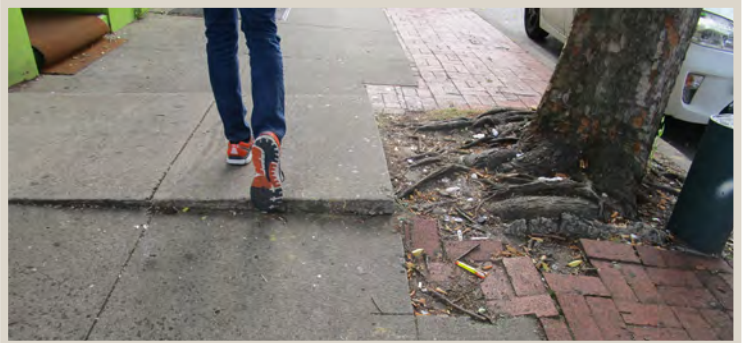
South Broad Street develops the look of a local downtown street in this section. There is one lane in each direction, with street parking, and no centerline. Retail lines both sides of the street, although many of the buildings are in poor condition. The sidewalk has a brick trim, but many locations are cracked or raised (Figure 166). Trashcans are frequent, but litter is everywhere.

Figure 166. Raised sidewalk causes a tripping hazard.

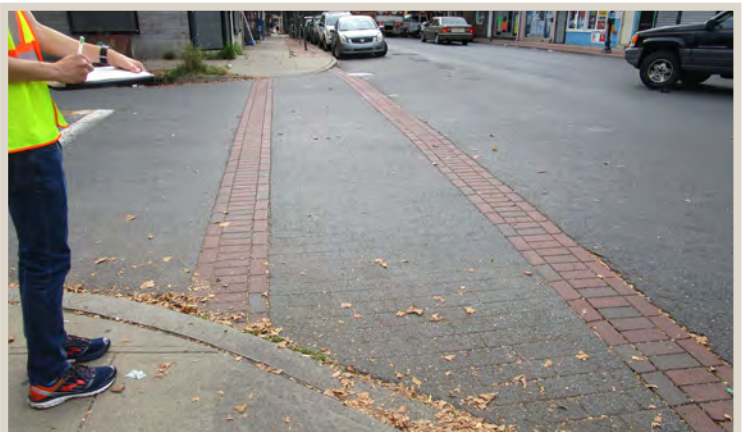
on the south side, running one-way. There are curb ramps with truncated domes, but the slope is not compliant, and there is a single faded crosswalk. Sixty feet away, Roebling Avenue is on the north side. Instead of having painted crosswalk lines, this intersection has a crosswalk outlined in brick (Figure 168). There are non-compliant curb ramps on either side and no crosswalk is provided for crossing South Broad Street.

Figure 168. Crosswalk outlined in brick.

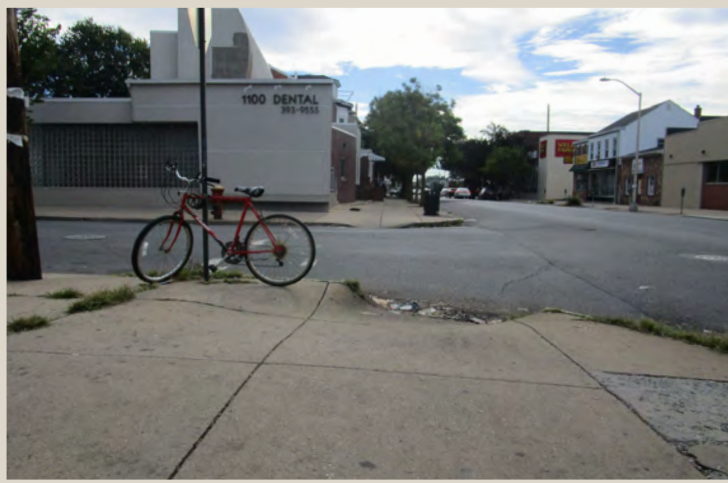
Figure 169. Steep ramp with litter.

Harding Street lies on the south side of South Broad Street, with Anderson Street on the north side 120 feet to the east. Once again, there are non-compliant curb ramps and badly faded crosswalks with no crossing infrastructure on Broad Street. However, the slope of the ramp on Anderson Street was particularly steep, and had a lot of litter at the base (Figure 169). Starting at Anderson Street, the overhead streetlights switch from

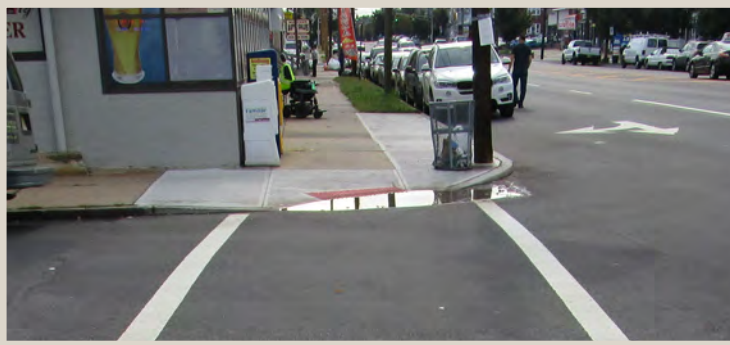
Figure 171. Water pooling at bottom of ramp.

Stanton Street and Remsen Avenue both intersect with South Broad Street at a standard four-way intersection where South Broad Street has the right of way. This means that traffic crossing Broad Street or turning onto it have to navigate five lanes of traffic that do not stop. For pedestrians, there are new ADA-compliant curb ramps and painted crosswalks to cross Stanton Street and Remsen Avenue, but no crossing provided over Broad Street. On the western corner of Stanton Street, an improperly built slope has resulted in pooled water at the base of the curb ramp (Figure 171).

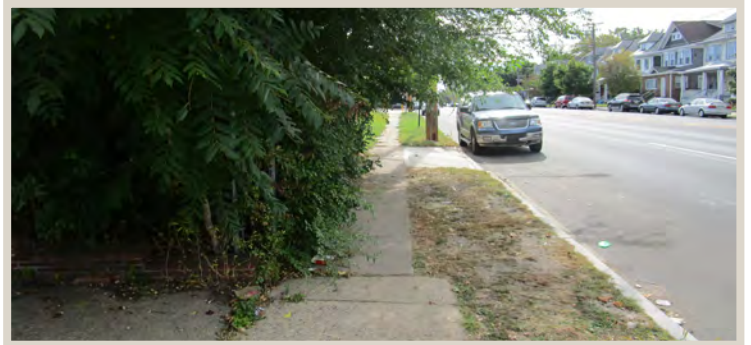
Figure 172. Overgrown bushes minimize usable sidewalk area.

Past the intersection, the sidewalk on the north side of the street is narrowed due to overgrown bushes (Figure 172). The sidewalk continues in decent shape after the intersection. Capner Street terminates on the north side, adjacent to an Investors Bank. The sidewalk in front of the bank is wide and in excellent shape. As with the previous intersections, the curb ramps have recently been rebuilt and are also in excellent shape. There is a crosswalk across Capner Street, but none across South Broad Street.

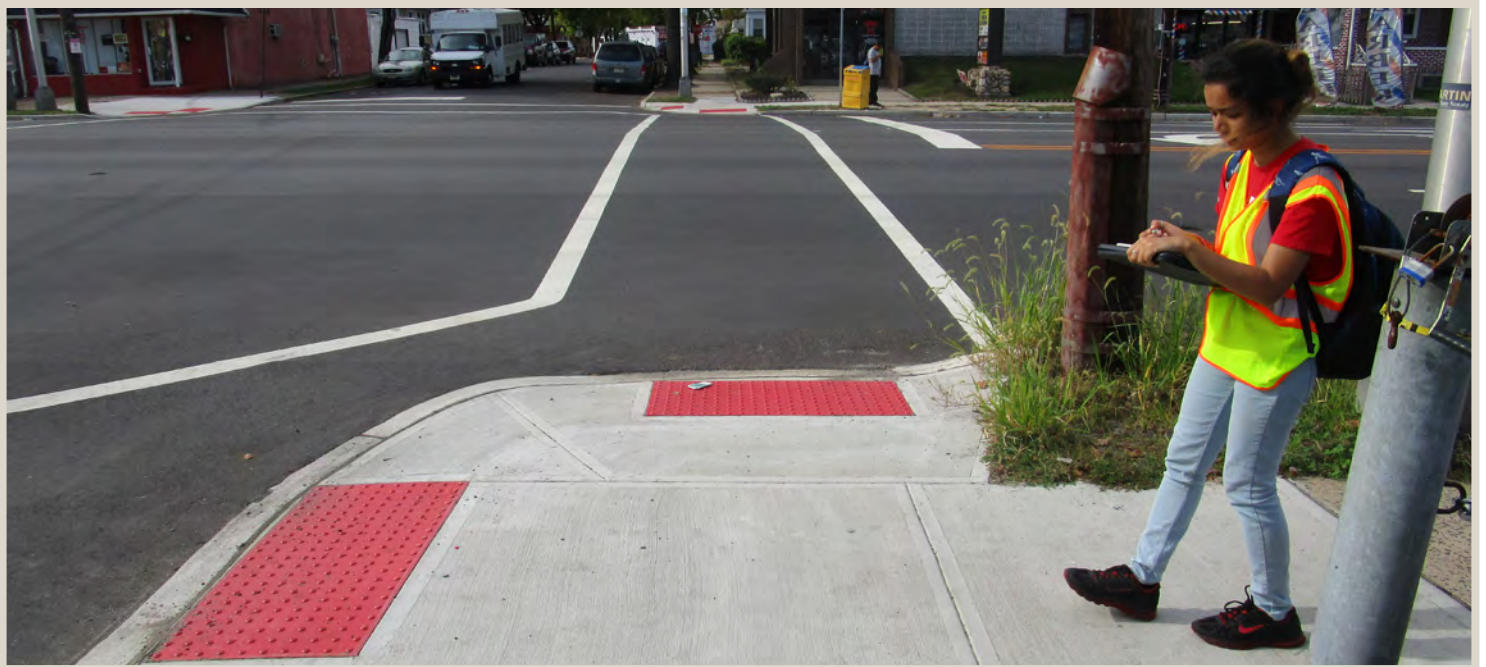
the crosswalks. The crosswalks are striped with parallel lines that are in very good condition (Figure 174 on page 75). However, the intersection is lacking in pedestrian signals. There are left turn lanes for both directions on South Broad Street, but no left turn signal.

Figure 174. Sidewalks and ramps in excellent condition.

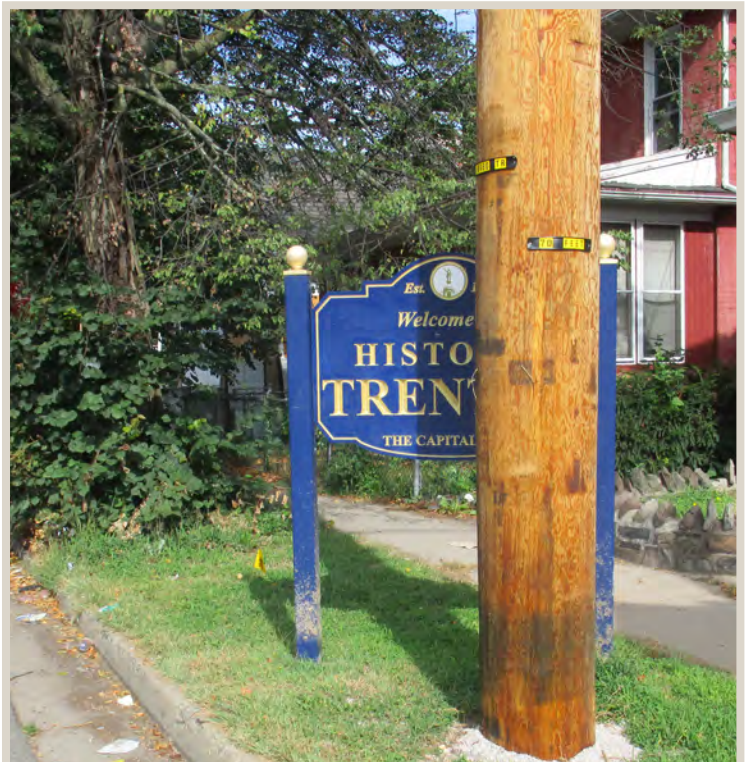
Street that has a planting strip between the curb and the sidewalk. There is no shelter, but there is a trash can. The bus stop on the north side of the street is also located adjacent to a planting strip, although there is a small concrete landing area. The signage is blocked by a tree, and there is another trash can. Vehicles were observed parking at the bus stop (Figure 175). Just east of the bus stop, a brand new utility pole has been installed in a way that completely blocks the “Welcome to Historic Trenton” sign (Figure 176).

Figure 176. Signage blocked by utility pole.

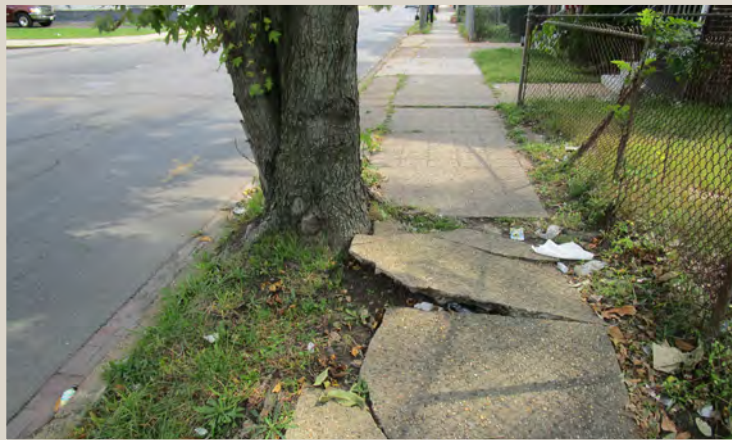
Figure 179. Dangerously uneven sidewalks along Pennington Avenue.

Poor sidewalk conditions were the most common issue noted along the assessed corridors (Figure 179). Cracked, heaved, and broken sidewalks make the city less accessible, especially for parents with strollers, residents with visual impairments, and those who use wheelchairs, canes, or walkers. To encourage more walking, communities must have ADA compliant sidewalks that are level, continuous, free from cracks, and lack obstructions such as signs, garbage cans, cars, and overgrown shrubbery and trees.

Sidewalk width and construction materials are important considerations for improving sidewalk usability. Sidewalks can be surfaced with a variety of materials to accommodate varying budgets and contexts. Safe sidewalk surfaces should be firm, stable, and slip-resistant. Although brick pavers may appeal to some, they can require more maintenance, become slippery in inclement weather, and create tripping hazards. Pavers can also pose a problem to pedestrians in wheelchairs if they settle unevenly or become lifted. Concrete sidewalks last longer and require less maintenance. The Federal Highway Administration (FHWA) recommends a sidewalk width of five feet for two adult pedestrians to comfortably walk side-by-side; at a minimum, all sidewalks should be constructed to this width. In areas with heavier pedestrian traffic such as near parks, schools and centers of commerce, sidewalks should be eight to ten feet wide (Figure 180).³ All streetlights, utility poles, sign posts, mail boxes, benches, and other street furniture should be located out of pedestrian pathway along the sidewalk. When not possible, these obstructions should be located consistently so a clear travel zone is provided for pedestrians with vision impairments and other disabilities.

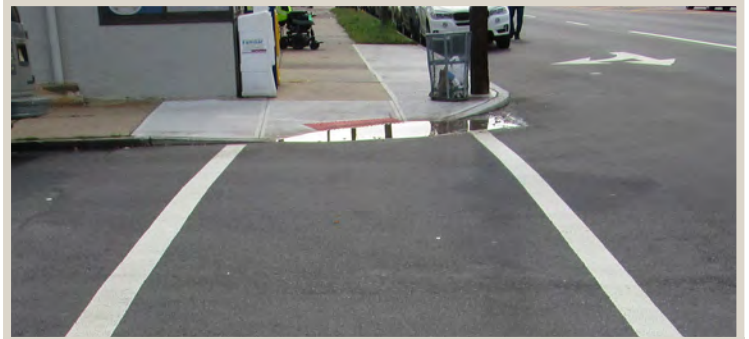
Figure 182. A curb cut which allows water to pool at the bottom is not usable.

ADA guidelines state that curb ramps should be directional wherever possible, where each corner has two ramps installed perpendicular to the face of the curb (vs. a single ramp facing diagonally into the intersection). In order to achieve ADA compliance, curbs cuts must provide a level maneuvering area or landing at the top of the curb ramp, provide a maximum ramp slope of 8.33 percent, and have a detectable warning surface to alert the visually impaired of the transition from the sidewalk to the roadway that extends across the full width of the curb ramp and includes a series of raised, truncated domes in a high contrast color relative to the surrounding sidewalk.⁴
